**MONITORING YEAR 1
ANNUAL REPORT**
Final

LYON HILLS MITIGATION SITE

Wilkes County, NC
Yadkin River Basin
HUC 03040101

DMS Project No. 100085
NCDEQ Contract No. 7620
USACE Action ID No. SAW-2018-01784
DWR Project No. 2018-1274 v1
Data Collection Dates: April-November 2021

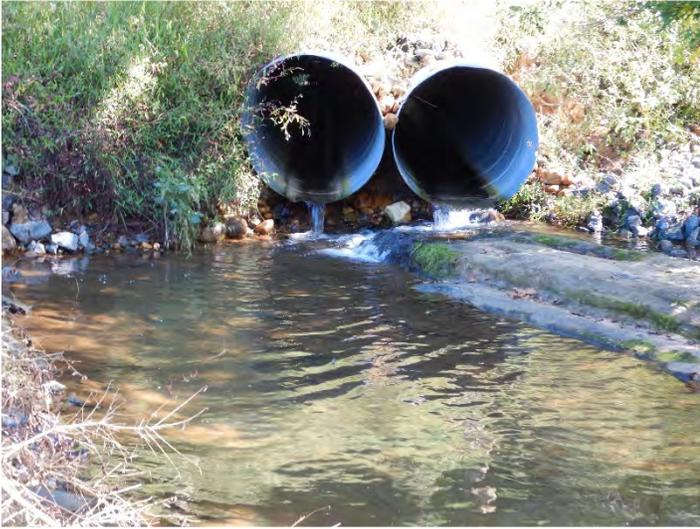
Hanks Branch R3 - Perched - Looking Upstream (09/27/2021)

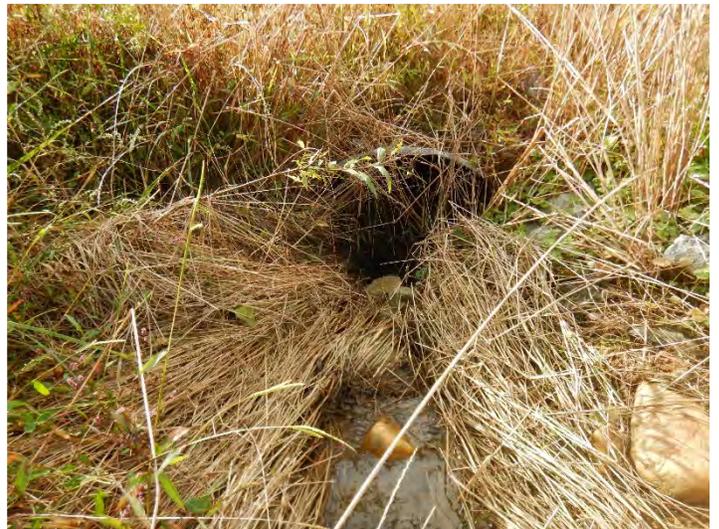
UT5 R2 - Looking Downstream (10/12/2021)

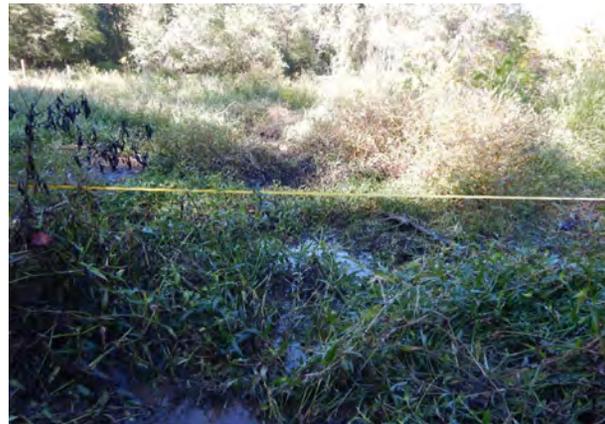
Cross-Section 11-UT5 Reach 2

Dense in-stream vegetation was observed along UT5 Reach 2 and sporadically found along UT4 Reach 1 and 3 (Figure 1c). Before vegetation was established on the banks, excess sediment washed into the channel from the surrounding areas after the pond was removed, causing aggradation along UT5 Reach 2. The in-stream vegetation continued to trap the sediment, preventing sediment from naturally moving through the system. Once the in-stream vegetation is treated in 2022, it is expected the sediment will flush through UT5. Dense vegetation has become established on the floodplain where the pond was removed, preventing further sediment from entering the stream. See Section 2.6 for further information on treating the in-stream vegetation.

0.9	x-section area (ft.sq.)
4.9	width (ft)
0.2	mean depth (ft)
0.4	max depth (ft)
5.1	wetted perimeter (ft)
0.2	hydraulic radius (ft)
26.3	width-depth ratio
35.0	W flood prone area (ft)
7.1	entrenchment ratio
< 1.0	low bank height ratio
