MONITORING YEAR 6 ANNUAL/CLOSEOUT REPORT

GLADE CREEK II RESTORATION PROJECT

Alleghany County, NC
DWR No. 20090049 v.2
DMS Project Number 92343
USACE Action ID 2009-00589

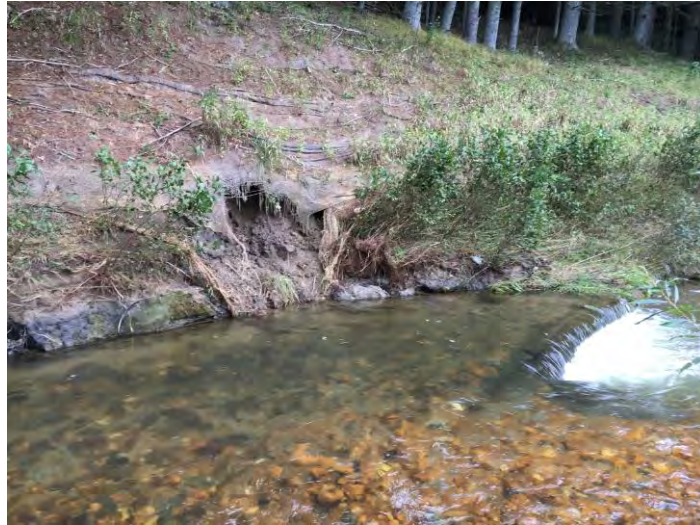
LEFT BANK HILLSLOPE EROSION AREA (STA 23+50)

Pre-construction - November 2019

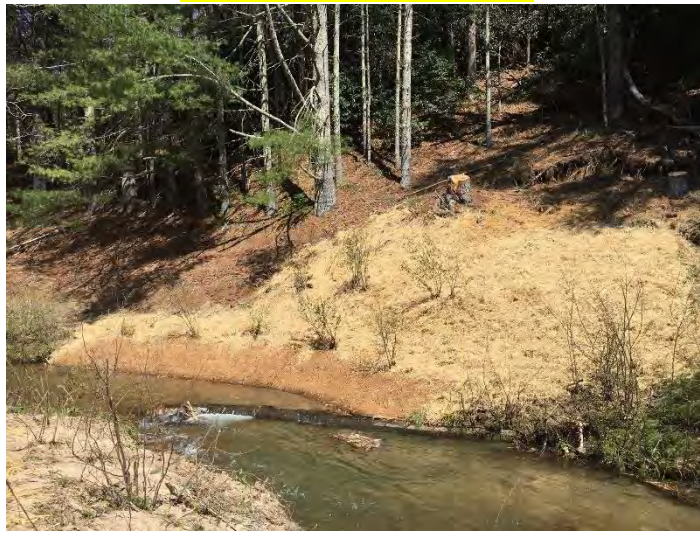
Post construction - April 2020

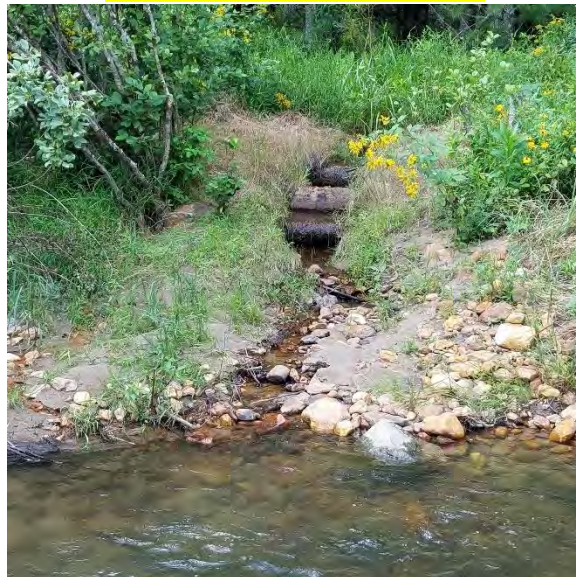
Wetland B Outlet Repair (STA 22+00)

Post construction - June 2020

Post construction - August 2020
