As-Built Baseline Monitoring Report FINAL Whittier Creek Mitigation Project

Surry County, North Carolina DMS Project ID No. 100020 DEQ Contract No. 7182 DWR# 17-1044 Yadkin River Basin: 03040101-110040 DMS RFP #16-006993 (Issued: 9/16/16) USACE Action ID No. SAW-2017-01503

Baseline Data Collection Period: Survey August 2021, Vegetation January 2022

Submission Date: April 2022

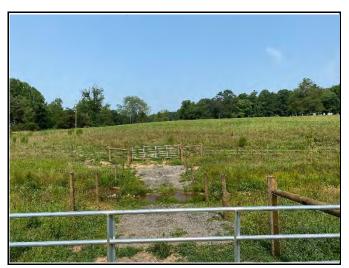
UT5 Rock Ford Crossing after fencing/gates installed (7/22/21)

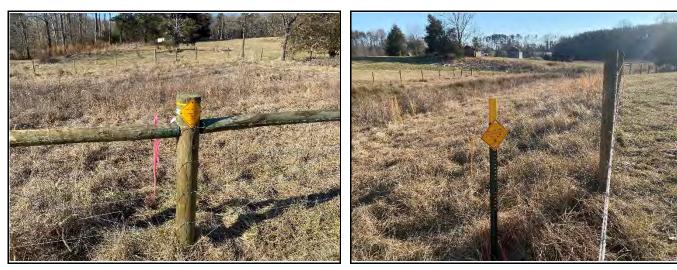
Fencing with CE marker (1/31/22)

Fencing with CE marker located inside (1/31/22)

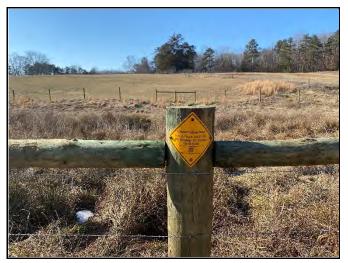
Fencing with CE marker (1/31/22)
