# **MYO FINAL MONITORING REPORT**

# LAUREL SPRINGS STREAM AND WETLAND MITIGATION SITE

Avery County, North Carolina French Broad River Basin Cataloging Unit 06010108

DMS Project No. 100122
Full Delivery Contract No. 7890
DMS RFP No. 16-007725 (issued 11/13/18)
USACE Action ID No. SAW-2019-00835
DWR Project No. 2019-0865

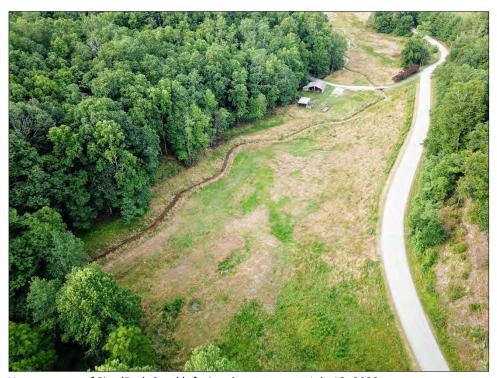
Upper extent of Site (Fork Creek), facing downstream – July 13, 2022

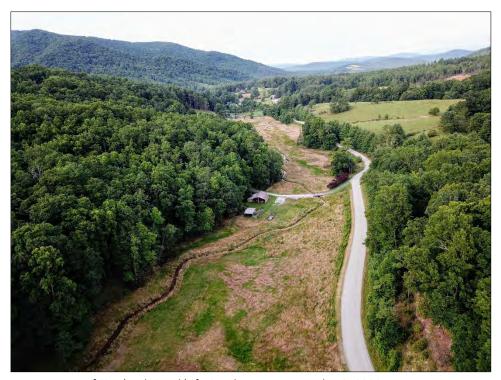
Upper extent of Site (Fork Creek), facing downstream – July 13, 2022

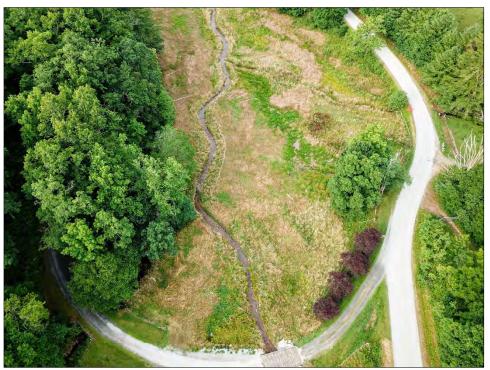
Downstream of Fork Creek crossing & UT1 confluence, facing downstream – July 13, 2022

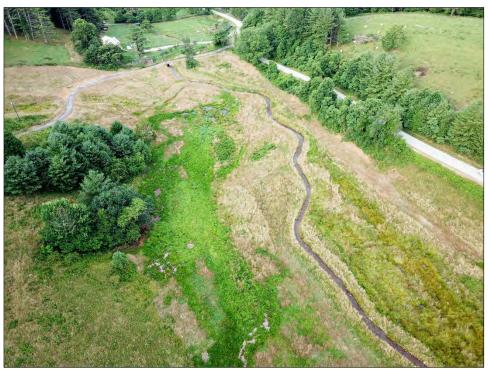
Downstream extent of Site (Fork Creek), UT2 confluence, facing downstream – July 13, 2022

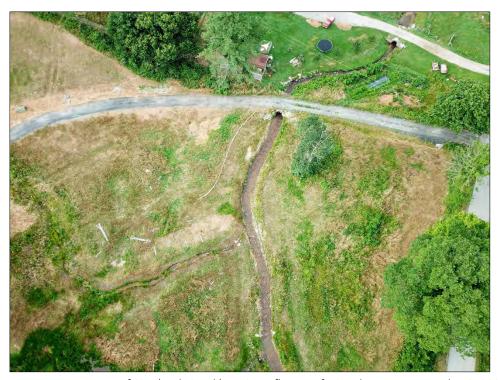
Downstream extent of Site (Fork Creek), UT2 confluence, facing downstream – July 13, 2022

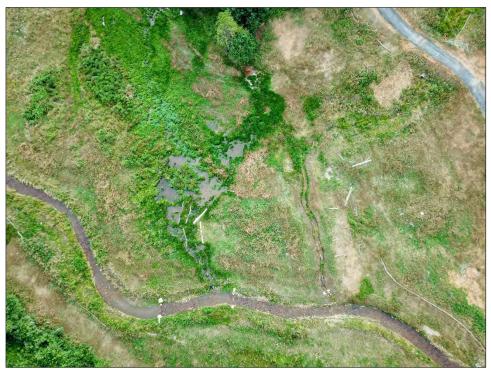
Fork Creek and UT2 confluence – July 13, 2022

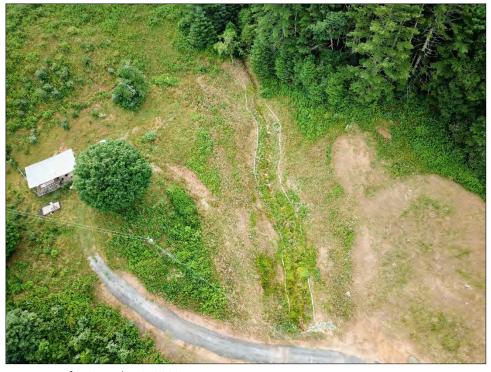
Upstream of UT2 – July 13, 2022

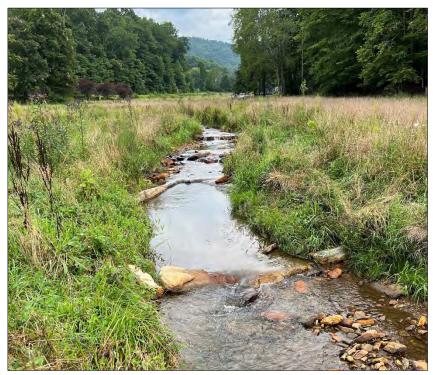
7. Section 2 As-Built Condition (Baseline): As discussed during the August 25, 2022 site visit, please provide additional discussion and details about the rock sills added to the site during construction. Additional report discussion of the sills, photos, and typical drawing details should be added to the MYO report and record drawings as necessary to relay the necessity and function of the added sill structures. Response: Section 2.1 was added to explain the necessity and function of the rock sills. It was explained that the sills consist of additional large cobble, they are not engineered or designed to hold grade, and are expected to shift and naturalize with the stream over time. Therefore, typical drawings were not included in the record drawings. Photos of sills have been added to the photo log in Appendix A.

Fork Creek – Rock sill, typical – August 25, 2022

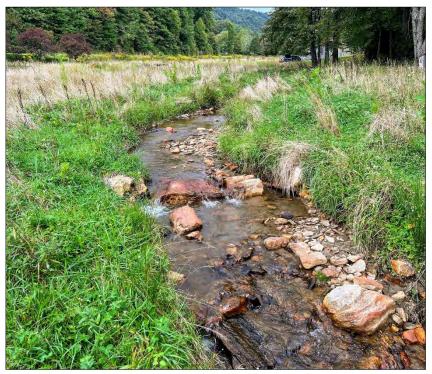
Fork Creek – Rock sill, typical – August 25, 2022

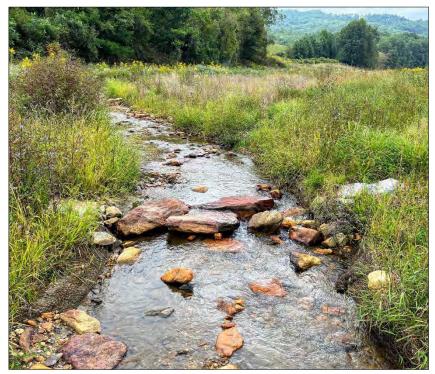
Fork Creek – Rock sill, typical – August 25, 2022
