# **Annual Monitoring Report**

Monitoring Year 1 of 7

Project Name: 601 East Stream Restoration

Data Collected: September 2015 – November 2015

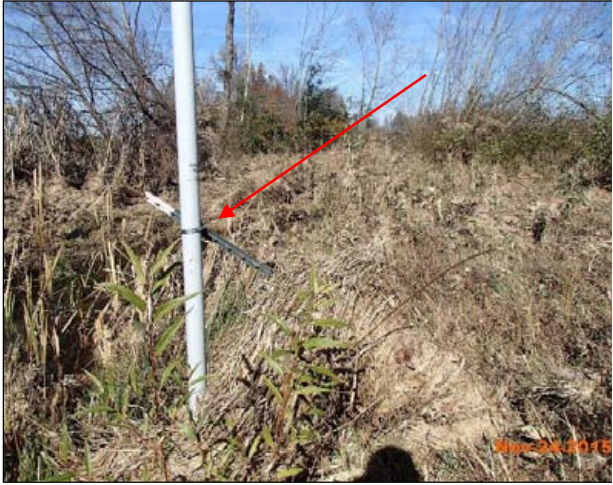
**Figure 3. Photo Verification of Bankful Events**

Wrack Lines Downstream of Crest Gauge on Reach 2

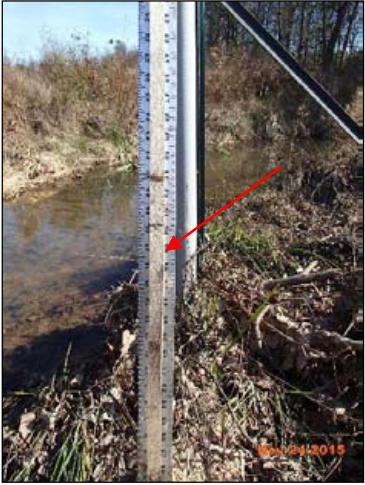
**Figure 4. Photo Verification of Bankful Events**

Reach 3 Crest Gauge

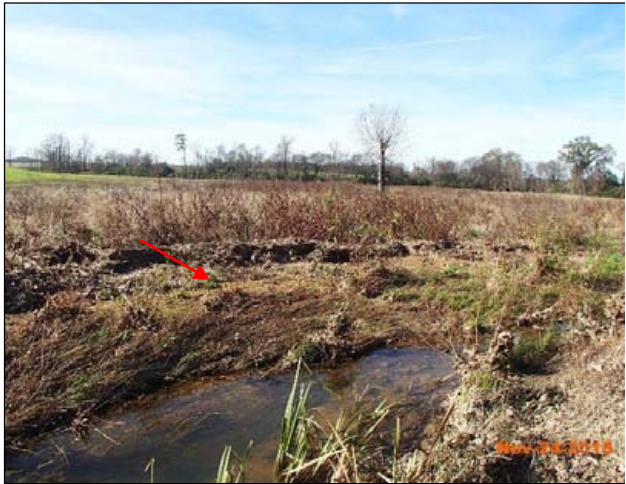
**Figure 5. Photo Verification of Bankful Events**

Wrack Lines Downstream of Crest Gauge on Reach 3
