**601 North II
Stream Restoration Site
NCDMS Project Number: 95025
Monitoring Contract Number: 003991
Monitoring Year 4
2016**

**601 North II
Stream Restoration Site
2016 Monitoring Report (MY 4)**

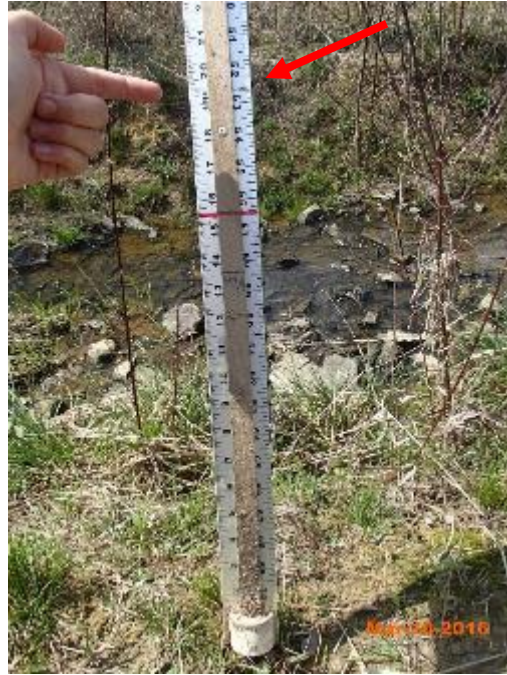
Reach 2 Crest Gauge

Bankfull Photo Verification

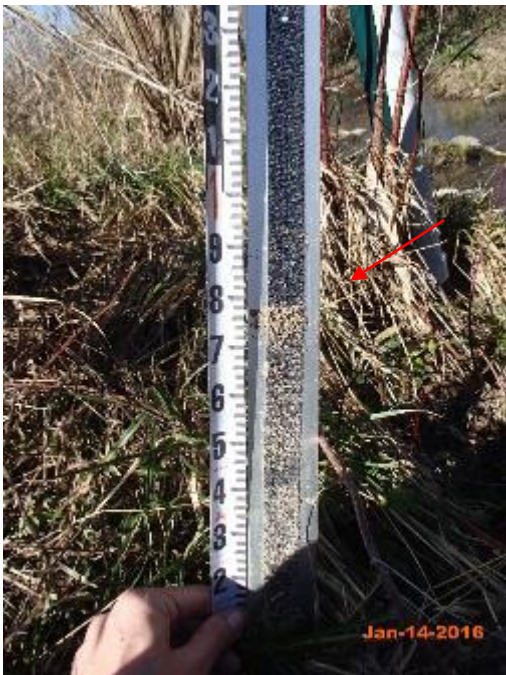
Reach 5 Crest Gauge

Bankfull Photo Verification
