YEAR 3 (2017) MONITORING REPORT
ABBEY LAMM
STREAM AND WETLAND MITIGATION SITE
ALAMANCE COUNTY, NORTH CAROLINA
FULL DELIVERY CONTRACT NO. 5790

CAPE FEAR RIVER BASIN
CATALOGING UNIT 03030002

Data Collection – March-October 2017

January 2018

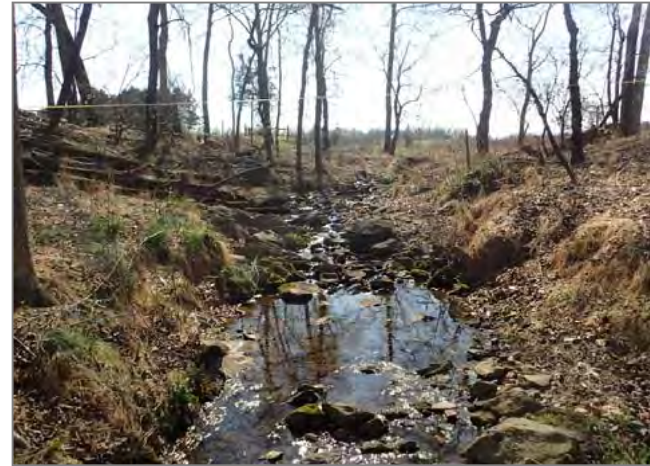
Site	Abbey Lamm
Watershed:	Cape Fear, 0303002
XS ID	Main Channel XS - 19, Pool
Feature	Pool
Date:	3/27/2017
Field Crew:	Perkinson, Keith

SUMMARY DATA	
Bankfull Elevation:	98.6
Bankfull Cross-Sectional Area:	13.4
Bankfull Width:	11.7
Flood Prone Area Elevation:	NA
Flood Prone Width:	NA
Max Depth at Bankfull:	1.5
Mean Depth at Bankfull:	1.1
W / D Ratio:	NA
Entrenchment Ratio:	NA
Bank Height Ratio:	1.8

Enhancement Level II Reach. BHR varies through this reach; however, the reach is stable.

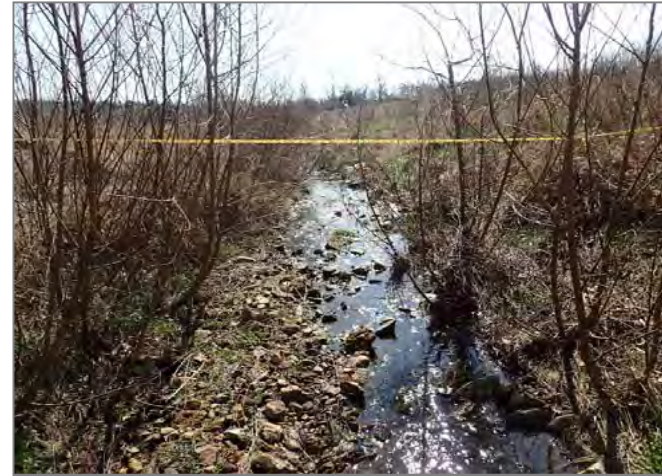
Site	Abbey Lamm
Watershed:	Cape Fear, 0303002
XS ID	Main Channel XS - 20, Pool
Feature	Pool
Date:	3/27/2017
Field Crew:	Perkinson, Keith

Sediment has aggraded behind a bedrock sill. Sediment has been stable MY-01 through MY-03.

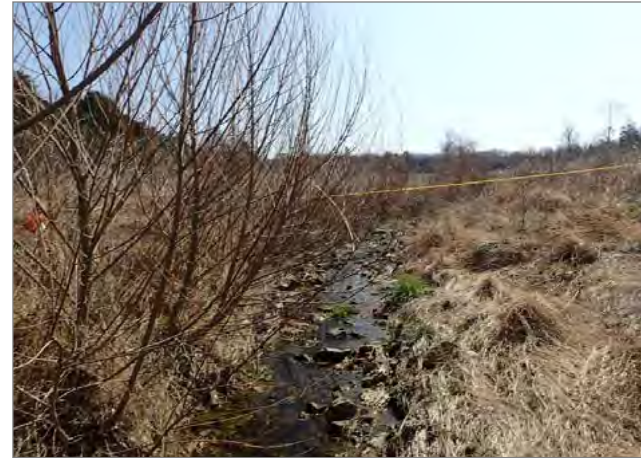
Site	Abbey Lamm
Watershed:	Cape Fear, 0303002
XS ID	Main Channel XS - 21, Riffle
Feature	Riffle
Date:	3/27/2017
Field Crew:	Perkinson, Keith

SUMMARY DATA	
Bankfull Elevation:	104.7
Bankfull Cross-Sectional Area:	9.1
Bankfull Width:	13.0
Flood Prone Area Elevation:	106.3
Flood Prone Width:	90.0
Max Depth at Bankfull:	1.6
Mean Depth at Bankfull:	0.7
W / D Ratio:	18.6
Entrenchment Ratio:	6.9
Bank Height Ratio:	1.14

No problems have been noted in this reach. Elevated BHR results from shallow channel depth.

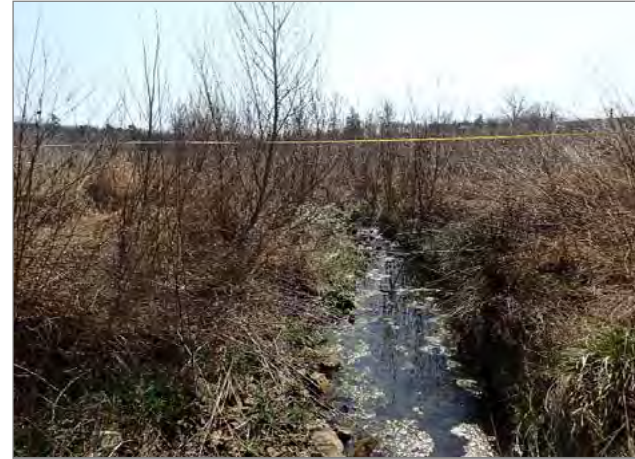
Site	Abbey Lamm
Watershed:	Cape Fear, 0303002
XS ID	Main Channel XS - 22, Riffle
Feature	Riffle
Date:	3/27/2017
Field Crew:	Perkinson, Keith

SUMMARY DATA	
Bankfull Elevation:	105.5
Bankfull Cross-Sectional Area:	11.5
Bankfull Width:	13.3
Flood Prone Area Elevation:	107.7
Flood Prone Width:	90.0
Max Depth at Bankfull:	2.2
Mean Depth at Bankfull:	0.9
W / D Ratio:	15.4
Entrenchment Ratio:	6.8
Bank Height Ratio:	1.57

Overall channel area has decreased. Sediment mobilization has resulted in minor downcutting, which has stabilized over the past 3 years. No problems are visible in this reach.

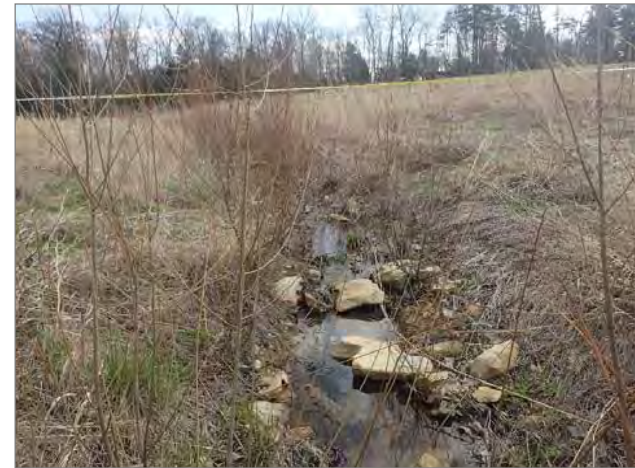
Site	Abbey Lamm
Watershed:	Cape Fear, 0303002
XS ID	UT 1 XS - 3, Riffle
Feature	Riffle
Date:	3/27/2017
Field Crew:	Perkinson, Jernigan

SUMMARY DATA	
Bankfull Elevation:	128.8
Bankfull Cross-Sectional Area:	6.4
Bankfull Width:	8.4
Flood Prone Area Elevation:	130.8
Flood Prone Width:	50.0
Max Depth at Bankfull:	2.0
Mean Depth at Bankfull:	0.8
W / D Ratio:	11.0
Entrenchment Ratio:	6.0
Bank Height Ratio:	1.67

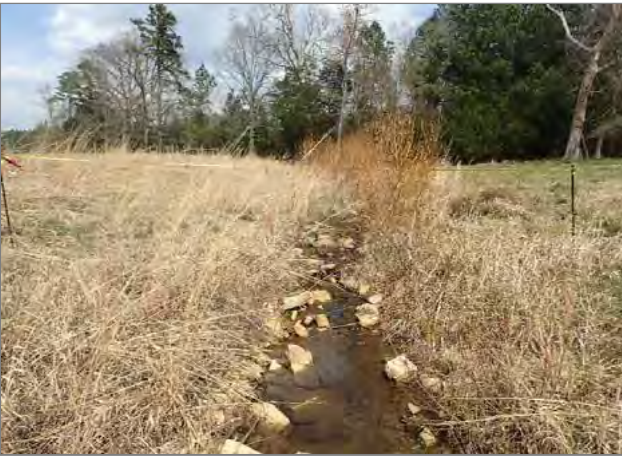
Site	Abbey Lamm
Watershed:	Cape Fear, 0303002
XS ID	UT 2 XS - 5, Riffle
Feature	Riffle
Date:	3/27/2017
Field Crew:	Perkinson, Jernigan

Overall channel area has remained constant. Sediment mobilization has resulted in minor downcutting, which has stabilized over the past 3 years. No problems are visible in this reach.

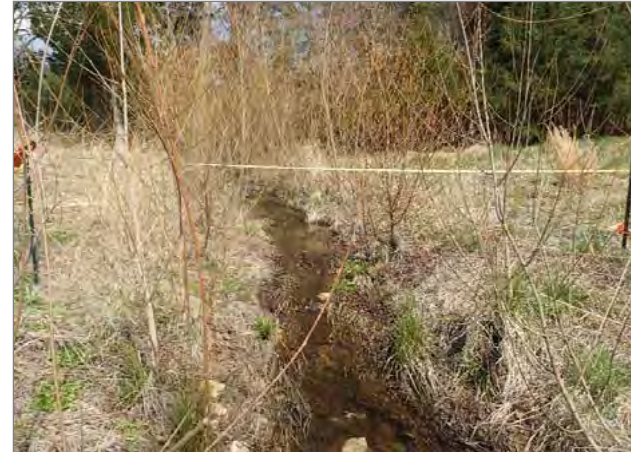
Site	Abbey Lamm
Watershed:	Cape Fear, 0303002
XS ID	UT 2 XS - 6, Riffle
Feature	Riffle
Date:	3/27/2017
Field Crew:	Perkinson, Jernigan

No problems have been noted in this reach. Elevated BHR results from shallow channel depth.

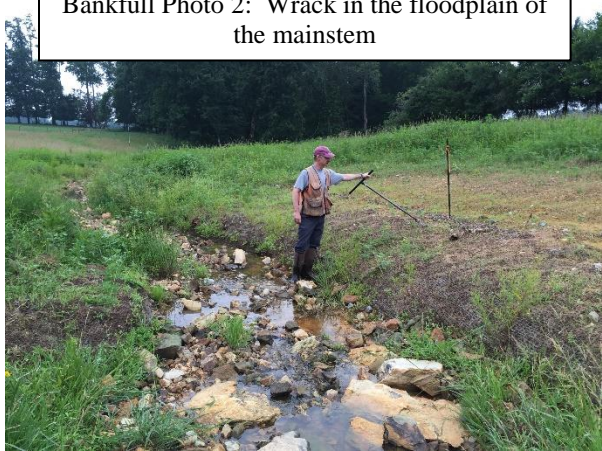
Bankfull Photo 2: Wrack in the floodplain of the mainstem

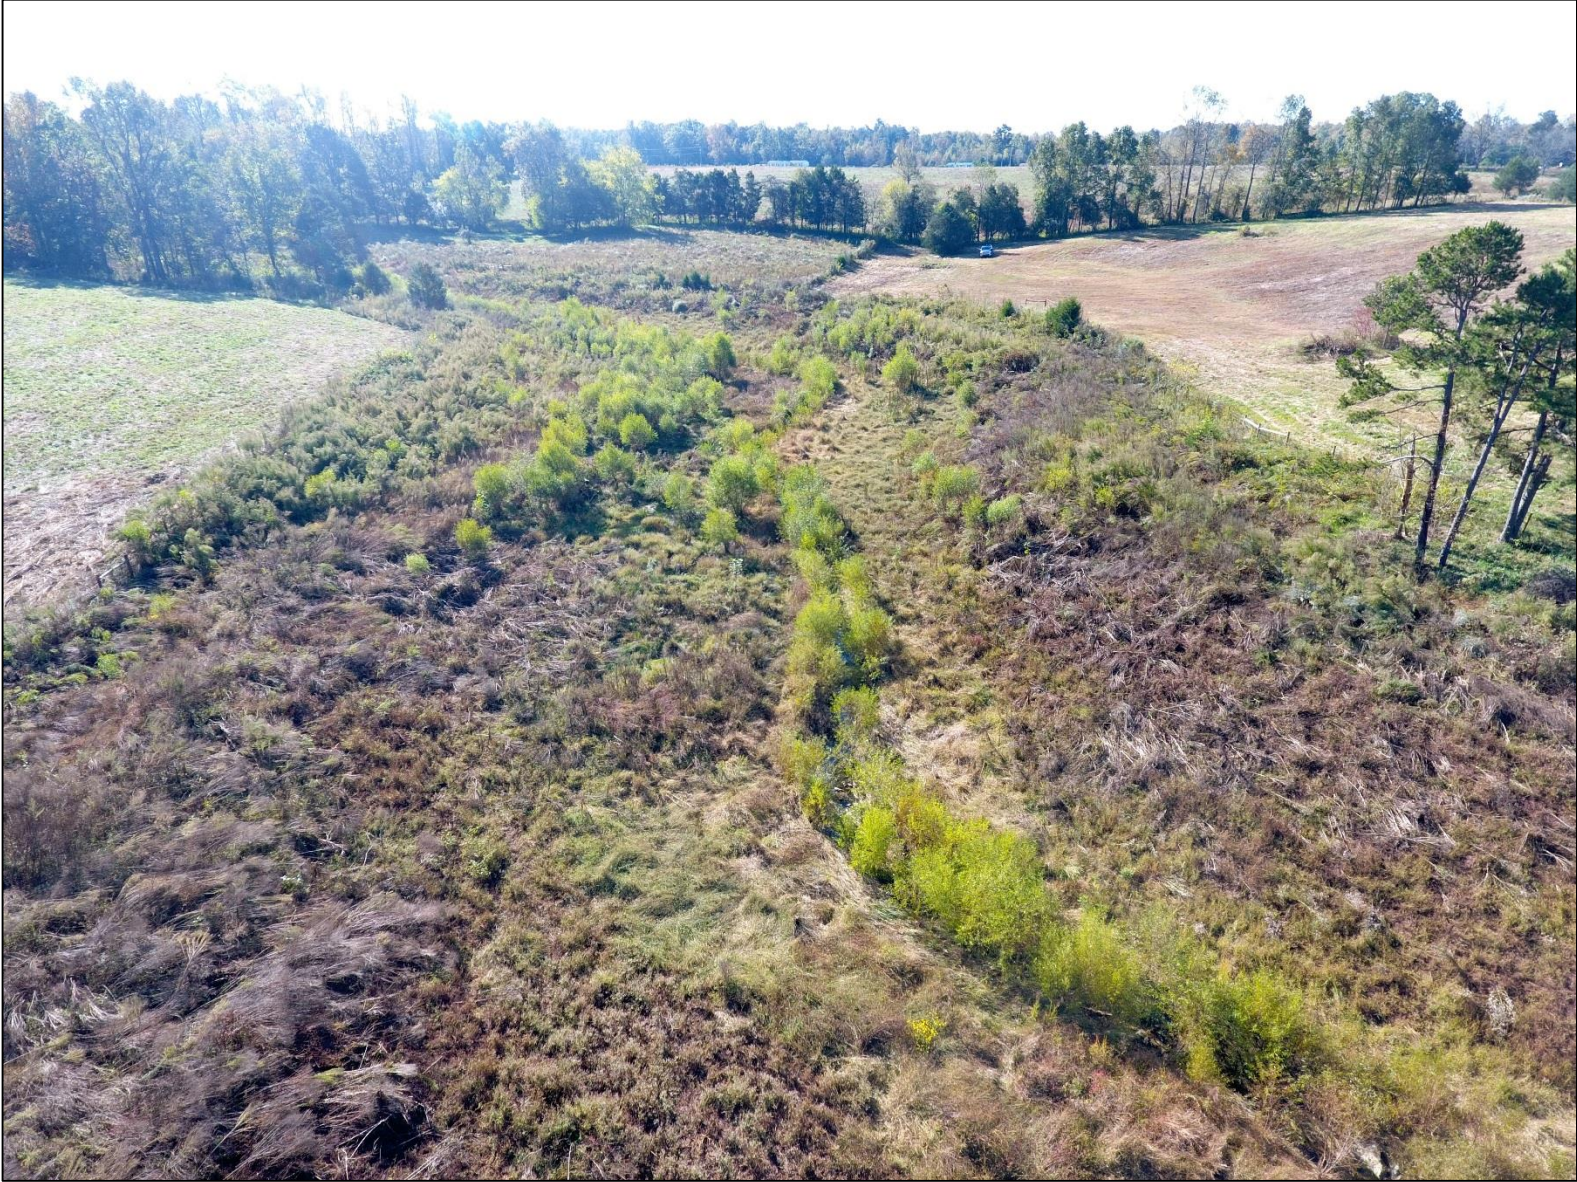
Photo 2: Downstream end of the Main Stem looking upstream into the old pond bed

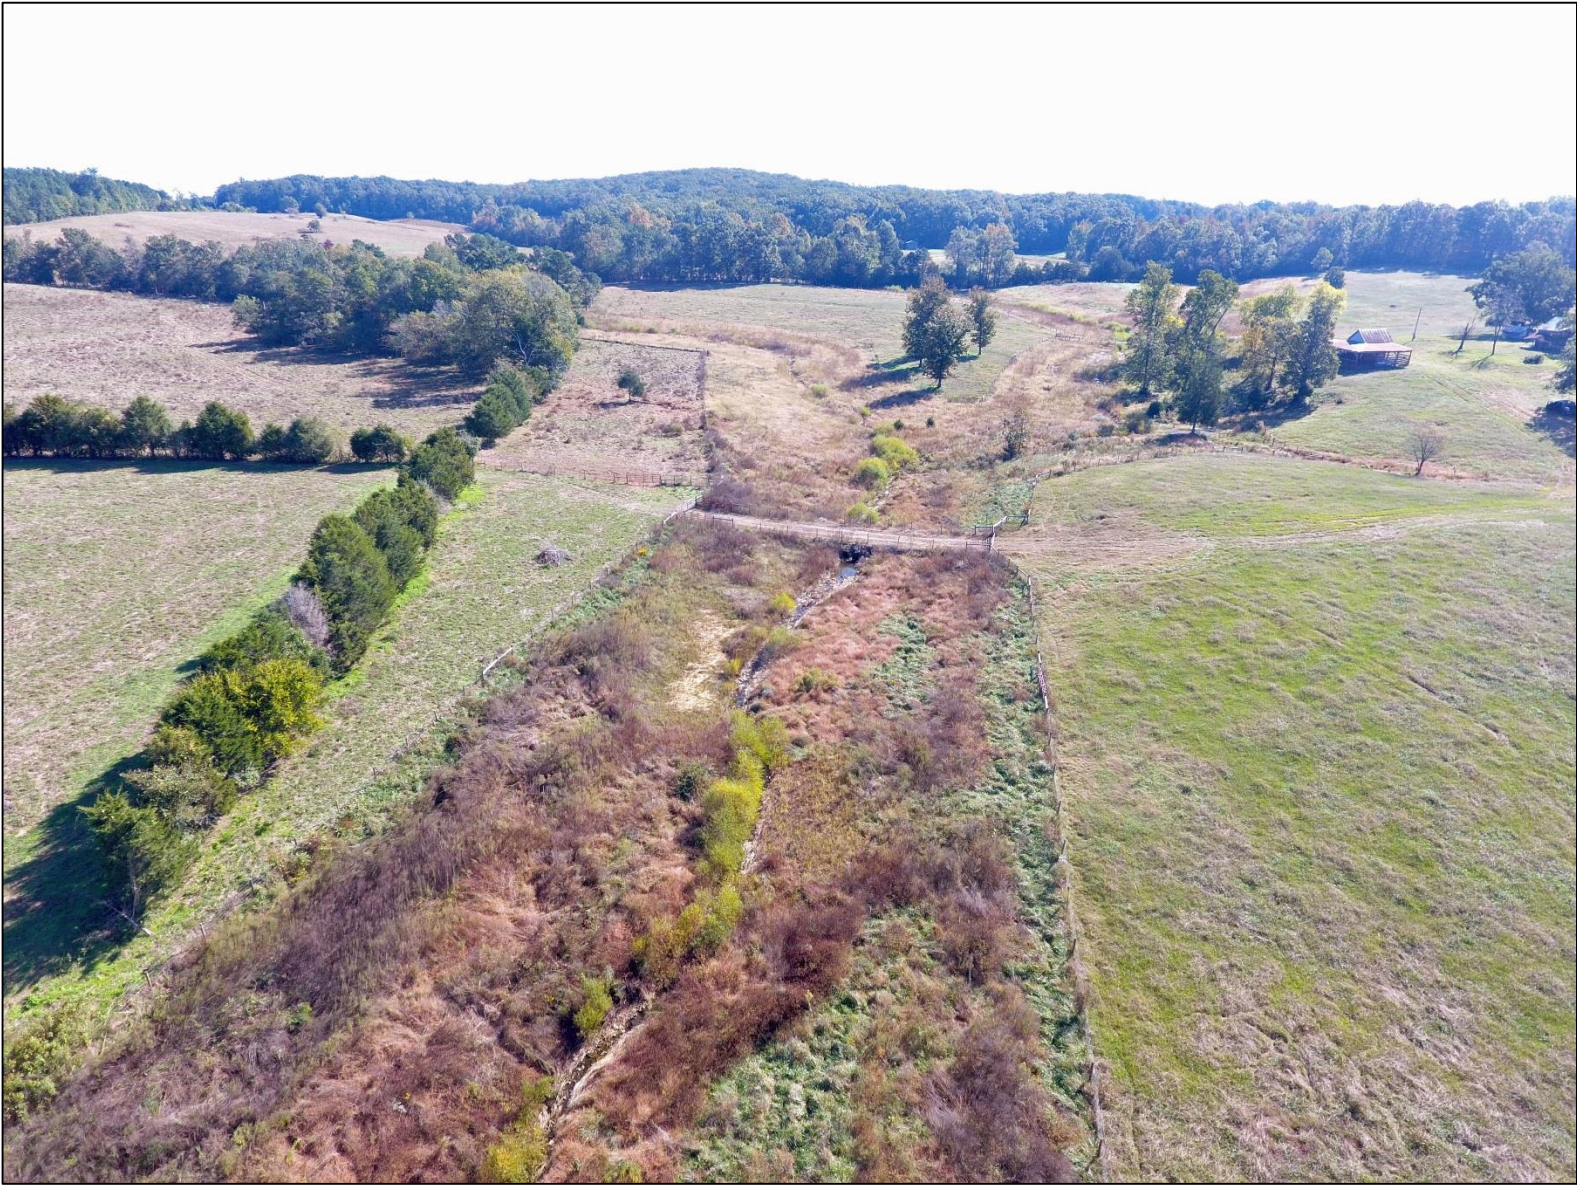
Photo 6: middle crossing looking upstream at the Main Stem and UT-3 on the left
