YEAR 6 (2020) MONITORING REPORT
ABBEY LAMM
STREAM AND WETLAND MITIGATION SITE
ALAMANCE COUNTY, NORTH CAROLINA
FULL DELIVERY CONTRACT No. 5790
DMS PROJECT No. 96311
NCDWR PROJECT No. 20140336
USACE ACTION ID No. SAW-2014-01710

Abbey Lamm Year 6, 2020 Monitoring Summary

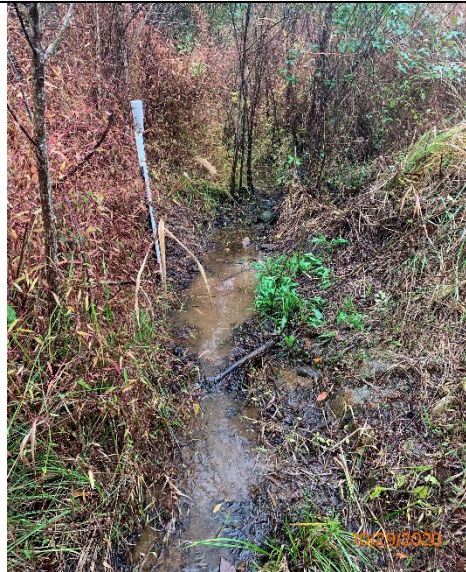
UT-1 channel formation at the stream gauge

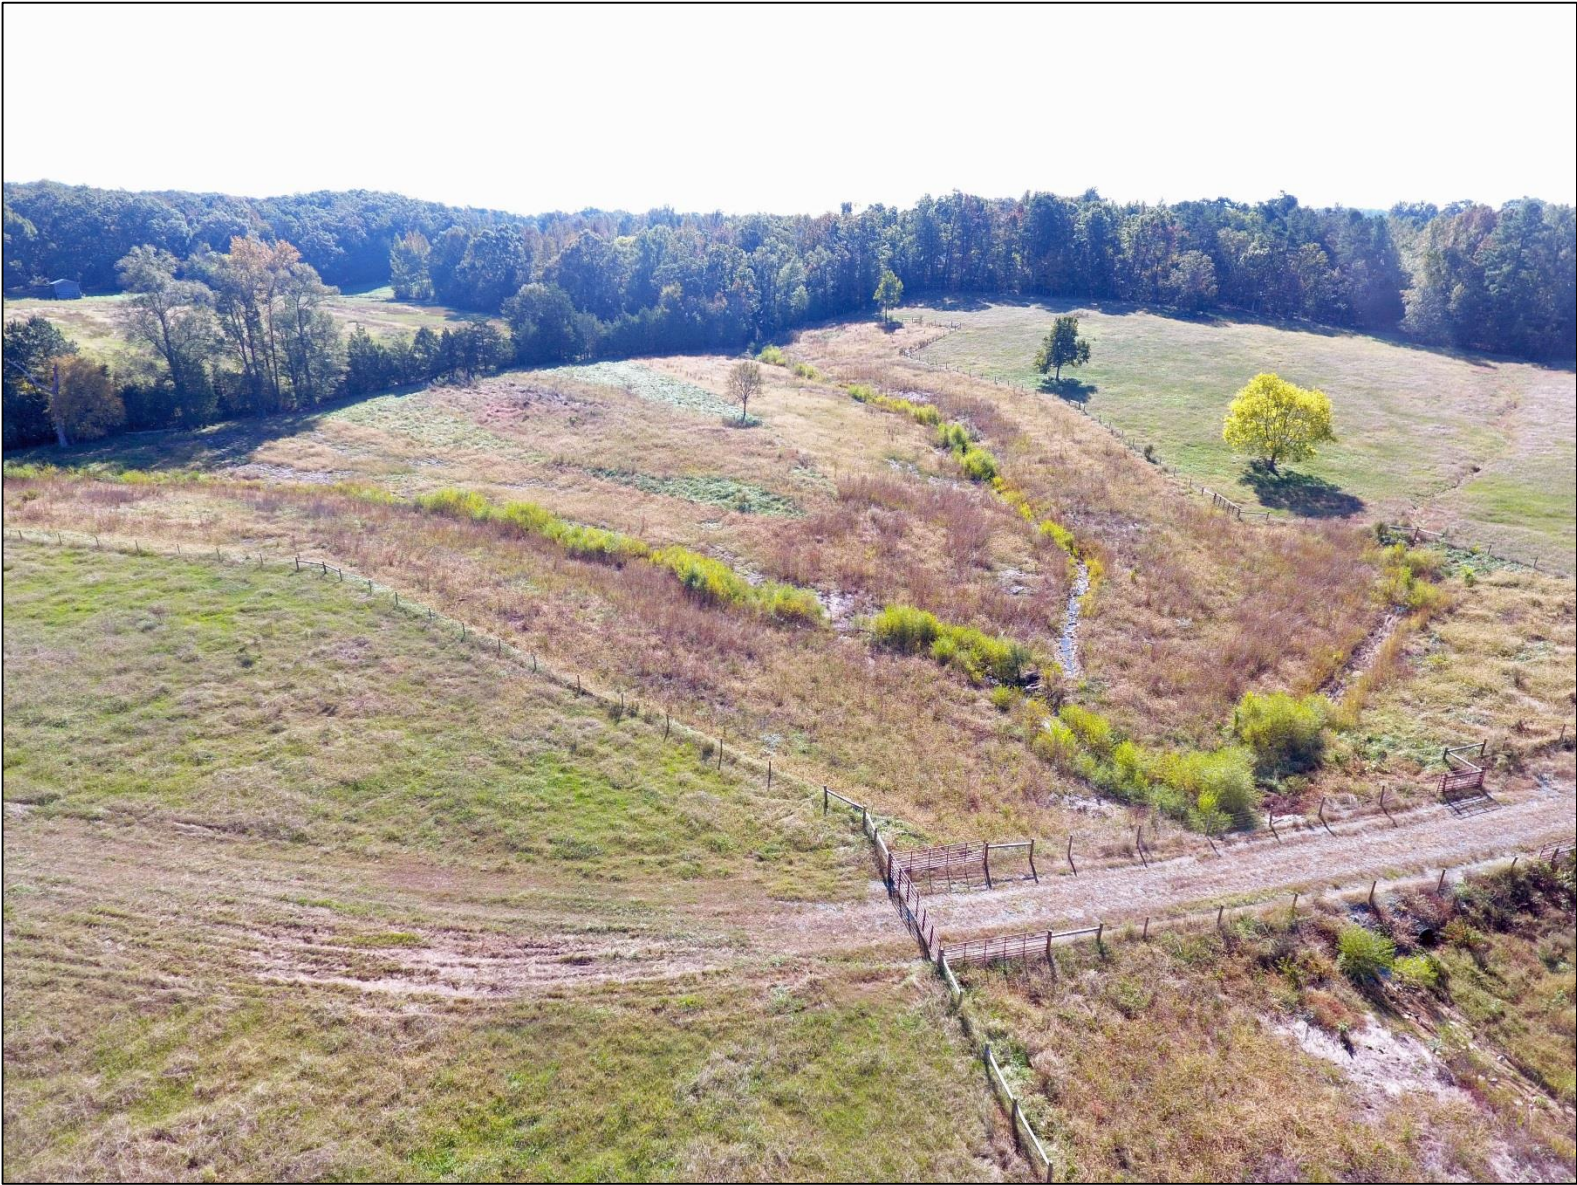
Photo 7: UT 1 & UT-2

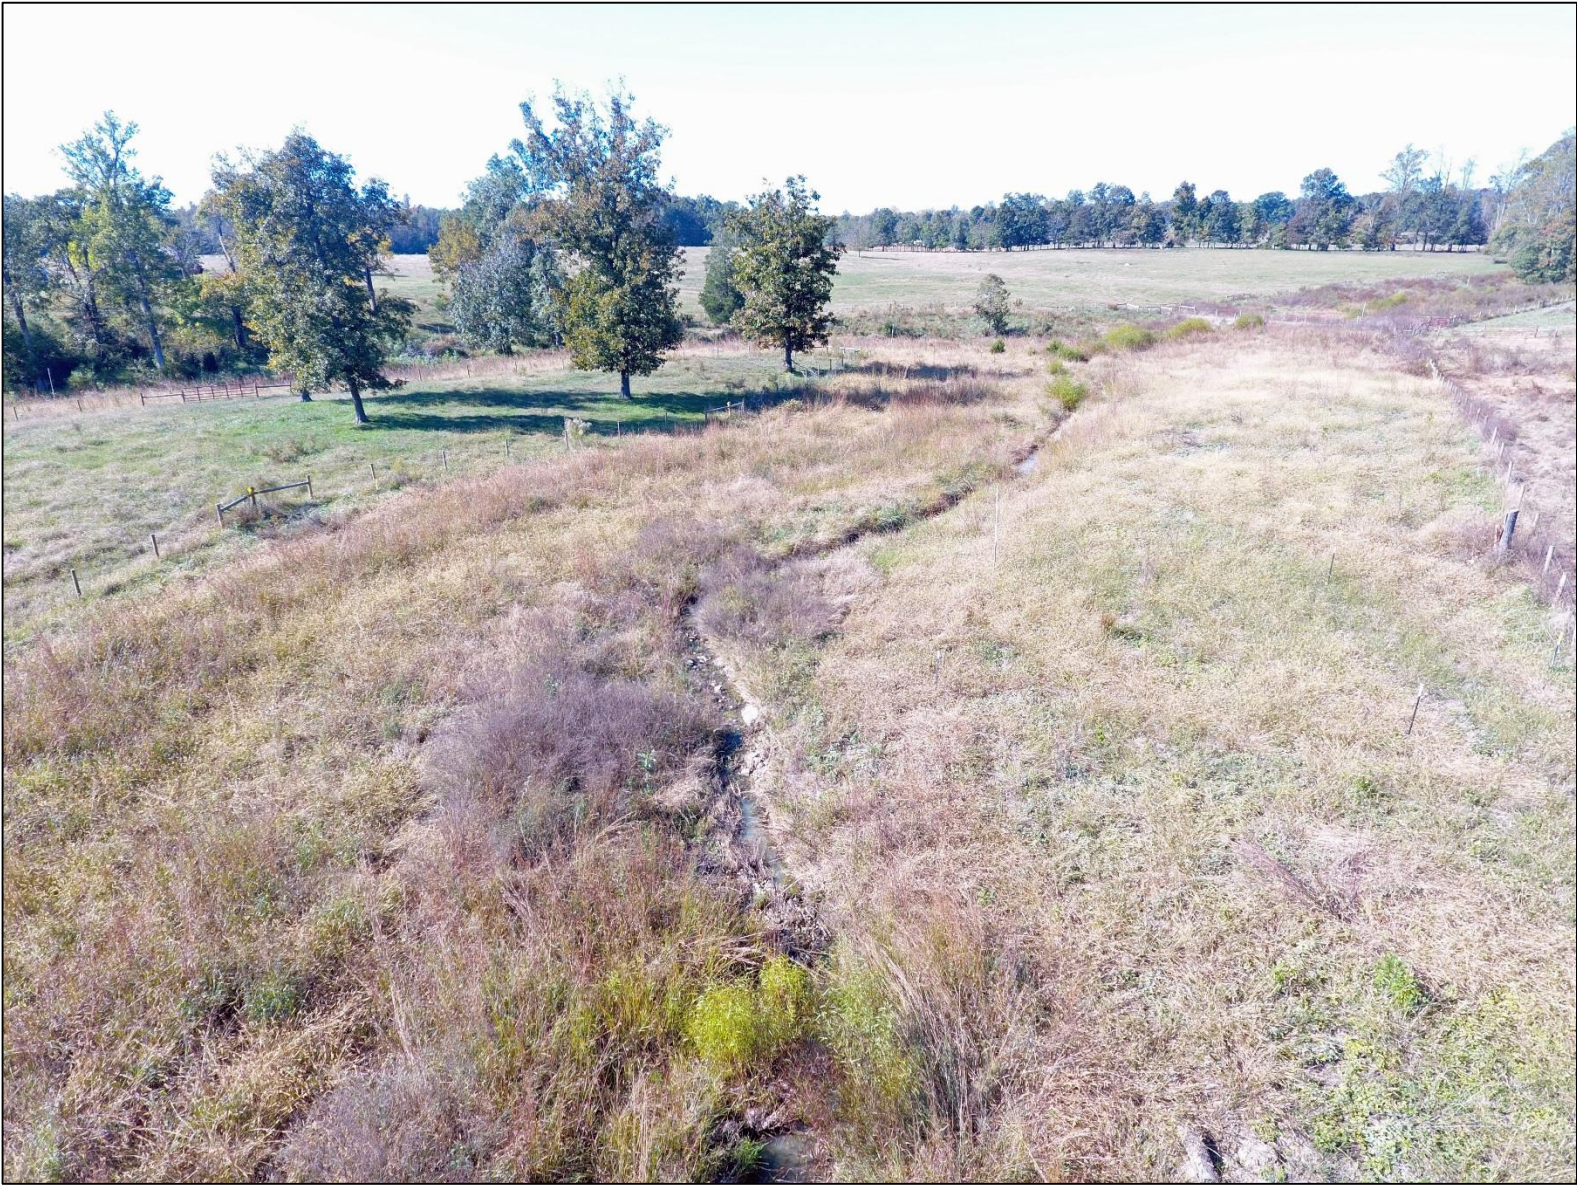
Photo 8: UT 3 (XC 5, 6, 7)

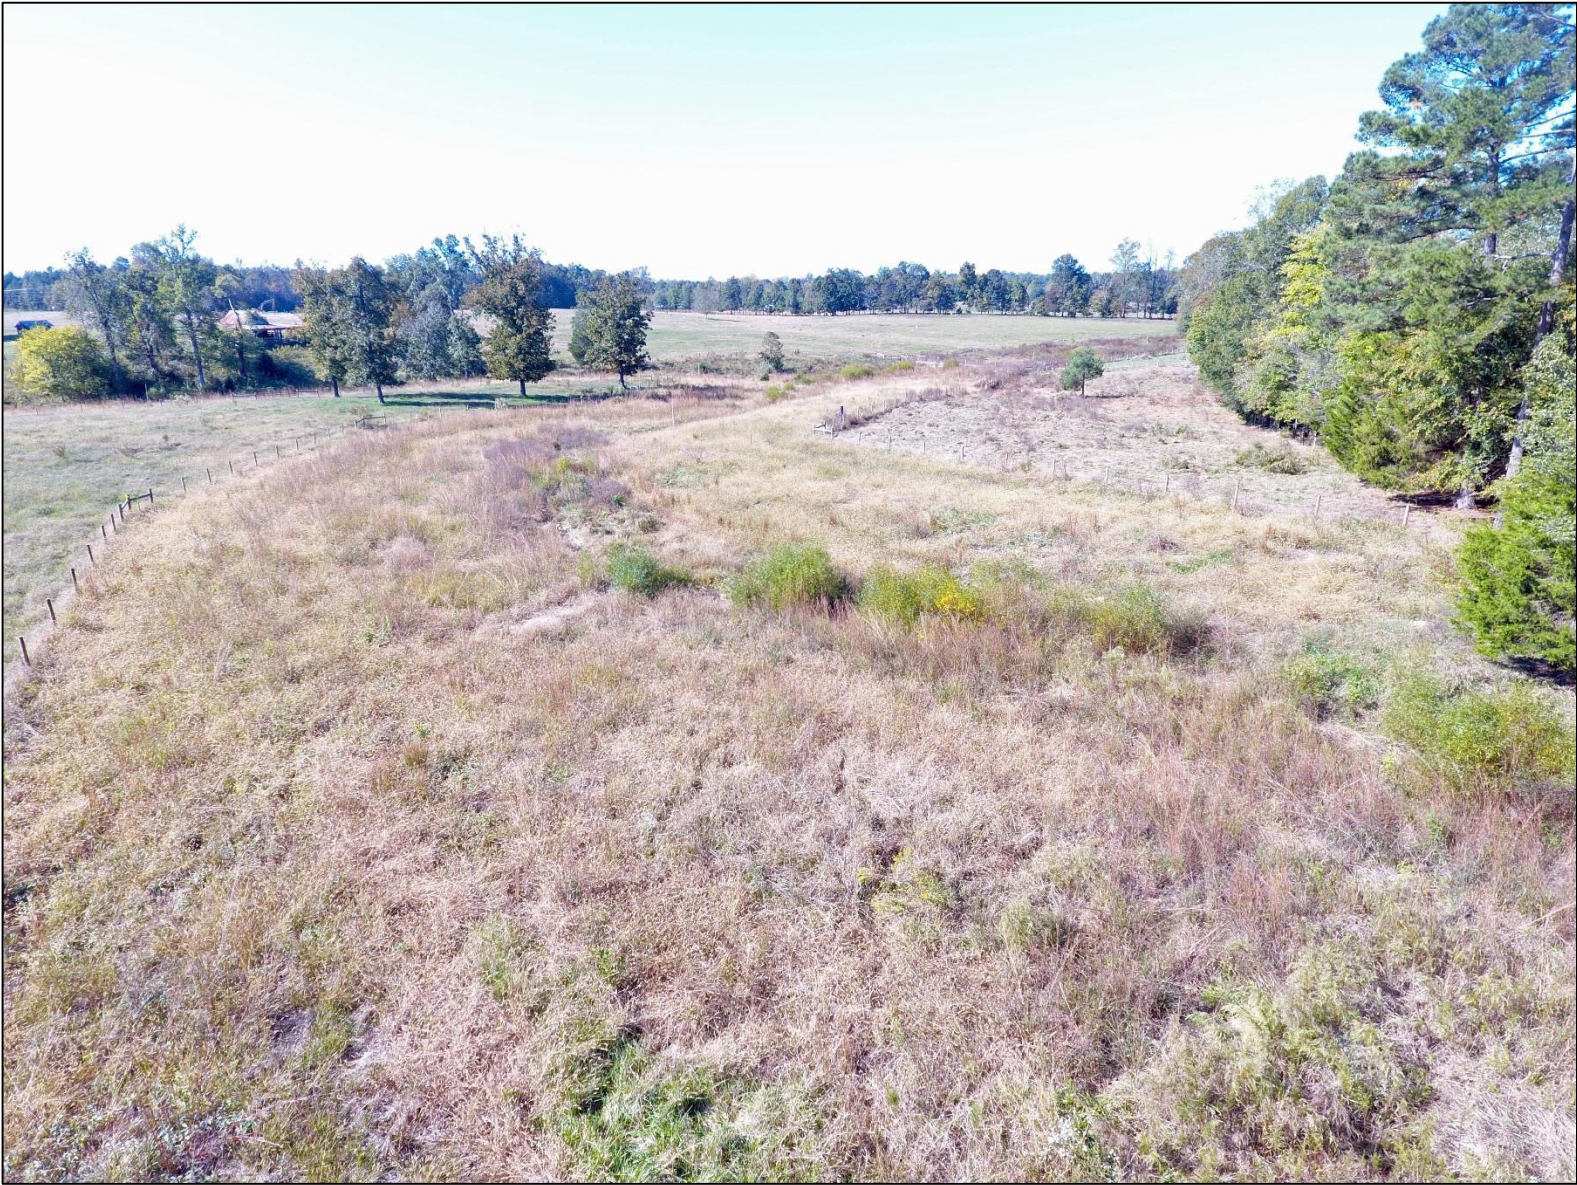
Photo 9: UT 3 (XC 6, 7, 8)

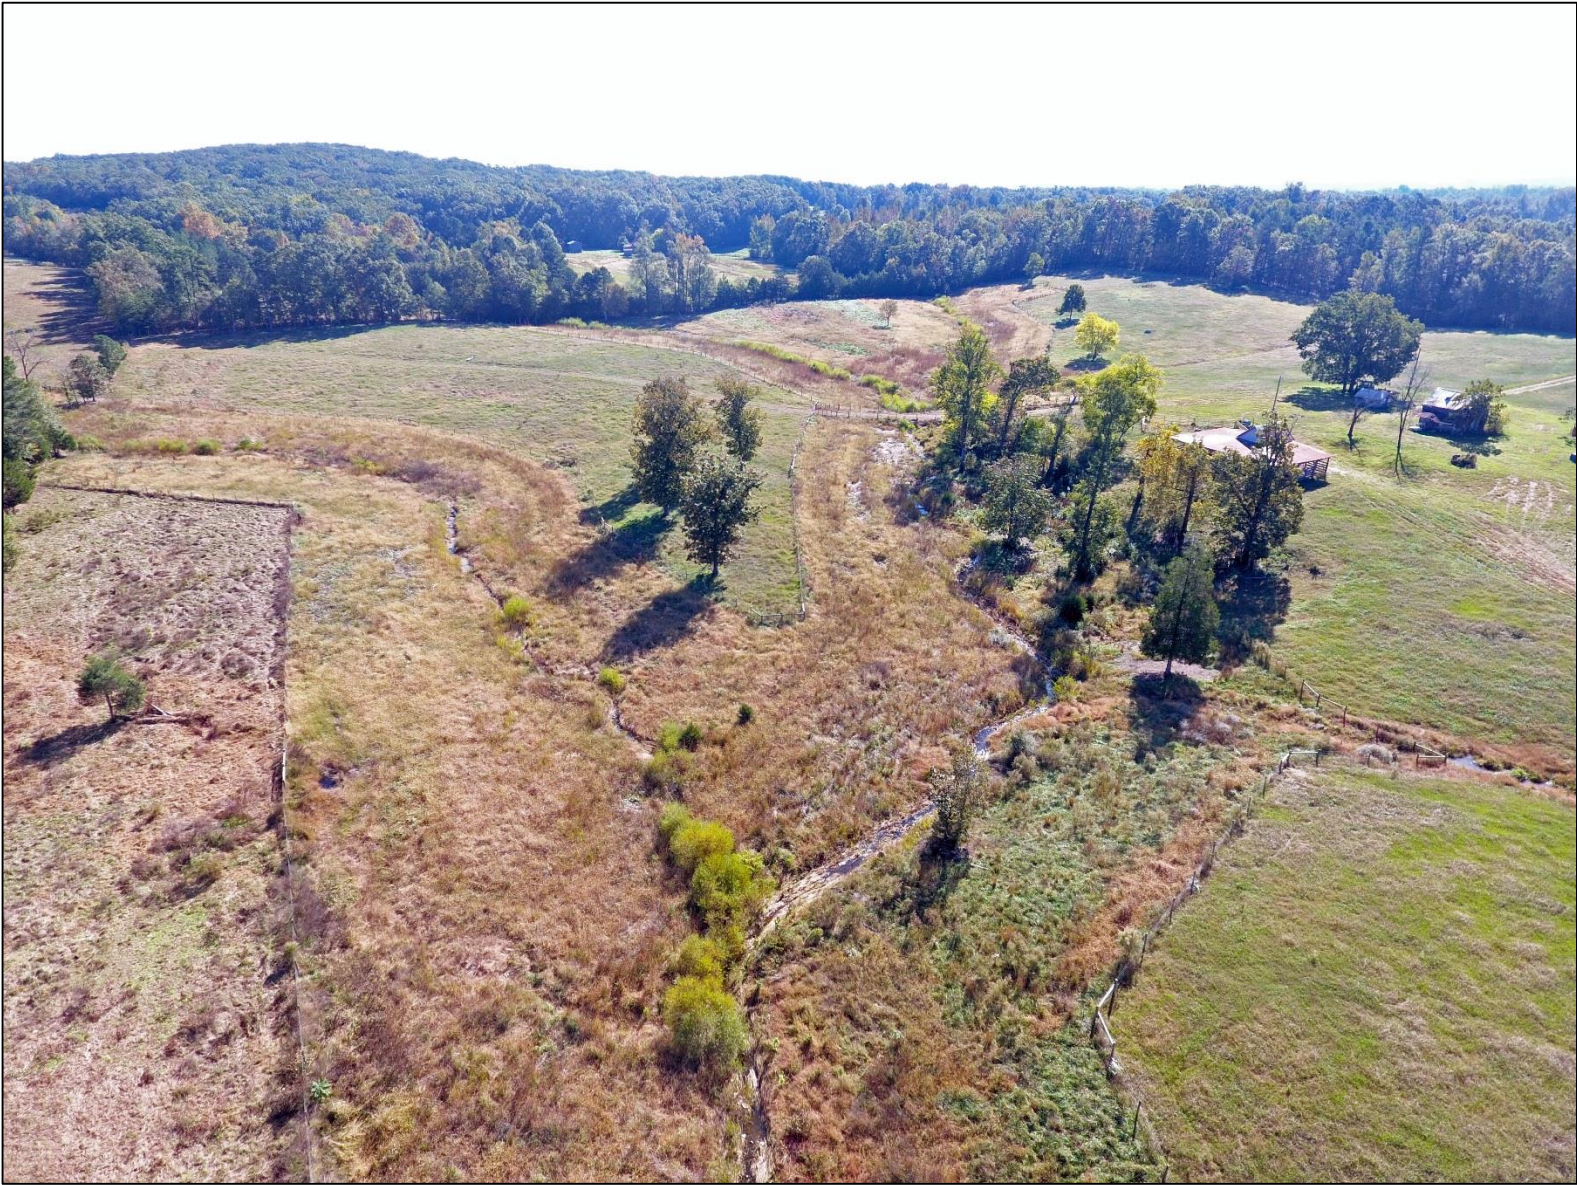
Photo 10: UT-1, 2, 3, & Main Stem

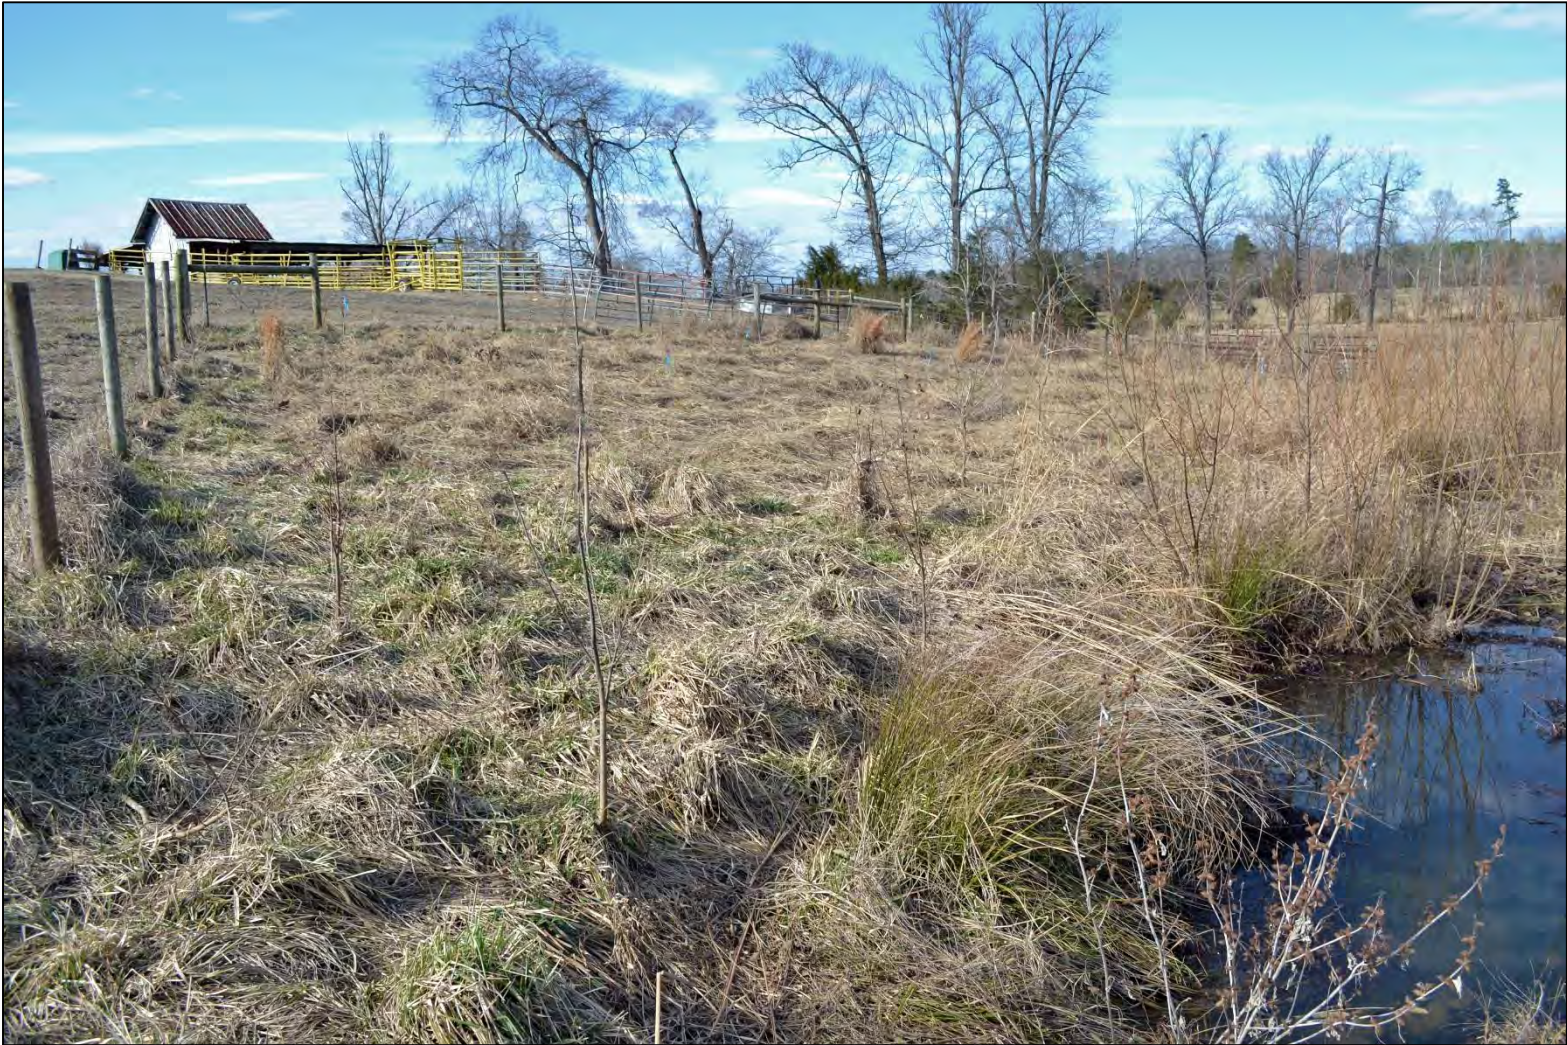
Photo 8: Looking NW. in Replant Area 10.

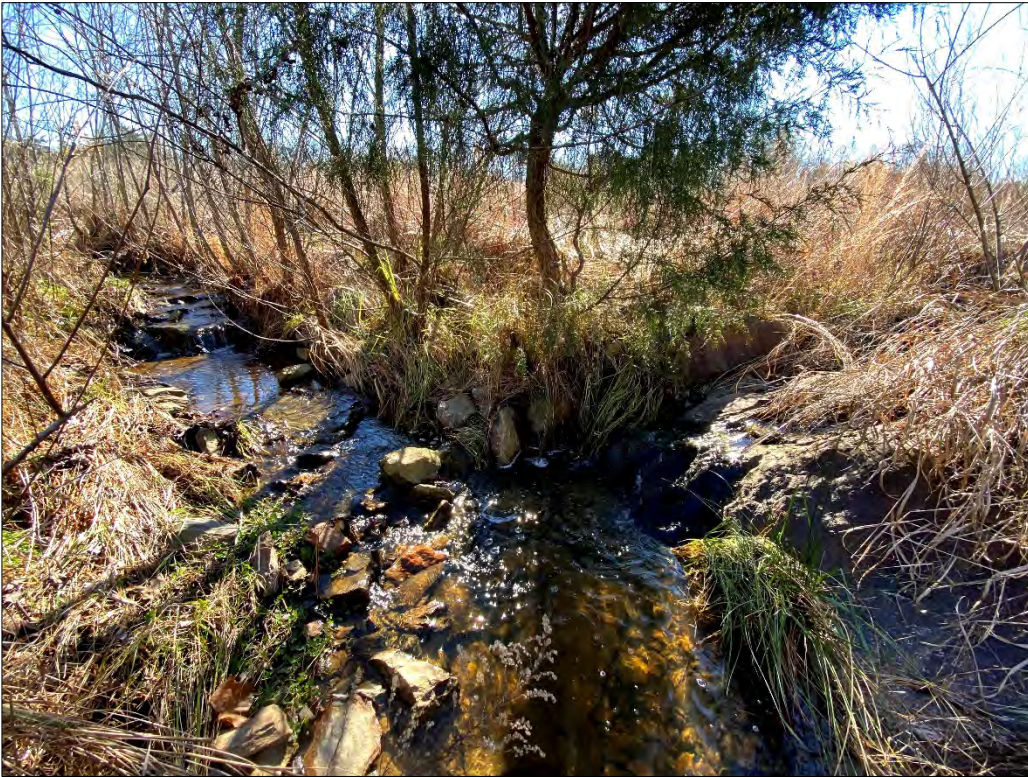
Confluence of UT1 and UT2

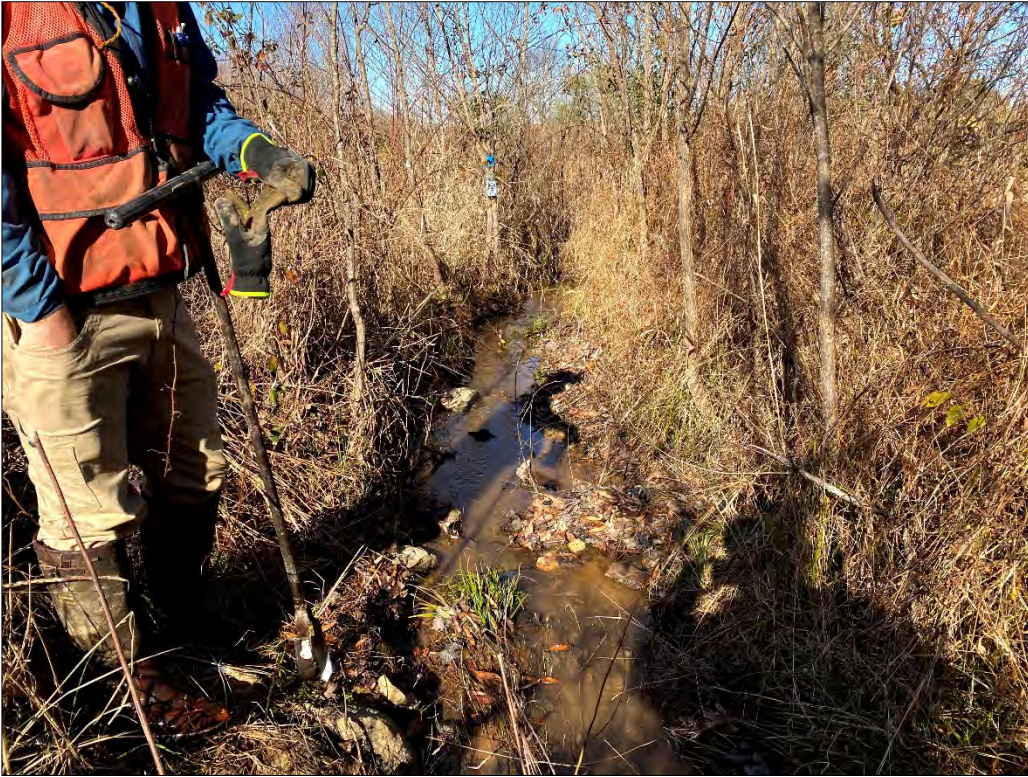
Upper Extent of UT1

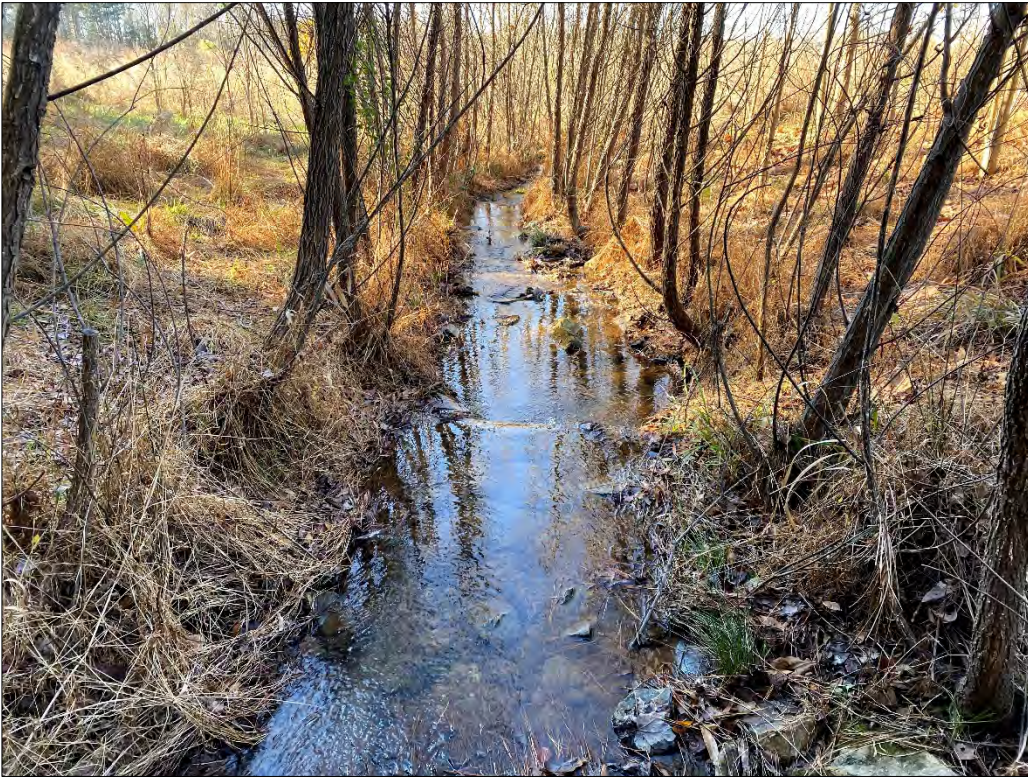
Upper Extent of UT2

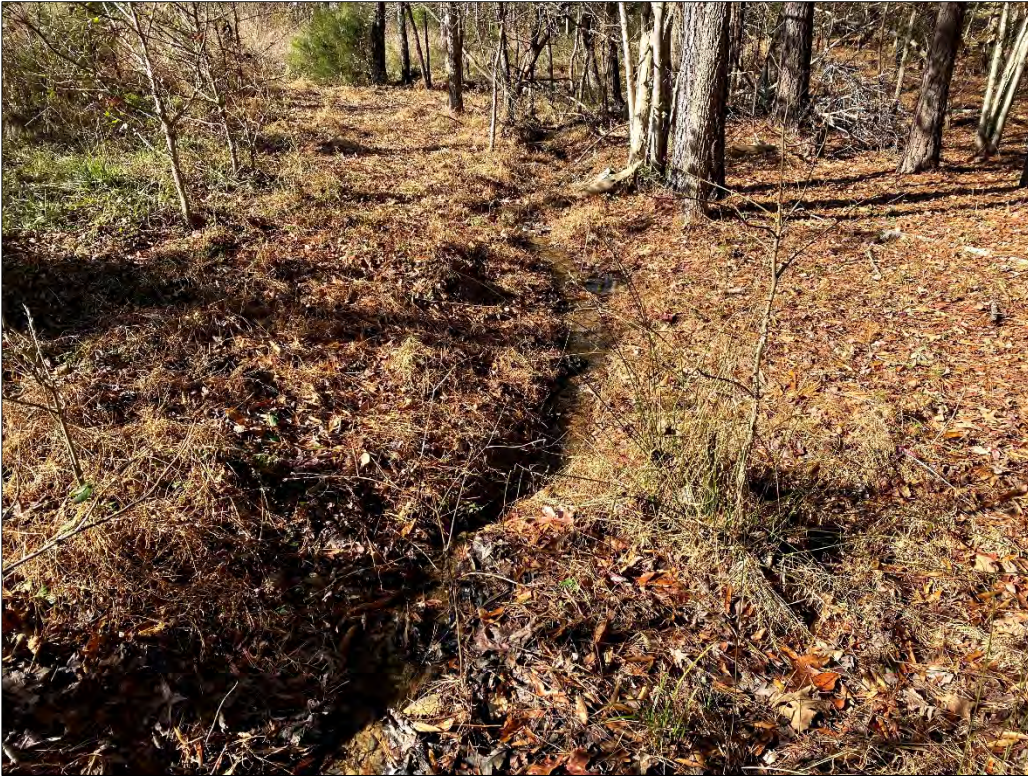
Headwaters of UT3 (near Plot 9)

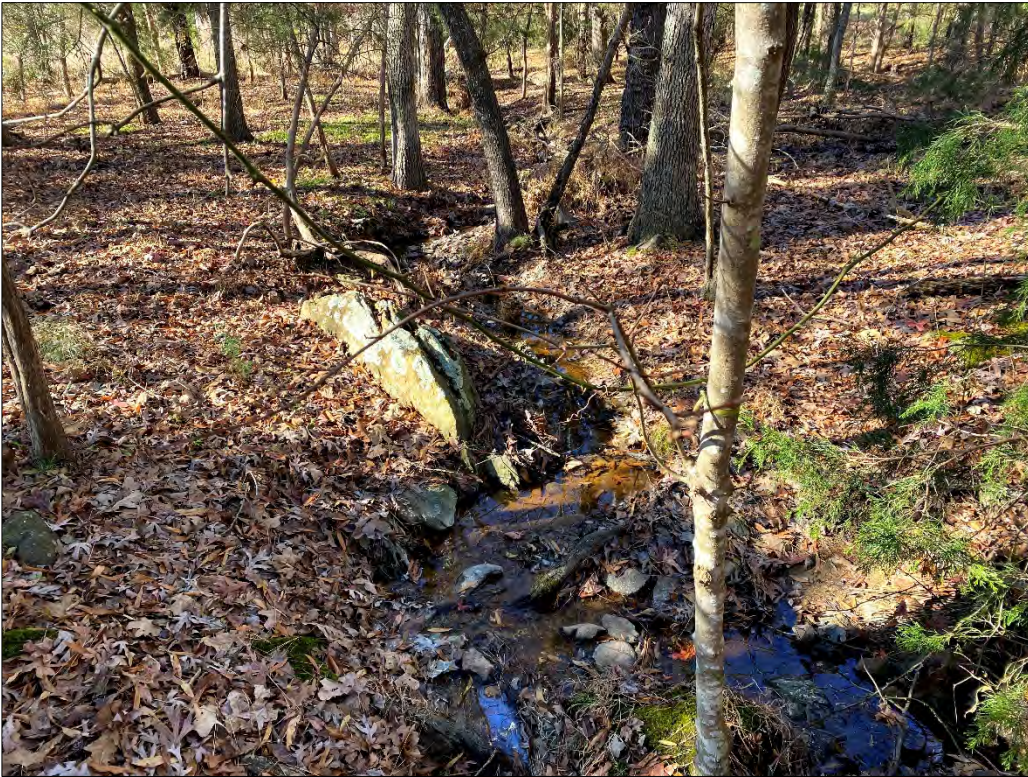
Middle Headwater Branch of UT3

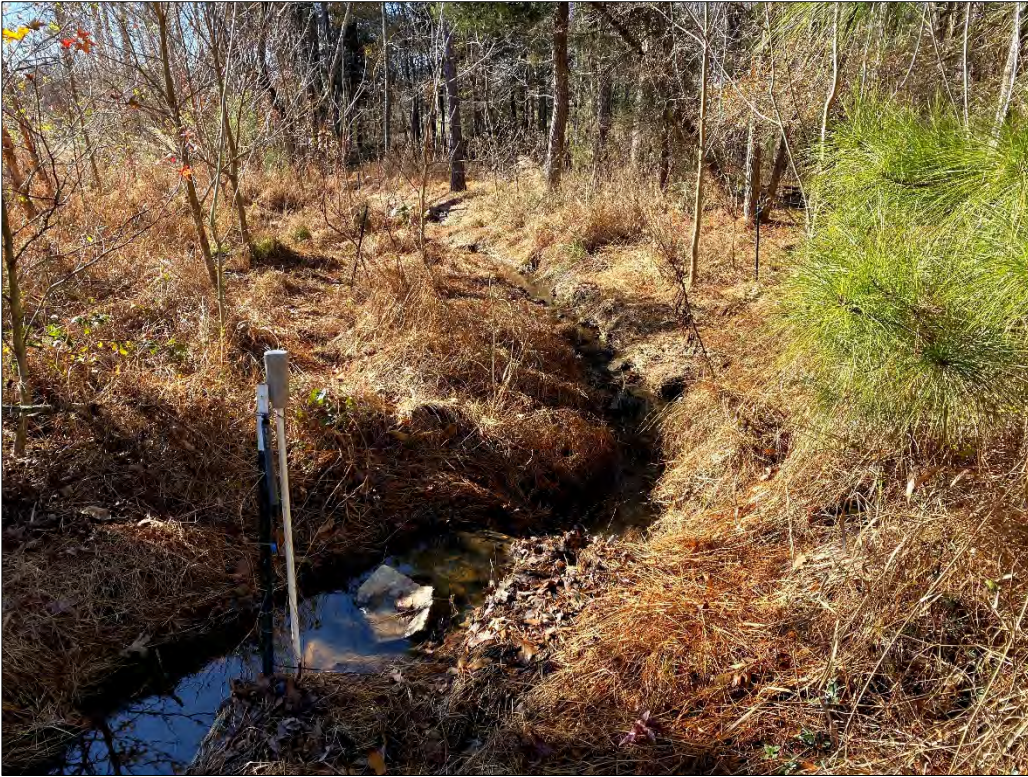
Confluence of UT3 Headwaters
