YEAR 1 MONITORING REPORT

ADKIN BRANCH STREAM RESTORATION PROJECT PHASE 1 – WASHINGTON AVE. TO LINCOLN ST.

Lenoir County, North Carolina

Project ID No. 050656101

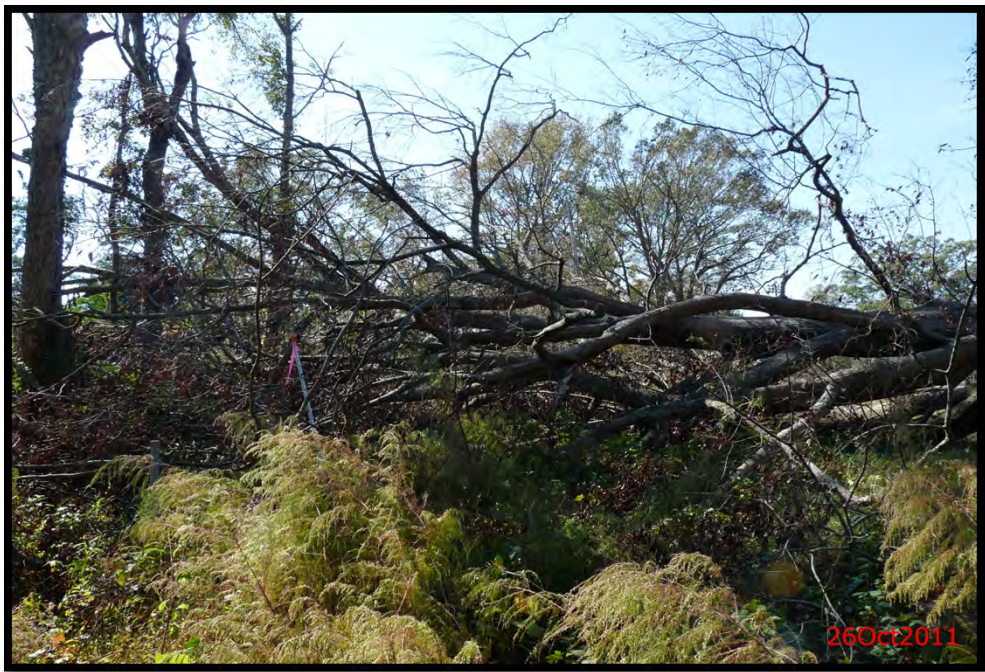
No Data - Fallen Tree over Channel
