# ***YEAR 2 MONITORING REPORT***

## **ADKIN BRANCH STREAM RESTORATION PROJECT PHASE 1 – WASHINGTON AVE. TO LINCOLN ST.**

Lenoir County, North Carolina  
EEP IMS No. 7

Construction Completed: April 2011  
Morphology Data Collected: October/November 2012  
Vegetation Data Collected: August 2012  
Submitted: January 2013

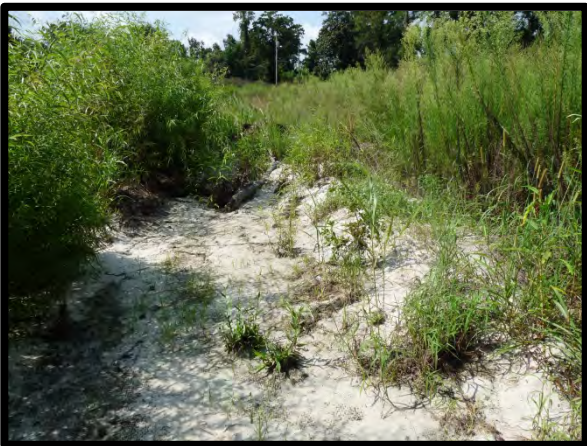
**3.26 Area of thin grass near 95+00**

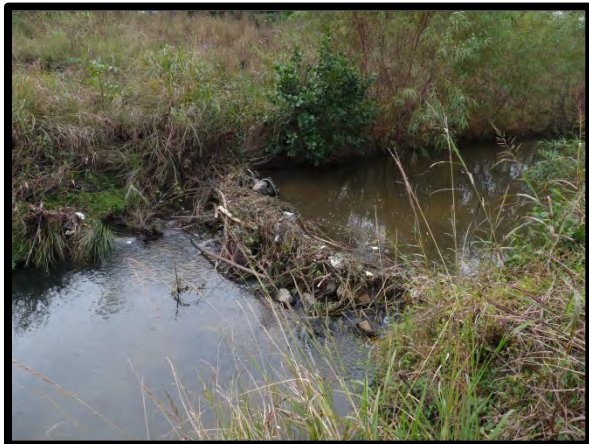
**3.27 Rip-rap/beaverdam near 69+50**

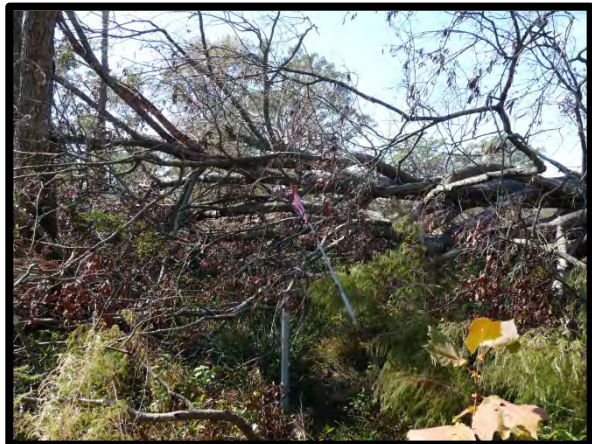
**3.28 Tree across UT near 19+00**
