# ***YEAR 4 MONITORING REPORT***

## **ADKIN BRANCH STREAM RESTORATION PROJECT PHASE 1 – WASHINGTON AVE. TO LINCOLN ST.**

Lenoir County, North Carolina  
EEP IMS No. 7

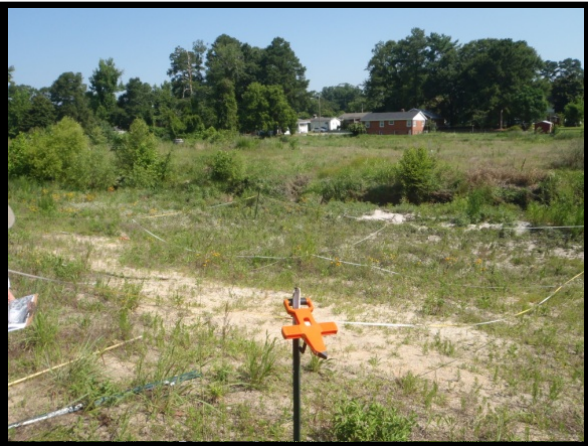
**3.9 Vegetation Plot 9**

Sixteen of the twenty-two individual vegetation plots met success criteria when counting planted stems alone. Vegetation in Plot 9 was damaged by construction equipment during stream repair efforts in July-September 2013; several planted stems have resprouted but overall the area around this plot is sparse. Five plots (Plots 7, 10, 11, 16, and 18) didn't meet success criteria based on planted stems alone; however, when including appropriate naturally recruited stems of hickory (*Carya* sp.) and American elm (*Ulmus americana*), these plots exceeded success criteria.

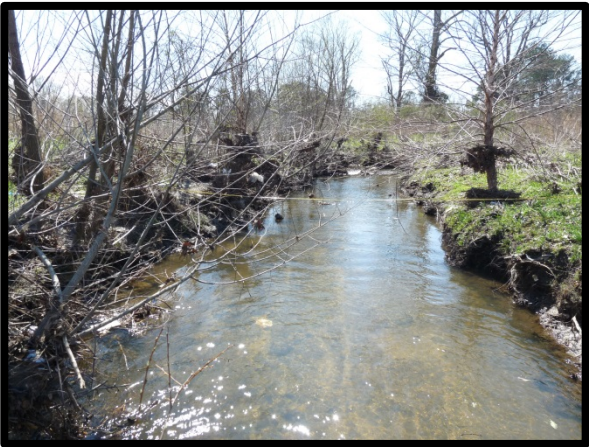
**3.22 Thin grass/bare on right bank of cross section 5**

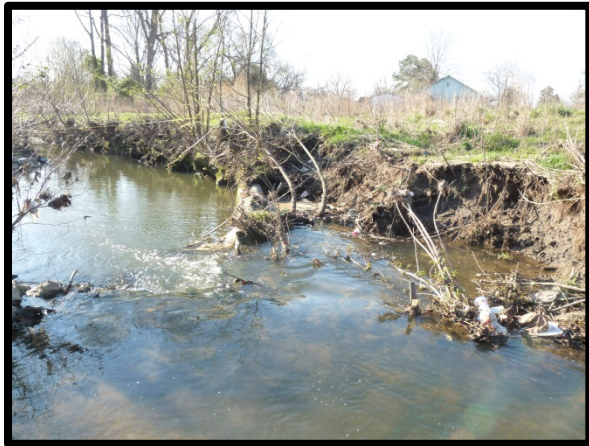
**3.23 Scouring on log vane XS 6**

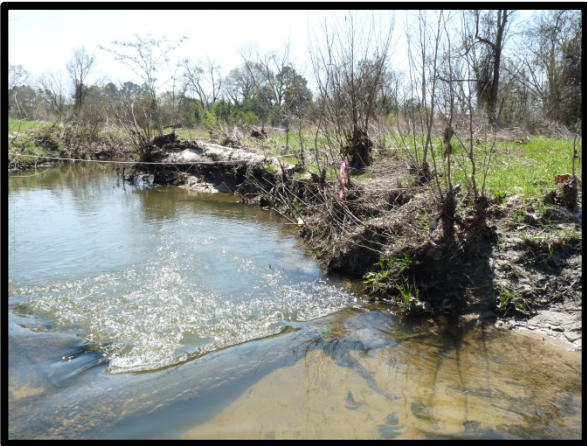
**3.24 Scouring on log vane XS 8**

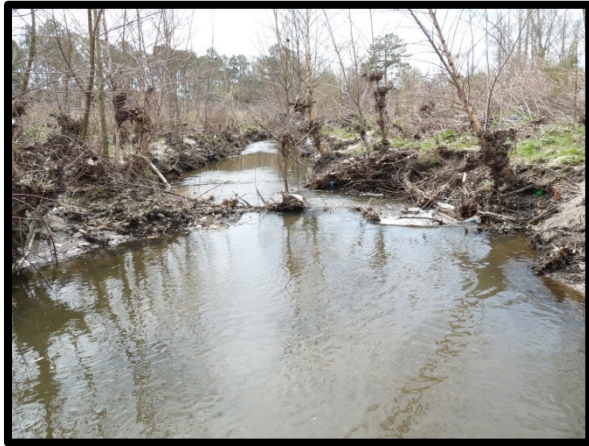
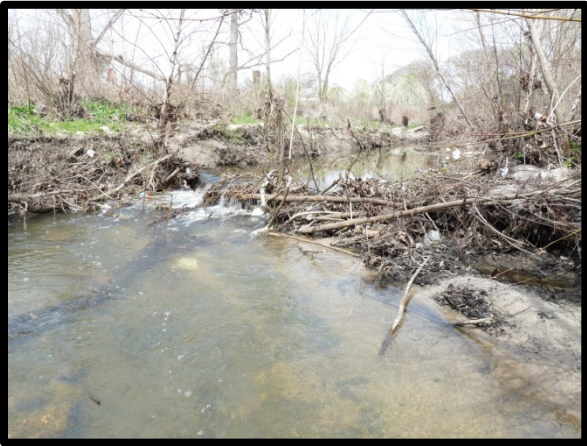
**3.25 and 3.26 Site of Beaver Dam Near Station 40+80**

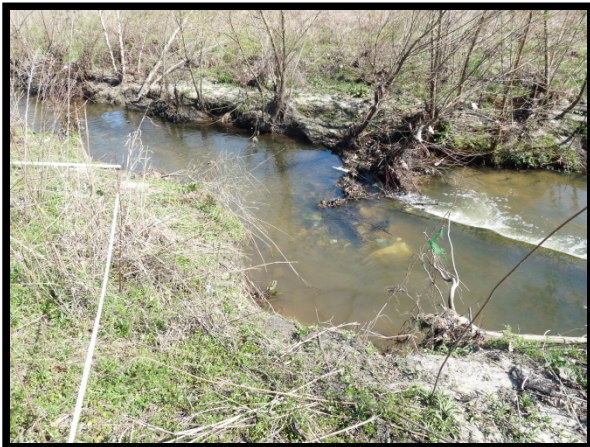
**3.27 Bank Widening**

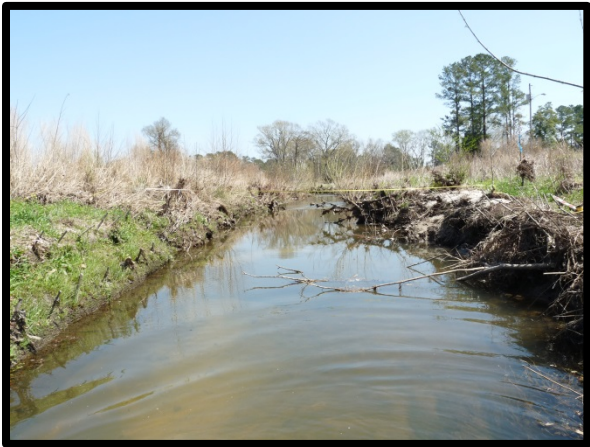
**3.29 Scouring at XS 10**

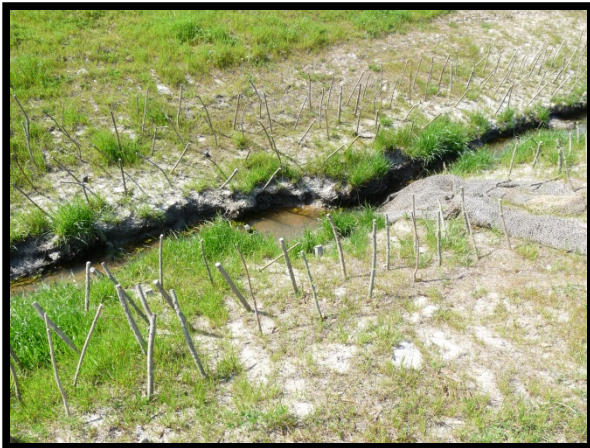
**3.27 Live Stakes on BMP Channel**

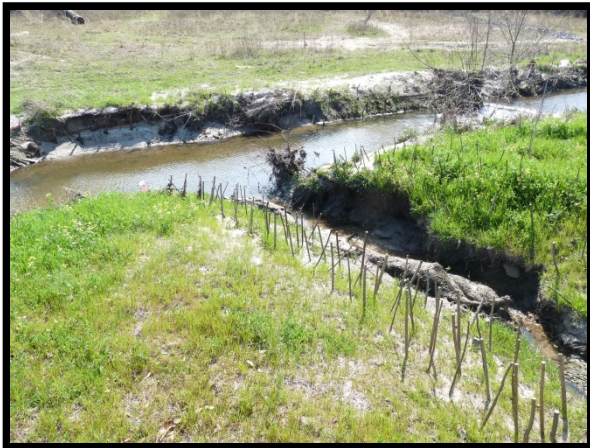
**3.28 Live Stakes on BMP Channel**

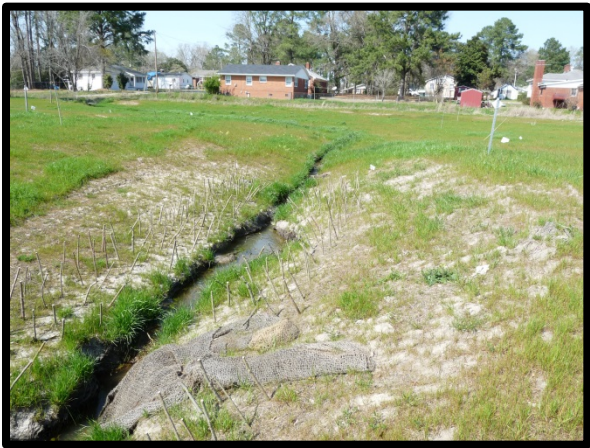
**3.29 Live Stakes on BMP Channel**

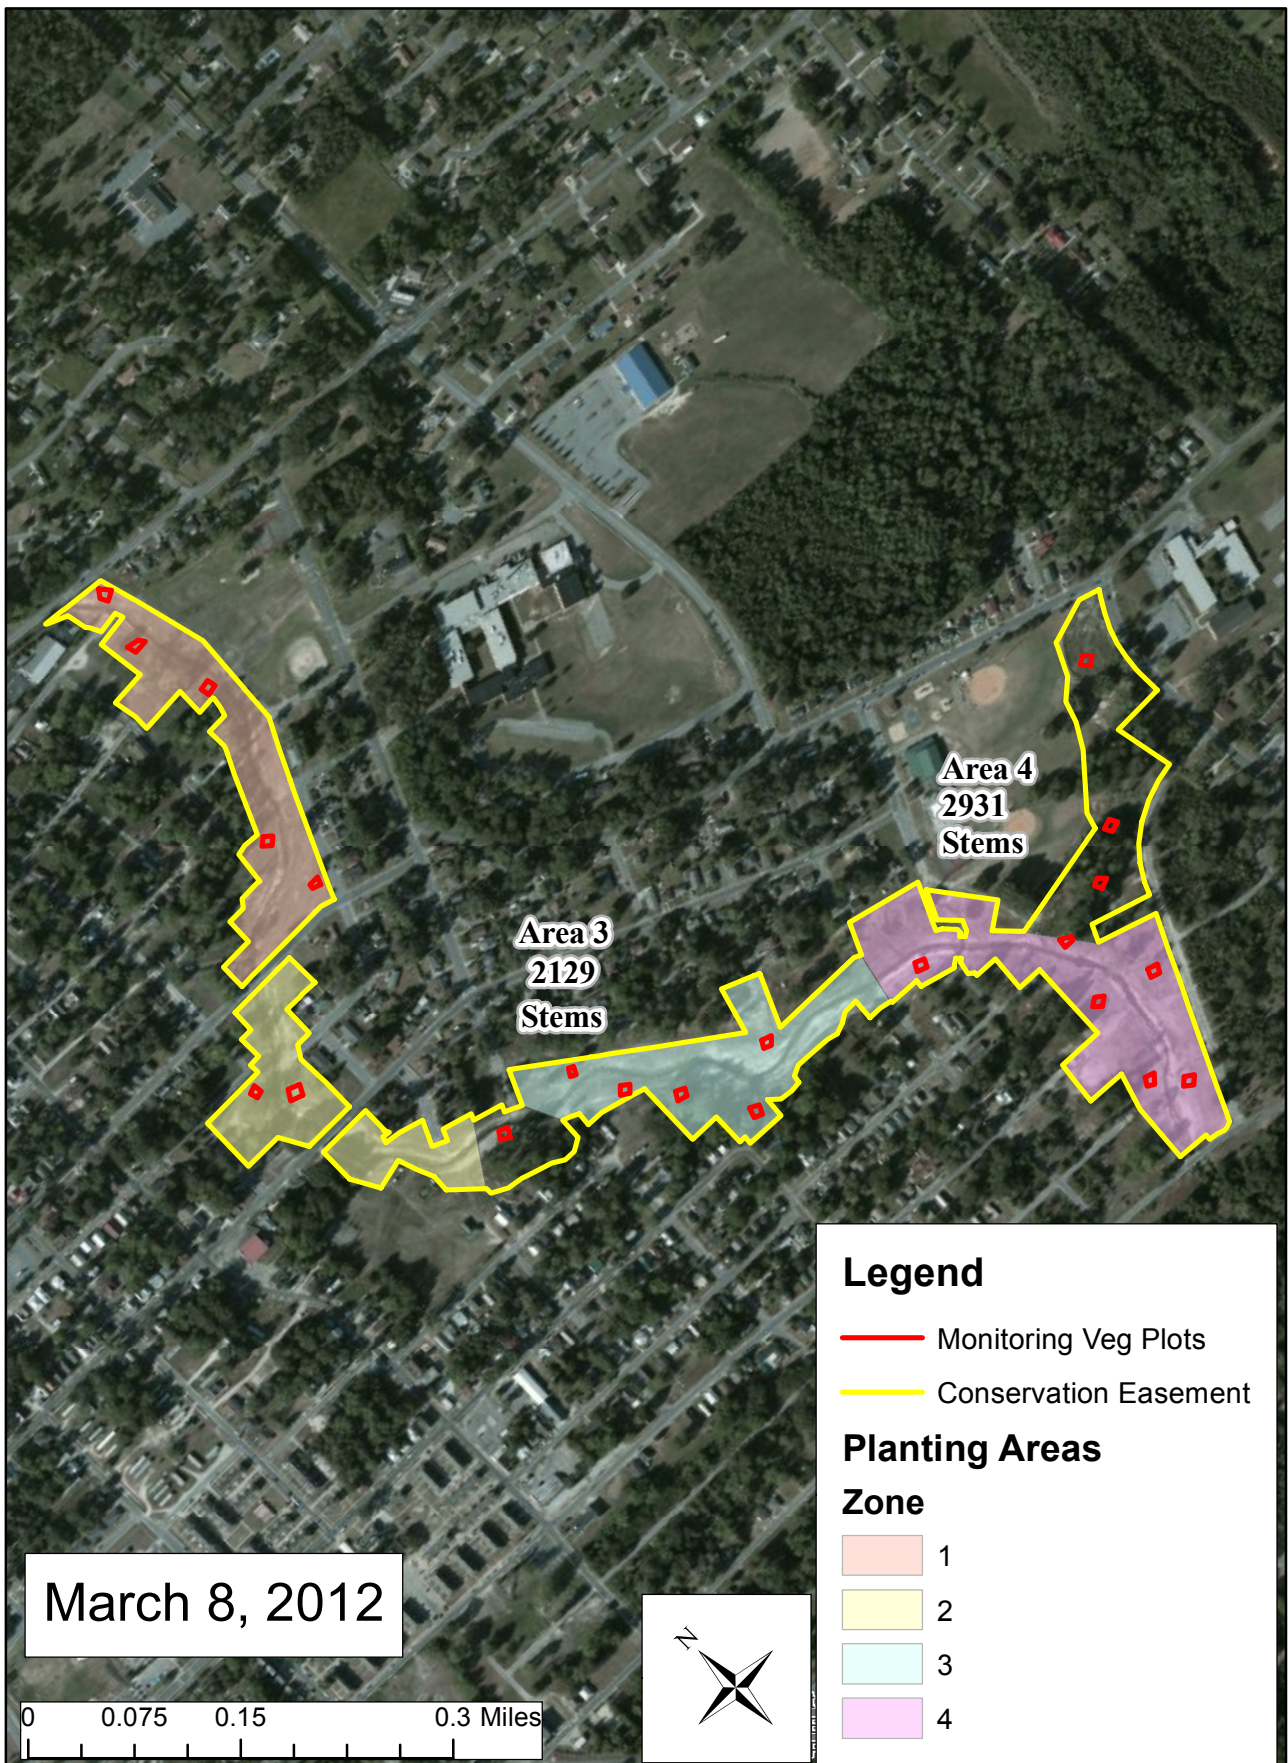
Figure 3a. Bare Root Supplemental Planting Map

The table below shows the number of stems needed to be planted in 4 areas. These areas are also depicted on the Supplemental Planting Map (attached). The planting zone for each is Coastal Plain Levee Forest (CPLF). The number of stems needed in each area was calculated by multiplying the average number of stems needed to meet warranty per plot by the acreage of the given area. Areas 1-4 were sectioned off due to similar plant deficiencies or a topographic break and are shown on the attached Supplemental Planting Map. A total of 11 Ball and Burlap trees also need to be replanted to meet the warranty.

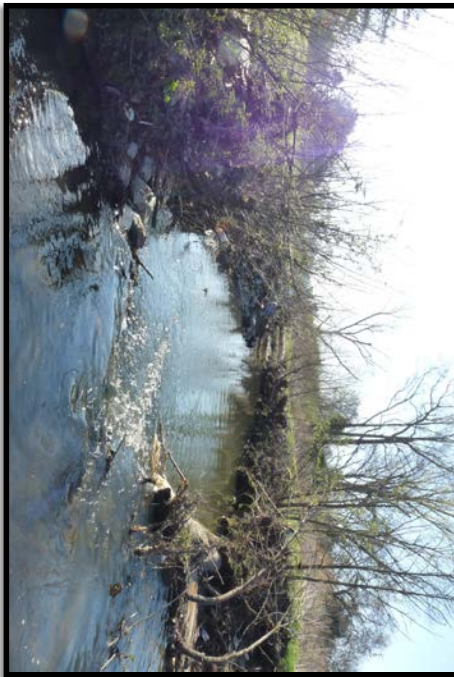
Figure 4.7 XS-7 Riffle, Sta. 70+00

Unstable sections repaired during September 2013 can be seen in the CCPV and are functioning as intended. Vegetation along the banks continues to mature and aid in bank stabilization. Soil lifts installed during the 2013 repairs can be seen in the cross section photos (Figure 4.7, 4.8, 4.10, 4.12) and are also contributing to the overall stabilization of banks. Moderate scour observed during Year 3 monitoring at Cross Section 6 continues to be an area of concern for the stream (Figure 3.23). Cross Section survey data shows the area to the right of the log vane continuing to scour. Woody vegetation growing on the banks is slowing the scouring, however, the area should still be closely observed during monitoring. Similar erosion is occurring at the

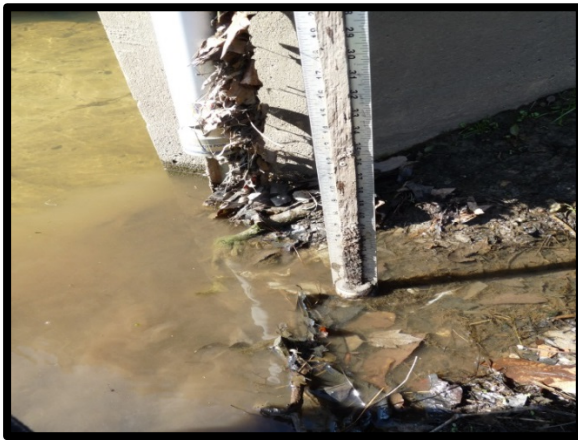
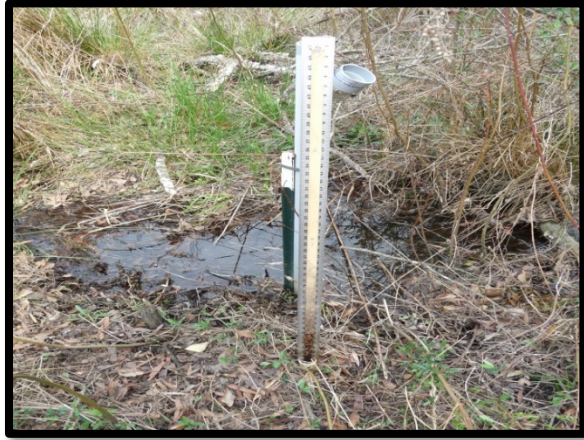
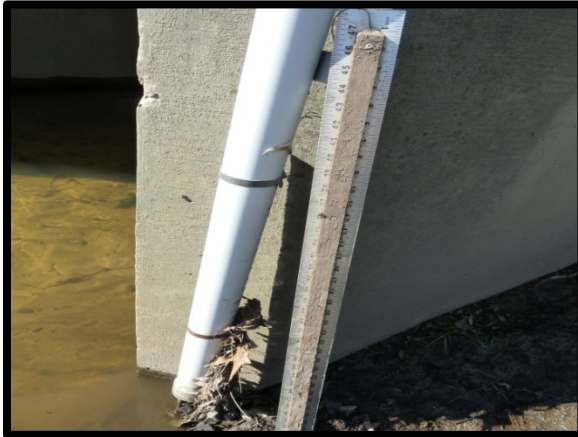
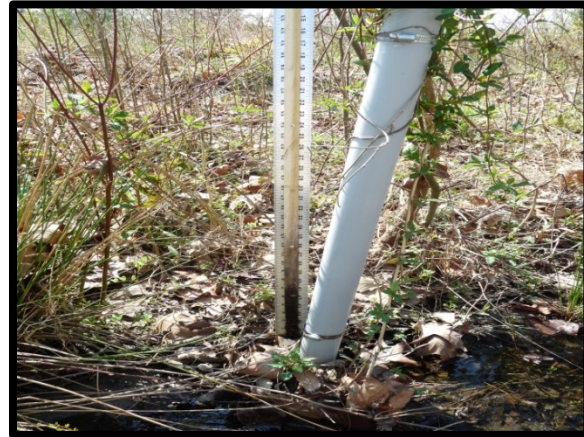
**Figures 6.1-6.4 April 2014 Crest Gauge Photos**

Date	Crest Gauge Info		Gauge Reading (ft)	Gauge Elevation (ft)	Crest Elevation (ft)	Bankfull Elevation (ft)	Height above Bankfull (ft)	Photo
	Site	Sta.						
4/1/2014	1	Adkin Branch Sta. 54+00 LT	4	25.27	29.27	27.03	2.24	6.2
4/1/2014	2	Adkin Branch Sta. 75+25 RT	1.14	23.60	24.74	24.43	0.31	6.1
4/1/2014	3	UT Adkin Sta. 22+65 LT	1.52	25.51	27.03	26.07	0.96	6.3
4/1/2014	4	UT Adkin Sta. 18+80 LT	1.97	29.47	31.44	30.16	1.28	6.4
