YEAR 5 MONITORING REPORT

ADKIN BRANCH STREAM RESTORATION PROJECT PHASE 1 – WASHINGTON AVE. TO LINCOLN ST.

Lenoir County, North Carolina
DMS IMS No. 7

Submitted: December 2015

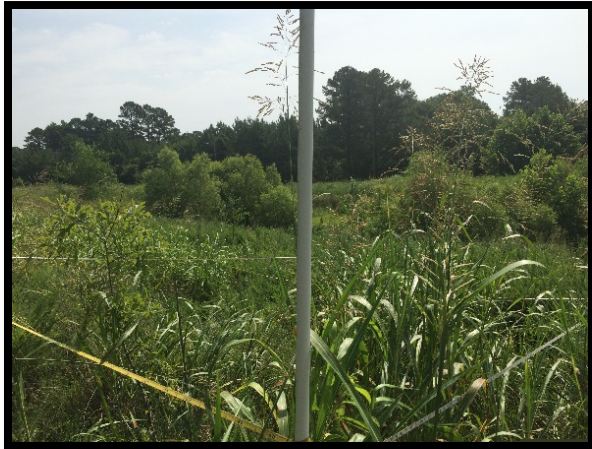
3.7 Vegetation Plot 7

Seventeen of the twenty-two individual vegetation plots met success criteria of 260 stems per acre when counting planted stems alone. Vegetation Plot 7 is located in a large community of *Lespedeza cuneata*. It is likely that the invasive population is strangling and shading native planted vegetation, inhibiting survival of species in the vegetation plot. Vegetation in Plot 9 was damaged by construction equipment during stream repair efforts in July-September 2013; several planted stems have resprouted but overall the area around this plot is sparse. Three plots (Plots 10, 11, and 16) didn't meet success criteria based on planted stems alone; however, when including

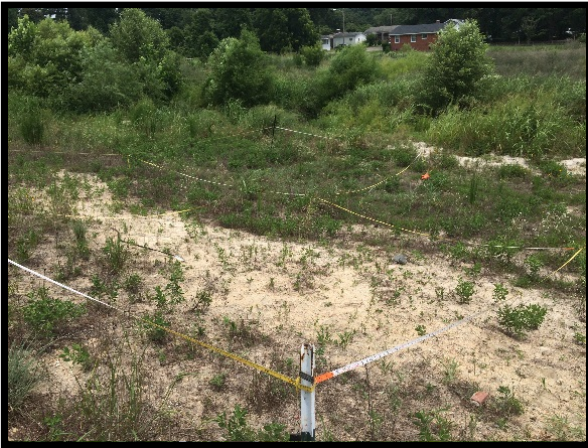
3.9 Vegetation Plot 9

Sixteen of the twenty-two individual vegetation plots met success criteria when counting planted stems alone. Vegetation in Plot 9 was damaged by construction equipment during stream repair efforts in July-September 2013; several planted stems have resprouted but overall the area around this plot was sparse. Five plots (Plots 7, 10, 11, 16, and 18) did not meet success criteria based on planted stems alone; however, when including appropriate naturally recruited stems of hickory (*Carya* sp.) and American elm (*Ulmus americana*), these plots exceeded success criteria.

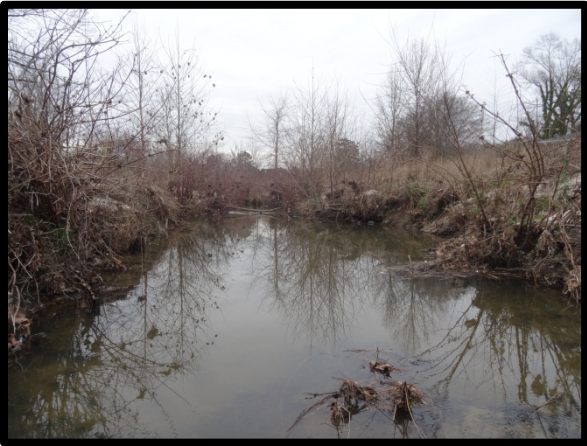
3.25 Minor and major erosion near 51+90

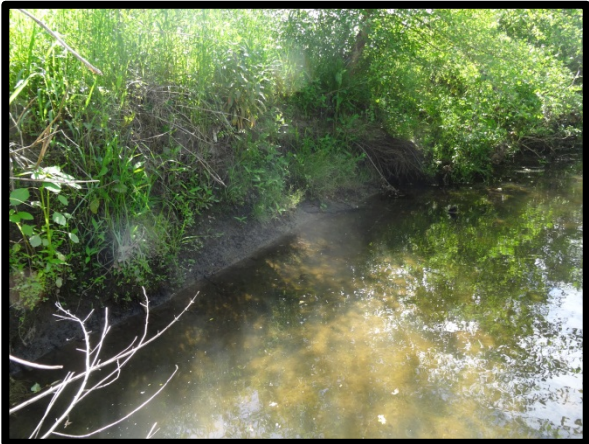
3.29 Stress structure near 62+10

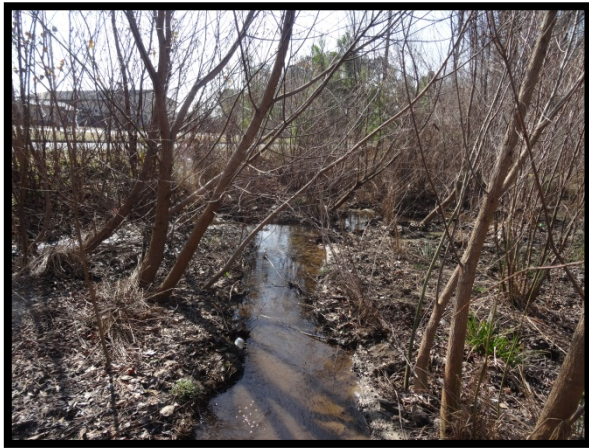
3.35 Severe erosion near 78+50
