FINAL
MONITORING REPORT (MY3)

ALLIANCE HEADWATERS MITIGATION SITE

Johnston County, North Carolina

DMS ID No. 97086

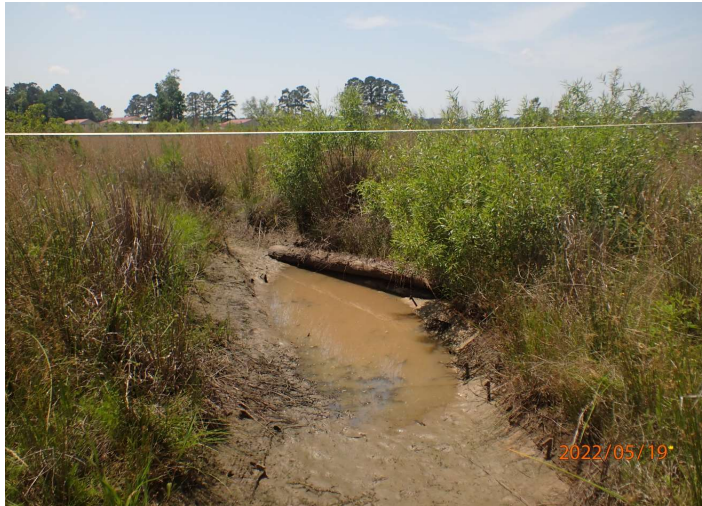
Site	Alliance Headwaters
Watershed:	Neuse River, 03020201
XS ID	UT 1 Reach 3, XS - 1
Feature	Pool
Date:	5/19/2022
Field Crew:	Harris, Lewis

SUMMARY DATA	
Bankfull Elevation:	103.9
Bankfull Cross-Sectional Area:	14.5
Bankfull Width:	17.3
Flood Prone Area Elevation:	NA
Flood Prone Width:	NA
Max Depth at Bankfull:	2.0
Low Bank Height:	2.0
Mean Depth at Bankfull:	0.8
W / D Ratio:	NA
Entrenchment Ratio:	NA
Bank Height Ratio:	0.97

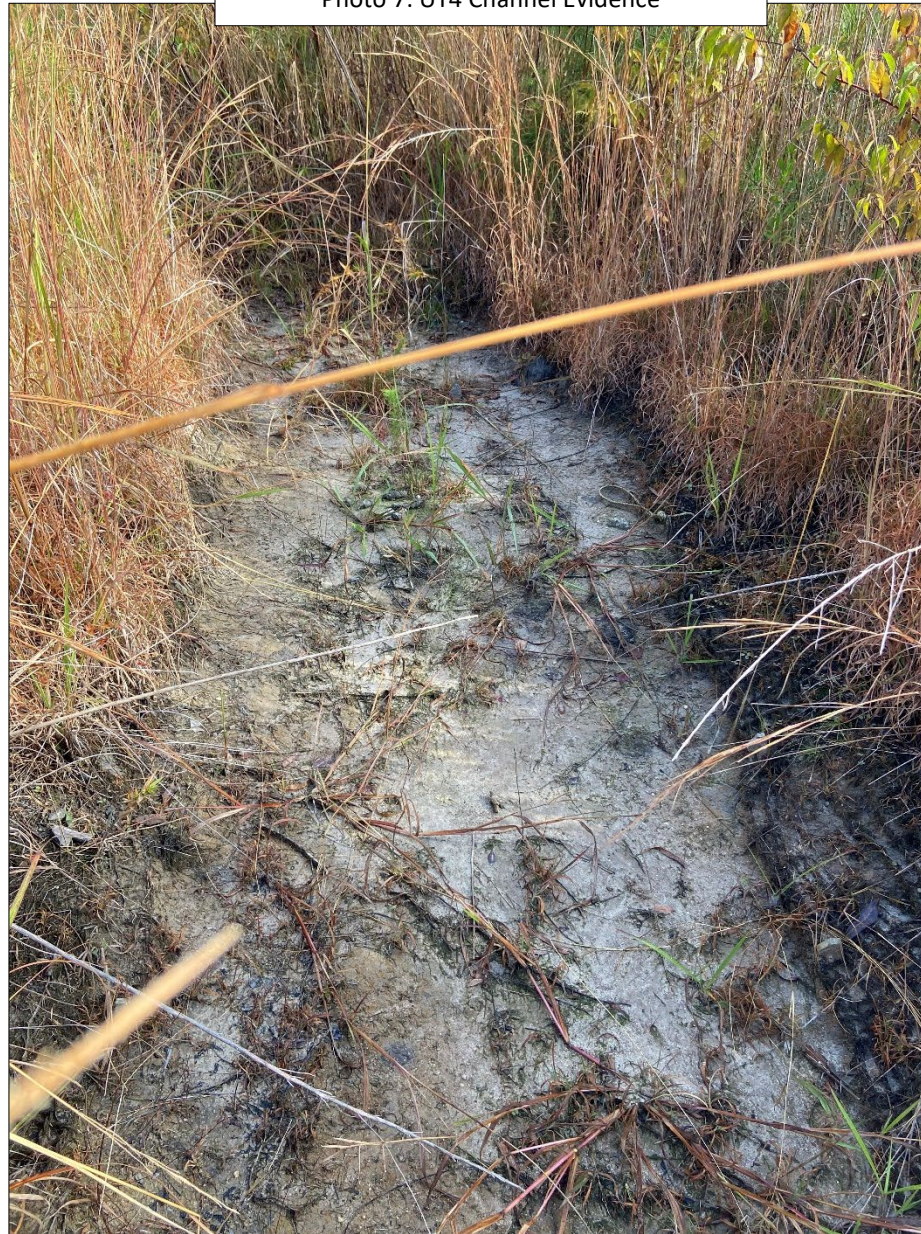
Photo 7: UT4 Channel Evidence

UT4 Channel Evidence	Year 1 (2020)	Year 2 (2021)	Year 3 (2022)	Year 4 (2023)	Year 5 (2024)	Year 6 (2025)	Year 7 (2026)
Max consecutive days channel flow	130	228	88				
Presence of litter and debris (wracking)	Yes	Yes	Yes				
Leaf litter disturbed or washed away	Yes	Yes	Yes				
Matted, bent, or absence of vegetation (herbaceous or otherwise)	Yes	Yes	Yes				
Sediment deposition and/or scour indicating sediment transport	Yes	Yes	Yes				
Water staining due to continual presence of water	Yes	Yes	Yes				
Formation of channel bed and banks	Yes	Yes	Yes				
Sediment sorting within the primary path of flow	Yes	Yes	Yes				
Sediment shelving or a natural line impressed on the banks	Yes	Yes	Yes				
Change in plant community (absence or destruction of terrestrial vegetation and/or transition to species adapted for flow or inundation for a long duration, including hydrophytes)	Yes	Yes	Yes				
Development of channel pattern (meander bends and/or channel braiding) at natural topographic breaks, woody debris piles, or plant root systems	Yes	Yes	Yes

Exposure of woody plant roots within the primary path of flow	No	No	No				
Other:

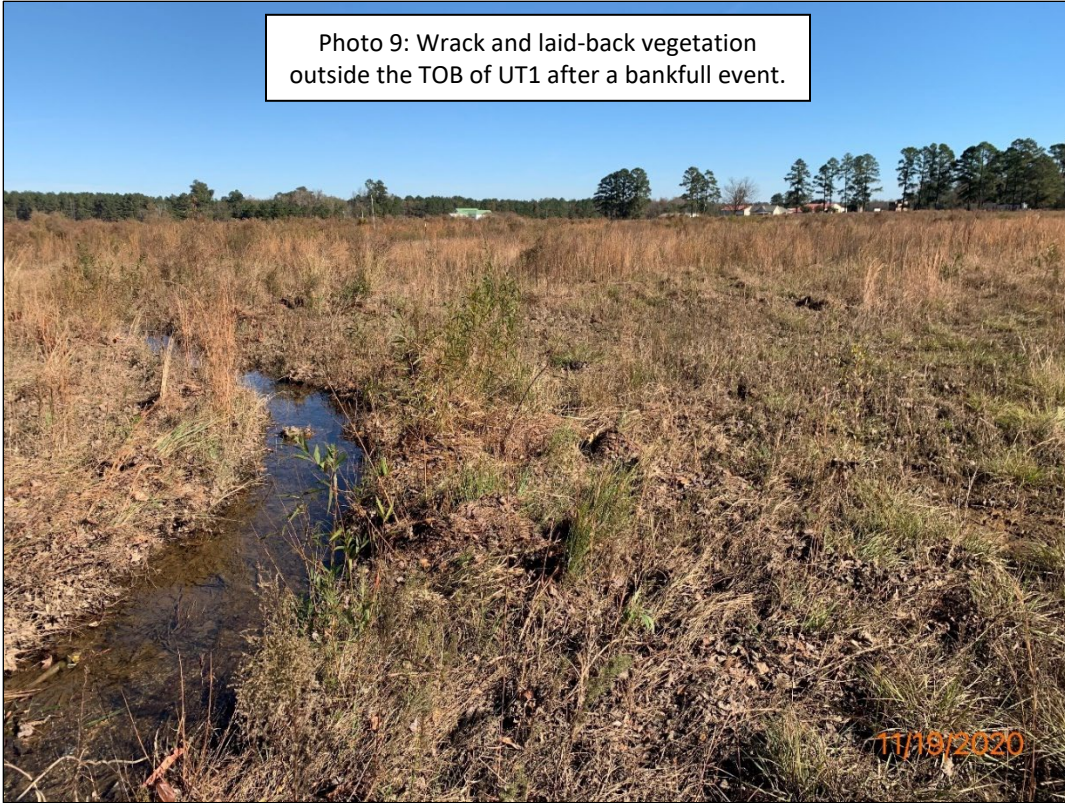
Photo 9: Wrack and laid-back vegetation outside the TOB of UT1 after a bankfull event.

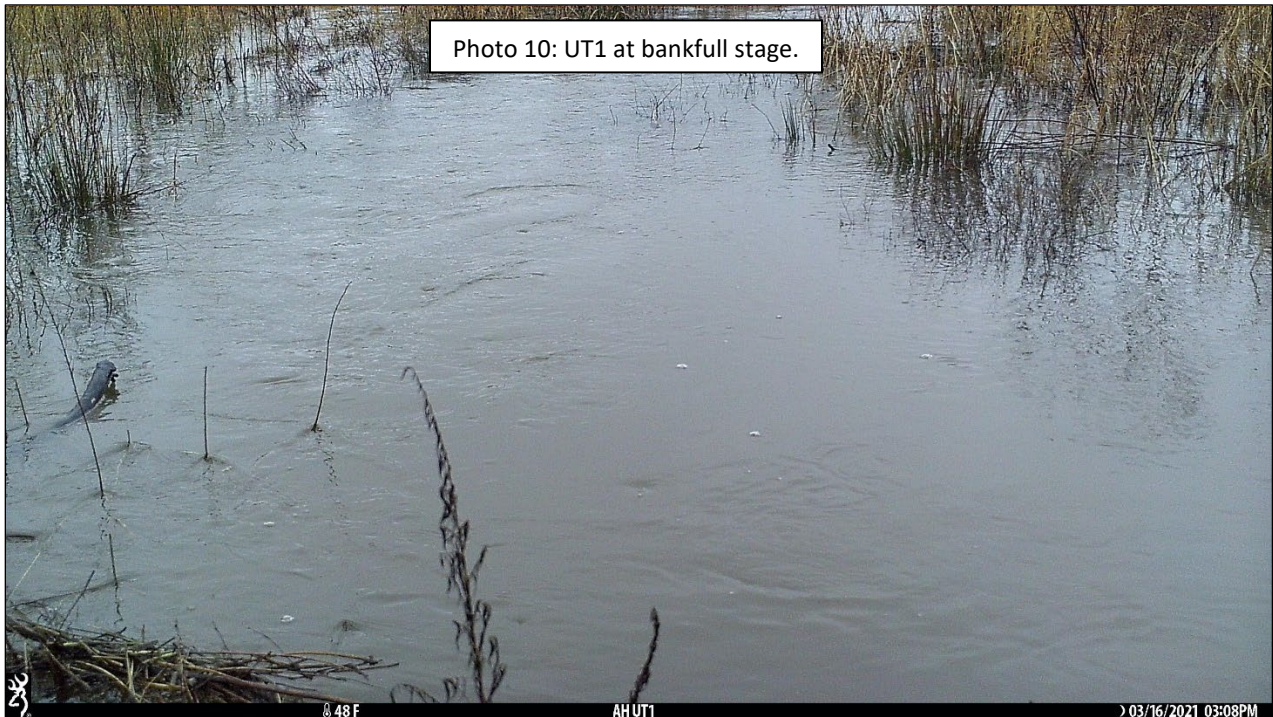
Photo 10: UT1 at bankfull stage.

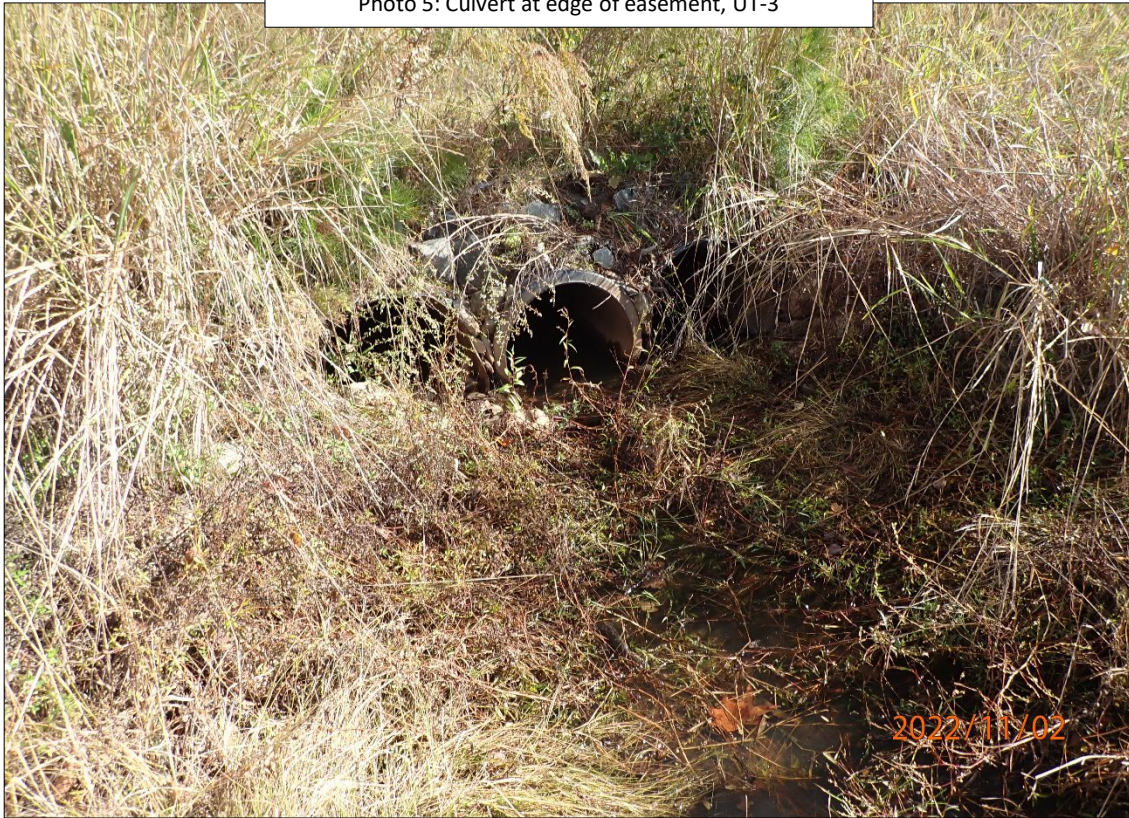
Photo 5: Culvert at edge of easement, UT-3

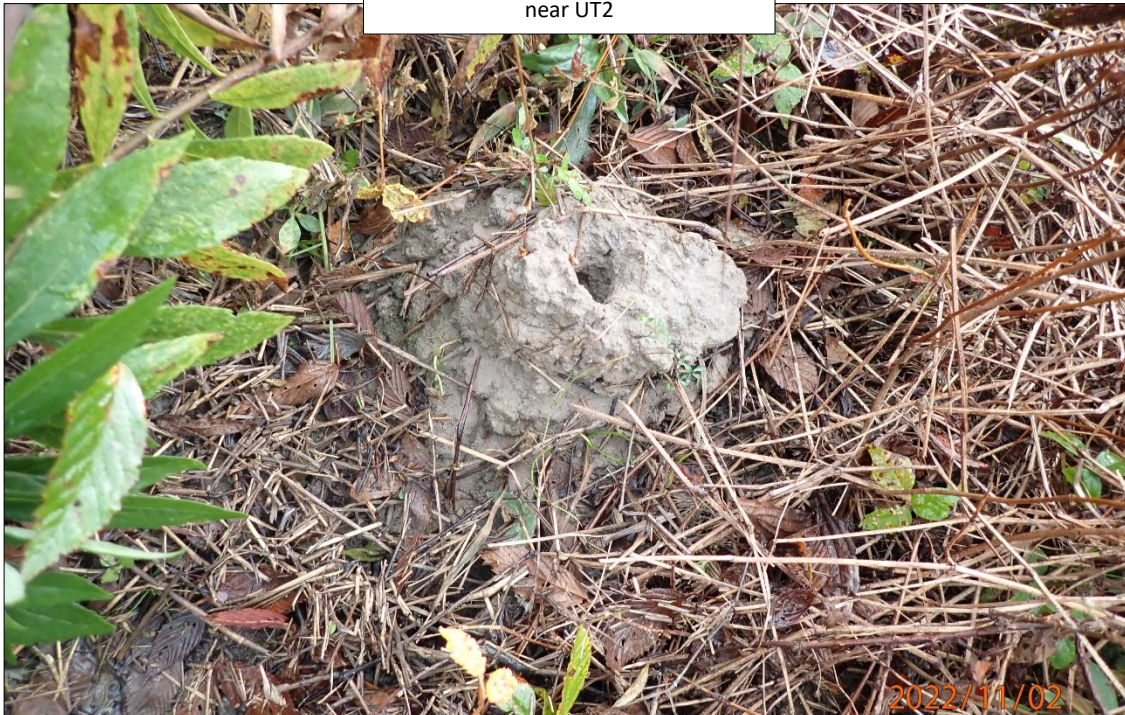
Photo 10: Crayfish Burrow in Wetland
near UT2

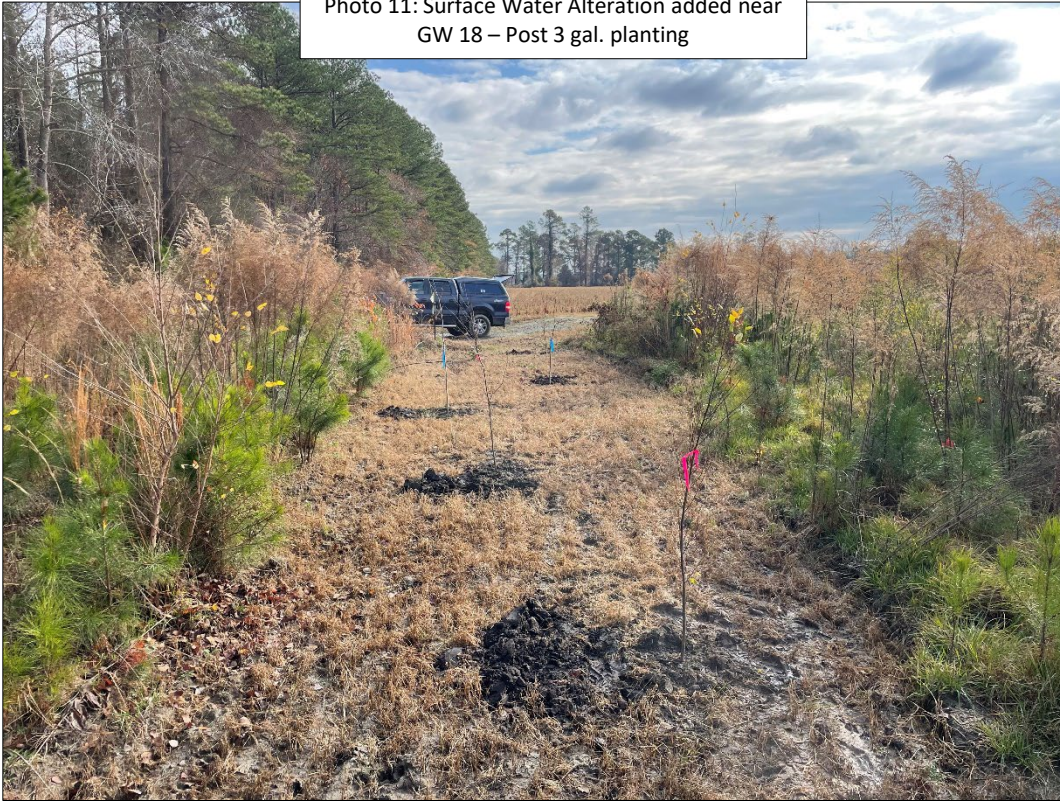
Photo 11: Surface Water Alteration added near
GW 18 – Post 3 gal. planting
