MONITORING REPORT (MY4)

ALLIANCE HEADWATERS MITIGATION SITE

Johnston County, North Carolina

DMS ID No. 97086

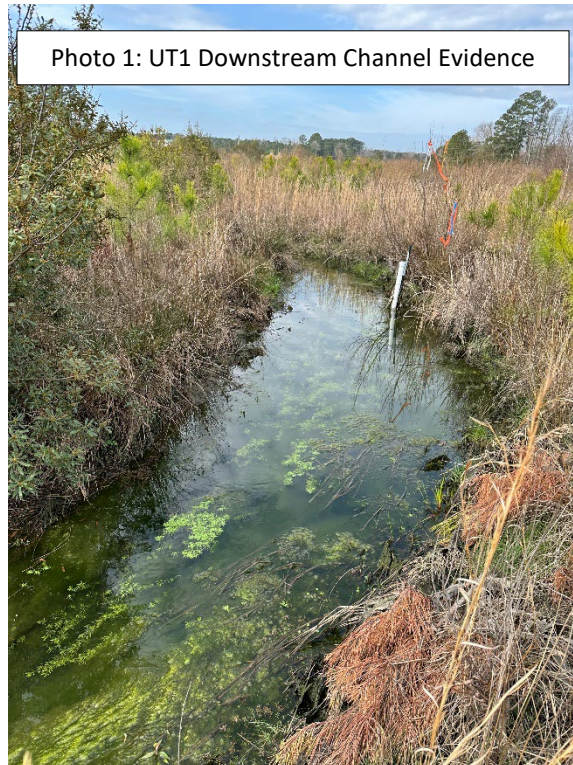
Photo 1: UT1 Downstream Channel Evidence

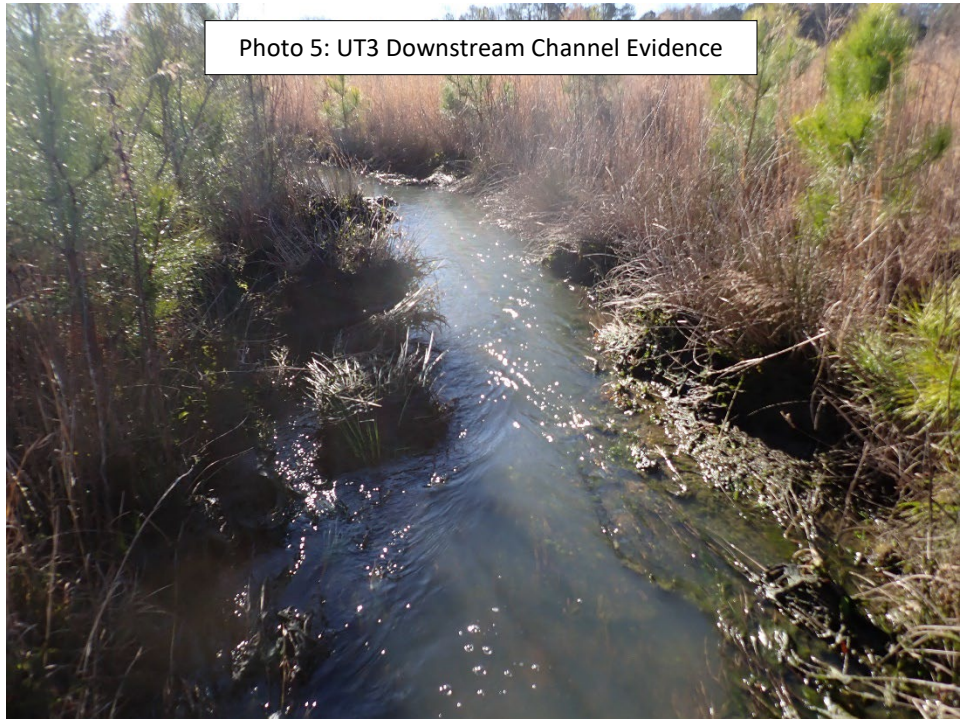
Photo 5: UT3 Downstream Channel Evidence

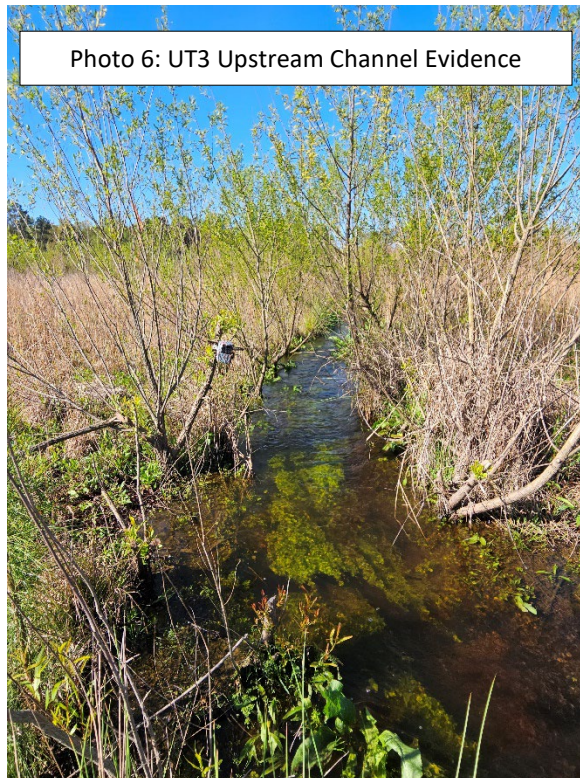
Photo 6: UT3 Upstream Channel Evidence

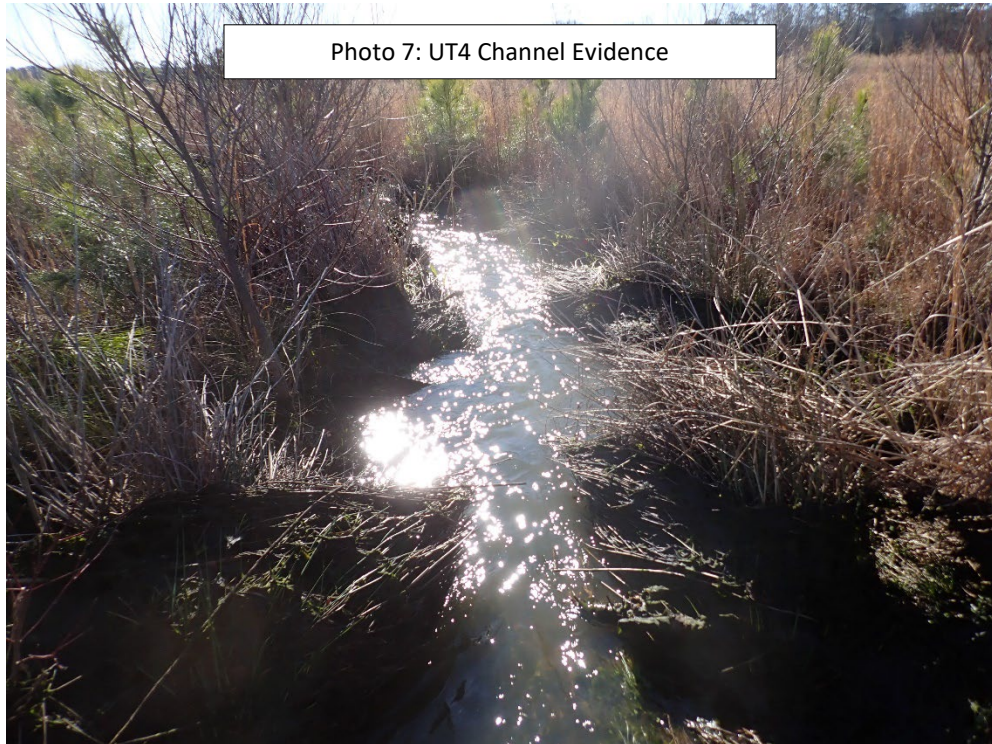
Photo 7: UT4 Channel Evidence
