YEAR 1 (2016) MONITORING REPORT
AYCOCK SPRINGS
STREAM AND WETLAND MITIGATION SITE
ALAMANCE COUNTY, NORTH CAROLINA
DMS PROJECT NO. 96312
FULL DELIVERY CONTRACT NO. 5791

CAPE FEAR RIVER BASIN
CATALOGING UNIT 03030002

Data Collection – May-October 2016

December 2016

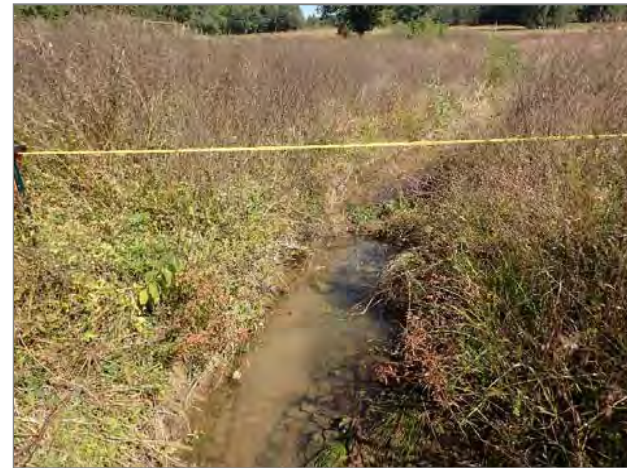
Site	Aycock Springs
Watershed:	Cape Fear, 0303002
XS ID	UT 1, XS - 9, Riffle
Feature	Riffle
Date:	10/18/2016
Field Crew:	Perkinson, Keith

The year 1 (2016) measurements for cross-sections 9 and 10 on UT-1 show stream bed erosion when compared with as-built data. Stream bed erosion was noted shortly after as-built measurements were taken, and were the result of the above mentioned rain events. It is evident bed material used during construction in this area was finer than it should have been. Two riffles show bed erosion, totaling approximately 50 feet

The observed degradation in and adjacent to cross-sections 9 and 10 on UT-1 encompasses approximately 50 linear feet of stream (1 percent of the project length). As noted above, bed material placed during construction was too fine. All of UT-1 used bed material harvested on-site. It is uncommon for us not to catch too fine of material during the harvesting and placing of bed material however it does happen. In this case, it appears that an oversight did occur and too fine of material was used along this stretch. Fine materials washed from the riffle during heavy rainfall events, resulting in minor bed scour and a small, less than 6 inch head cut beginning to develop at the top of riffle. Suitable sized channel bed material is proposed to be installed at the proper elevation in two riffles within UT-1. Bed material will be installed such that bank toe protection is provided and planting with willow stakes will occur. Bank toe protection designates that channel bed material will extend up the lower one-third of the bank. The riffle will be monitored by established cross-sections 9 and 10. This work will occur in winter of 2016/2-17 and will be done by hand in order to minimize impact within the conservation easement.

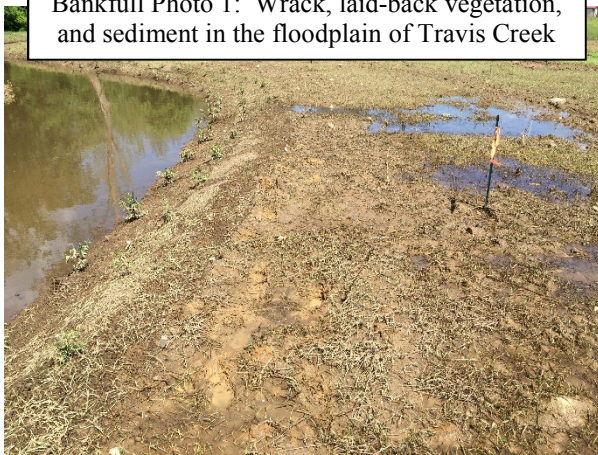
Bankfull Photo 1: Wrack, laid-back vegetation, and sediment in the floodplain of Travis Creek

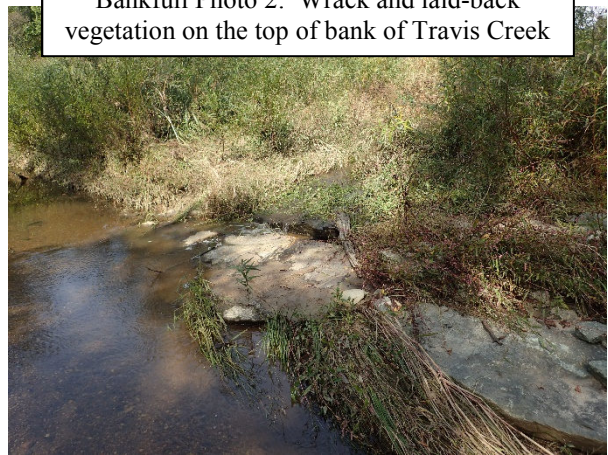
Bankfull Photo 2: Wrack and laid-back vegetation on the top of bank of Travis Creek
