**YEAR 7 (2022) MONITORING REPORT**  
**AYCOCK SPRINGS**  
**STREAM AND WETLAND MITIGATION SITE**

ALAMANCE COUNTY, NORTH CAROLINA  
DMS PROJECT No. 96312  
FULL DELIVERY CONTRACT No. 5791  
NCDWR PROJECT No. 20140335  
USACE ACTION ID No. SAW-2014-01711

**Data Collection – January-October 2022**

**February 2023**

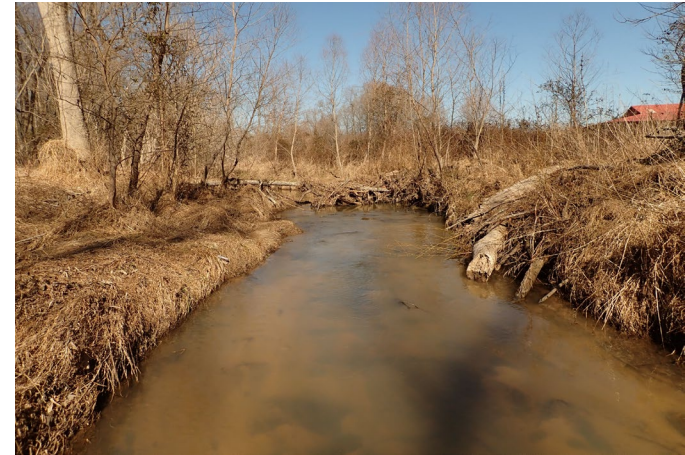
<b>Site</b>	Aycock Springs
<b>Watershed:</b>	Cape Fear, 0303002
<b>XS ID</b>	Travis Creek, XS - 11, Riffle
<b>Feature</b>	Riffle
<b>Date:</b>	2/10/2022
<b>Field Crew:</b>	Adams, Harris, Perkinson

Note: Sediment deposition appears natural and is not expected to lead to instability.

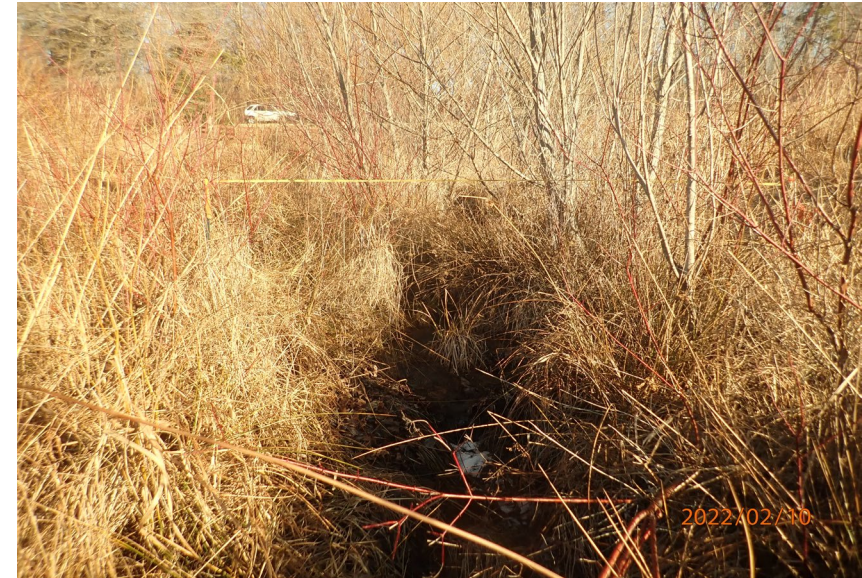
<b>Site</b>	Aycock Springs
<b>Watershed:</b>	Cape Fear, 0303002
<b>XS ID</b>	UT 1, XS - 24, Riffle
<b>Feature</b>	Riffle
<b>Date:</b>	2/10/2022
<b>Field Crew:</b>	Adams, Harris, Perkinson

Note: Point bar development appears to have stabilized during years 1-7.

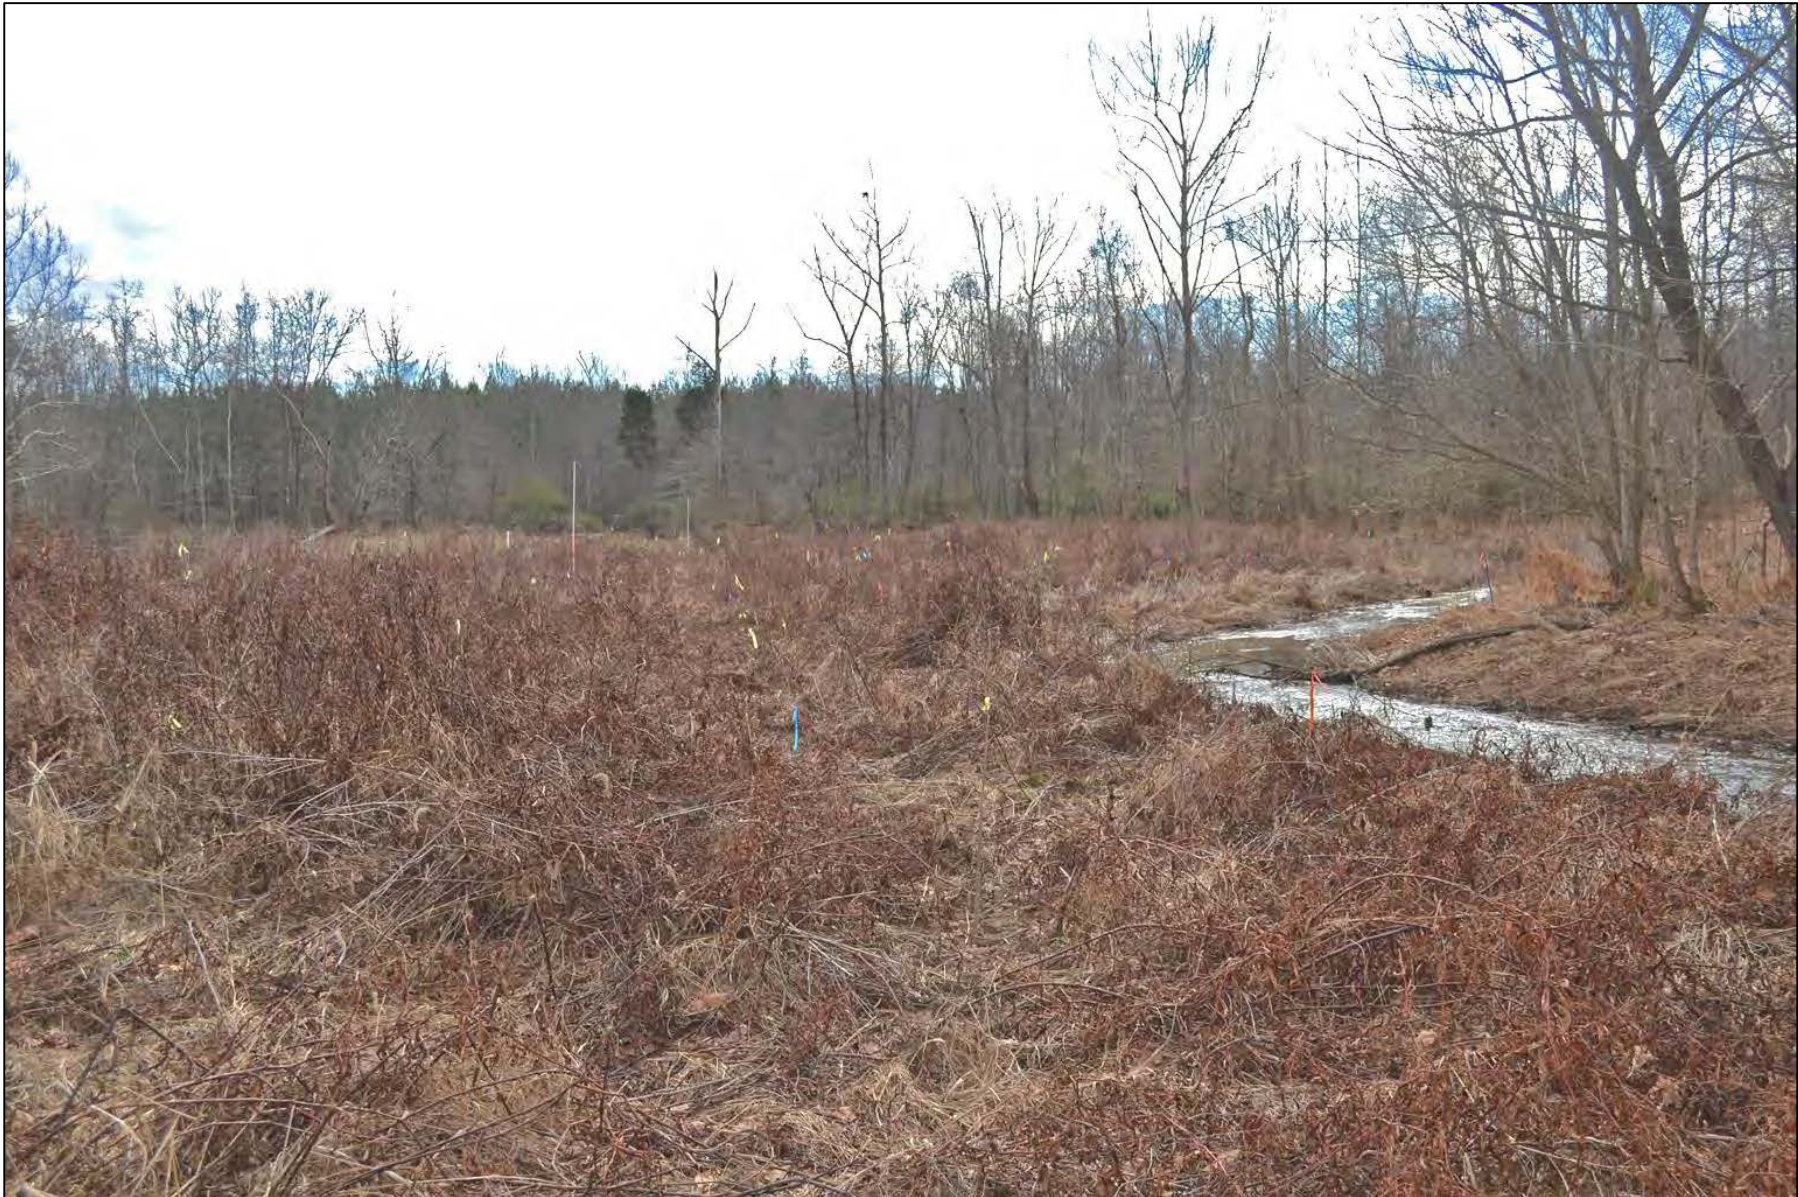
Photo 2: Looking S. in Replant Area 2, just N. of veg. plot 14

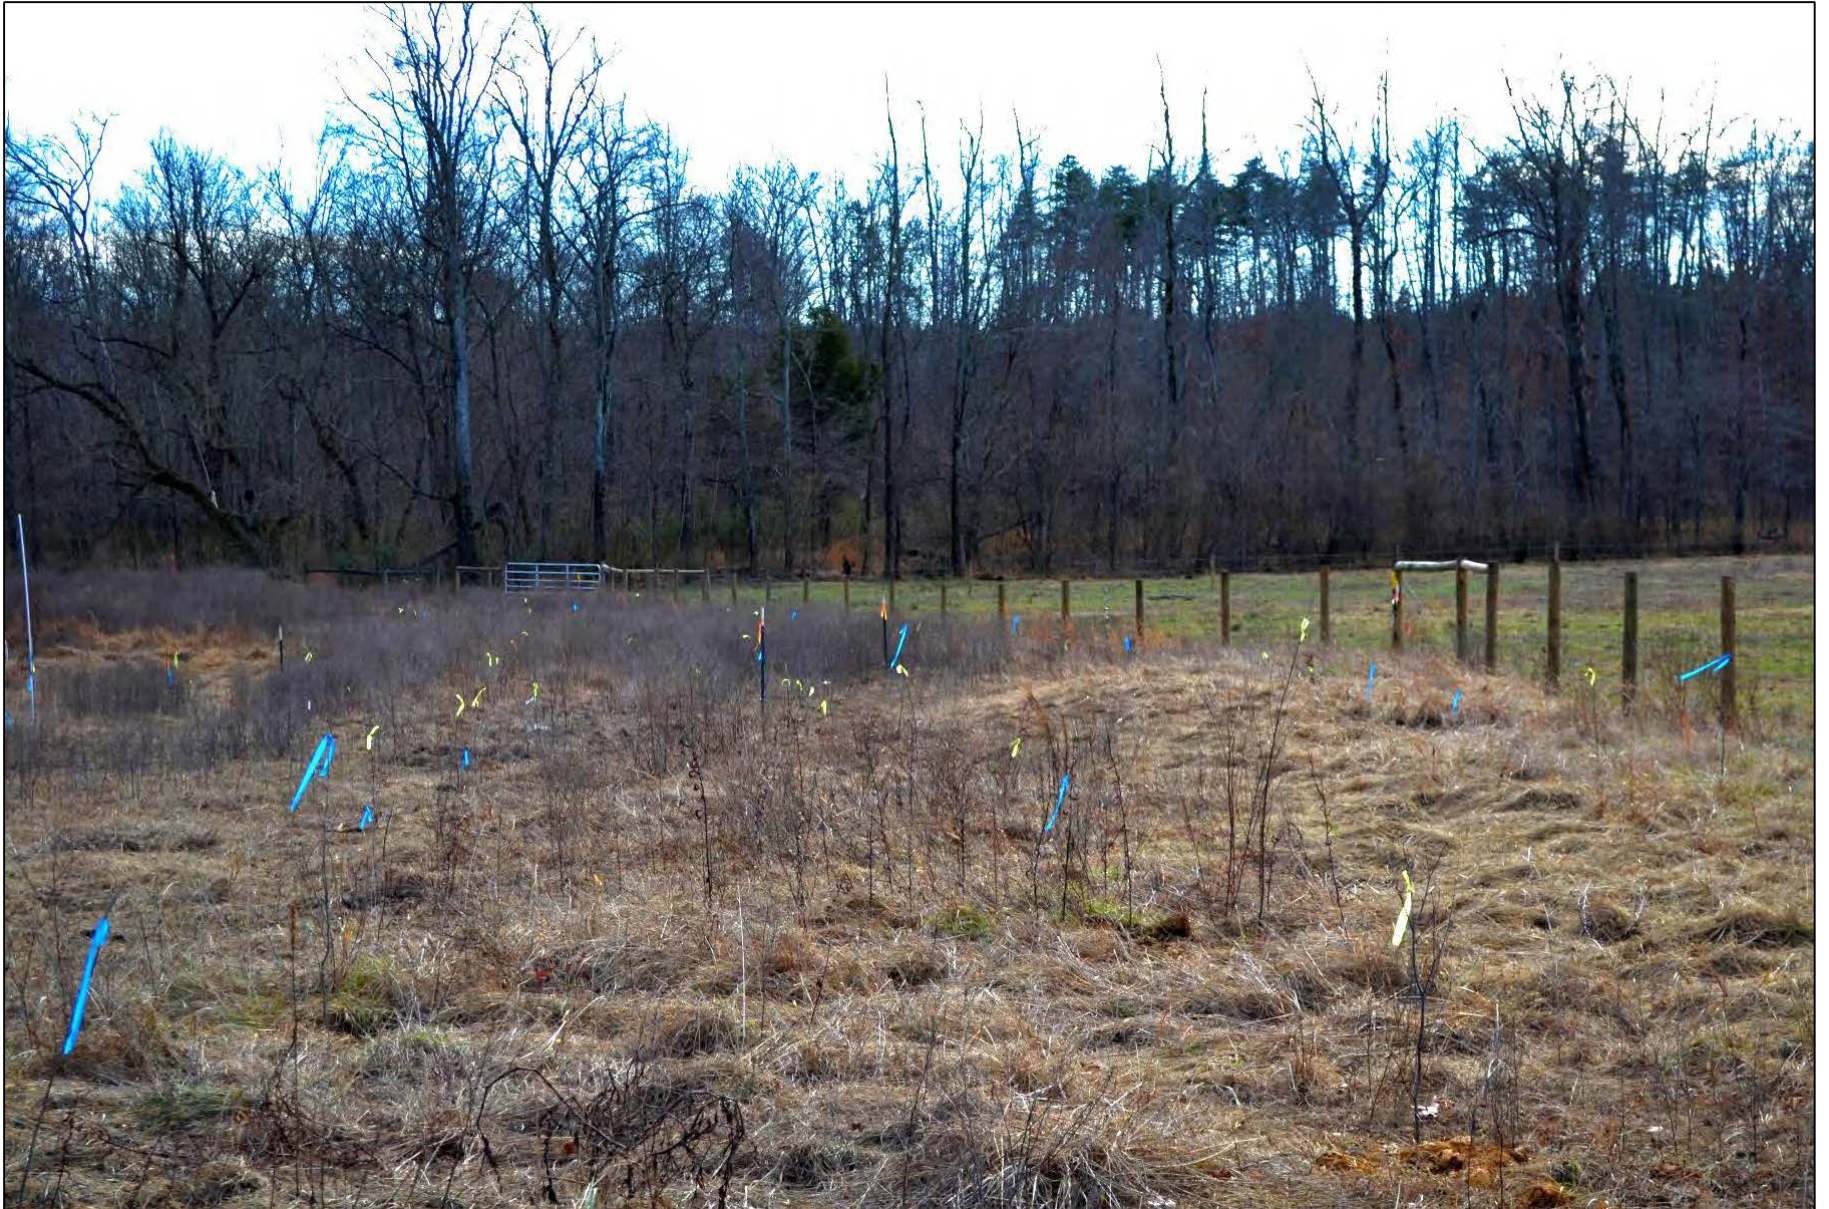
Photo 3: Looking SE. in Replant Area 4, near veg. plot 9

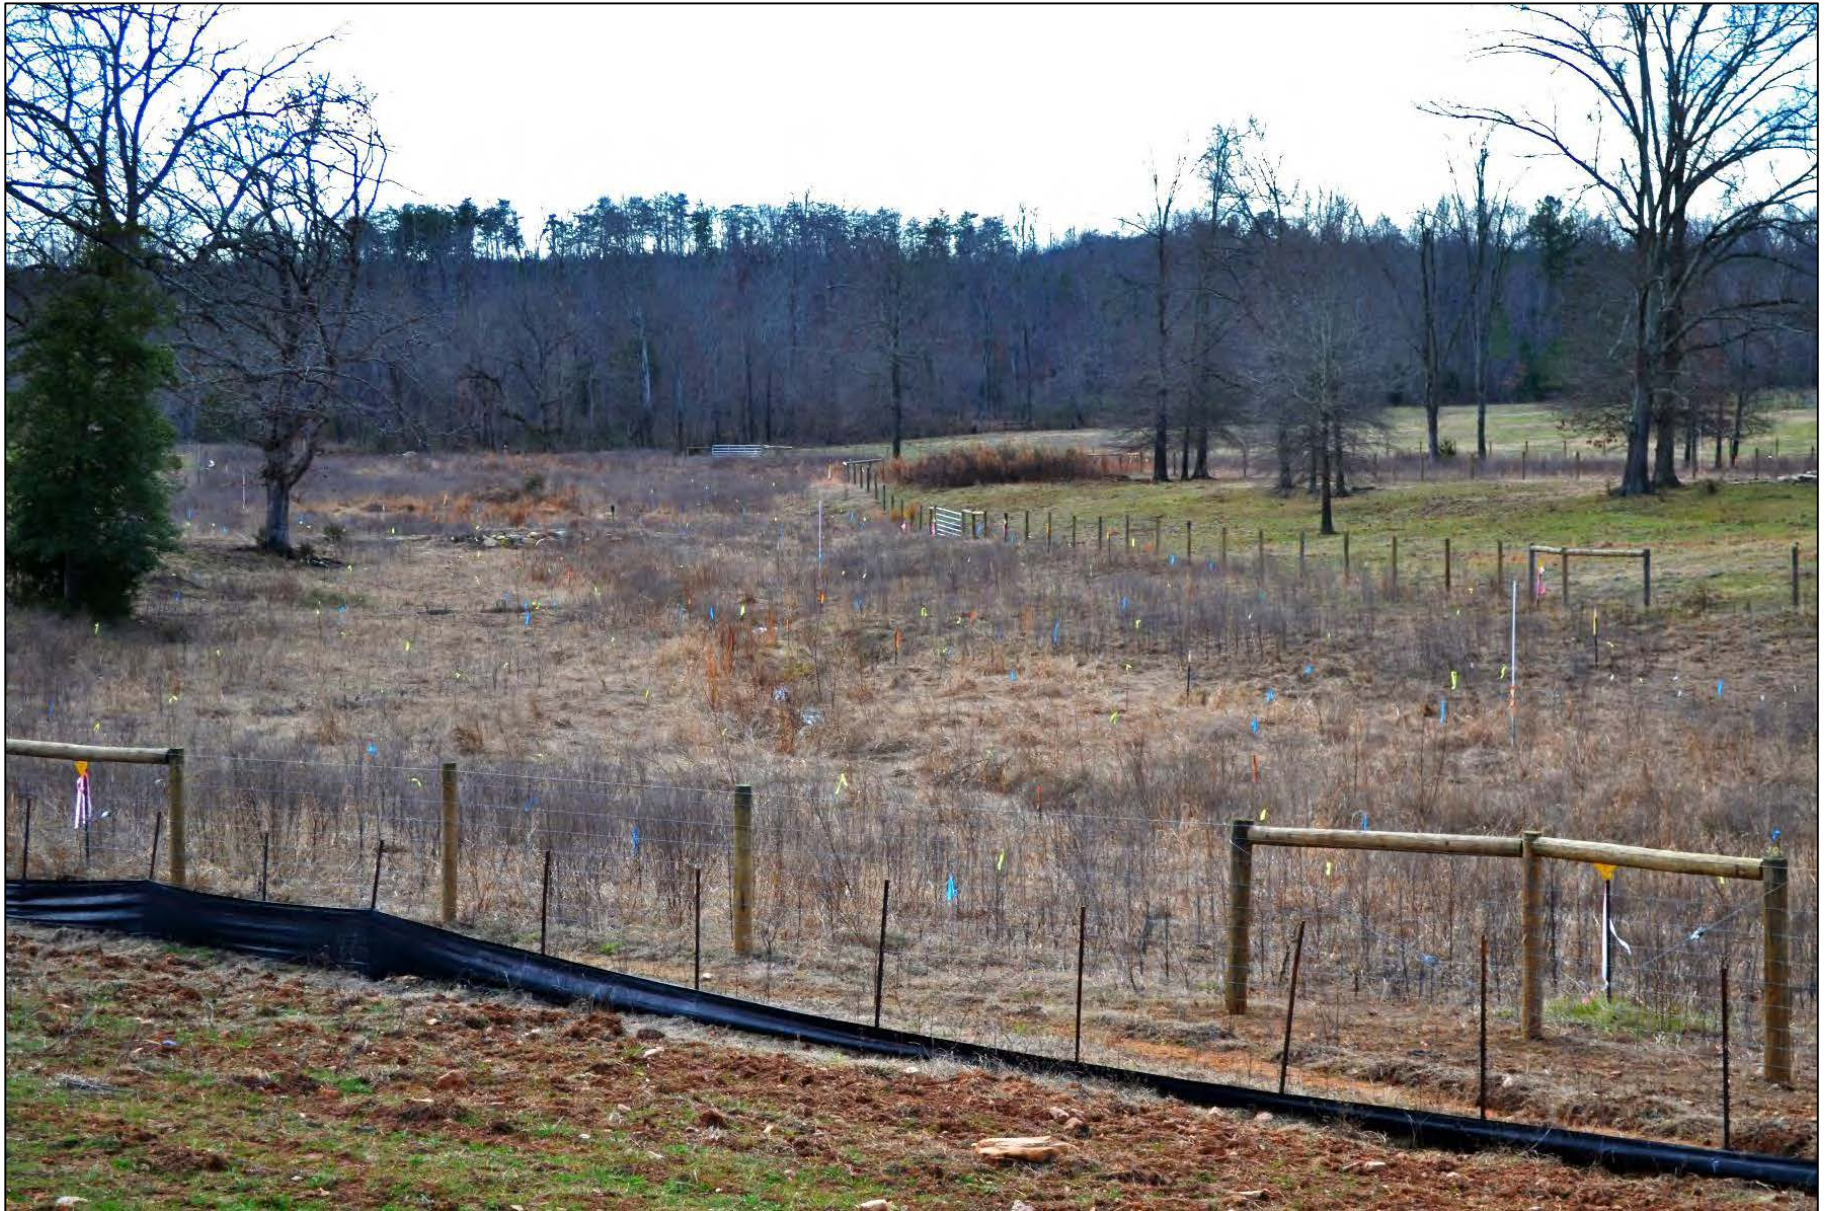
Photo 5: Looking S. in Replant Area 5, N. of veg. plot 5

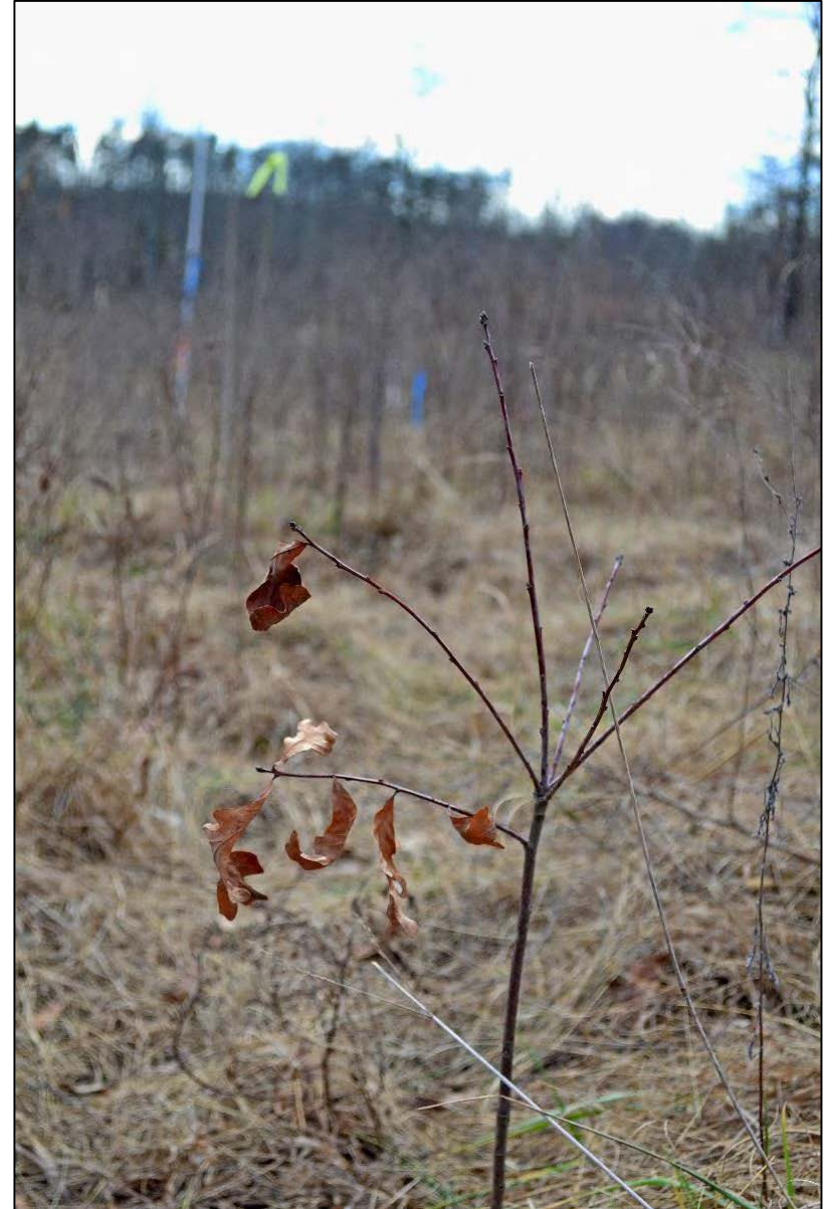
Photo 6 / 7: Live stake establishment on bank in Replant area 6

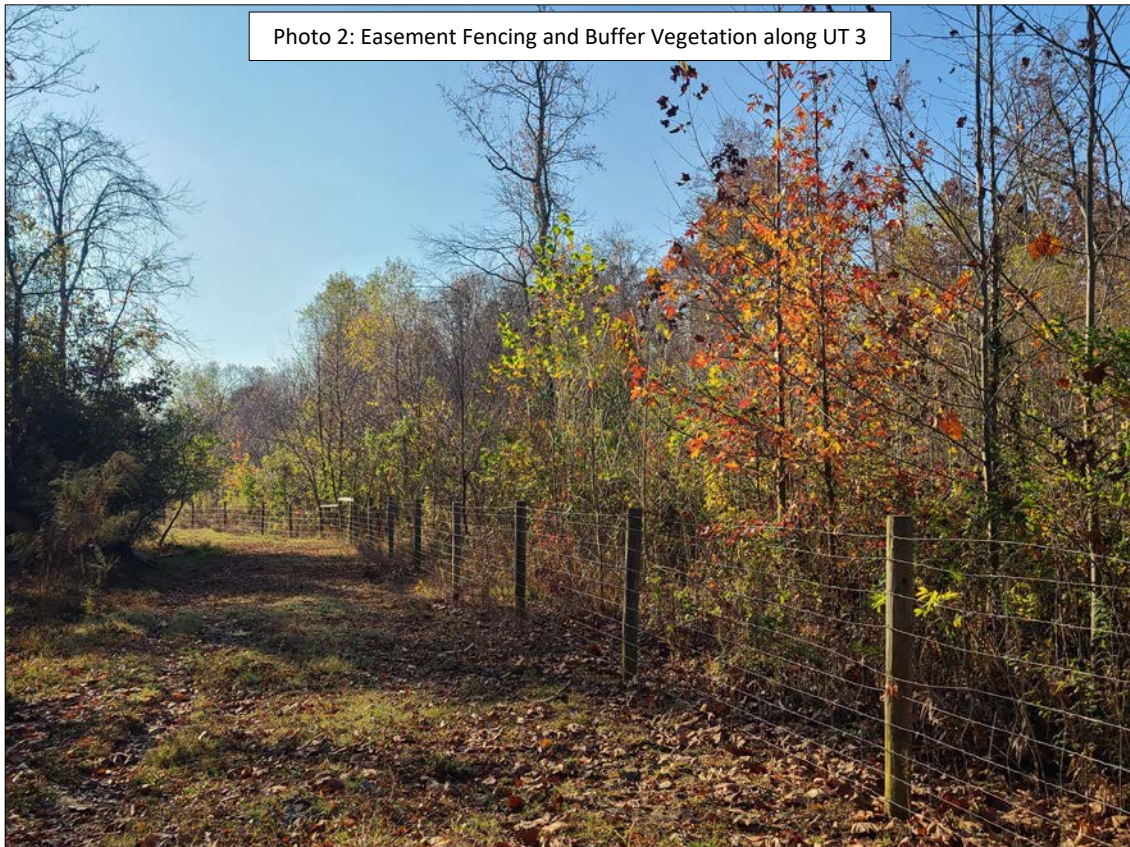
Photo 2: Easement Fencing and Buffer Vegetation along UT 3

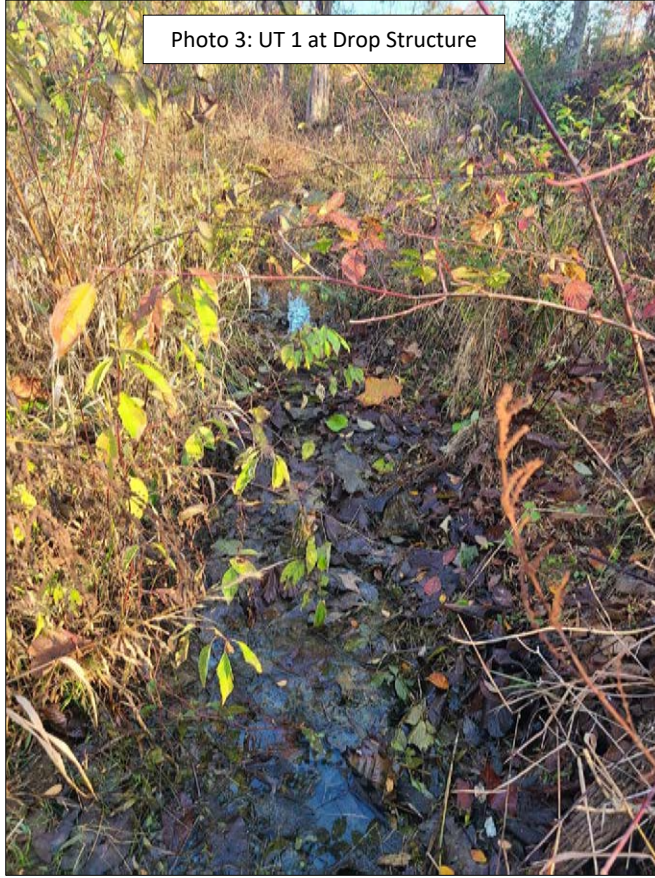
Photo 3: UT 1 at Drop Structure

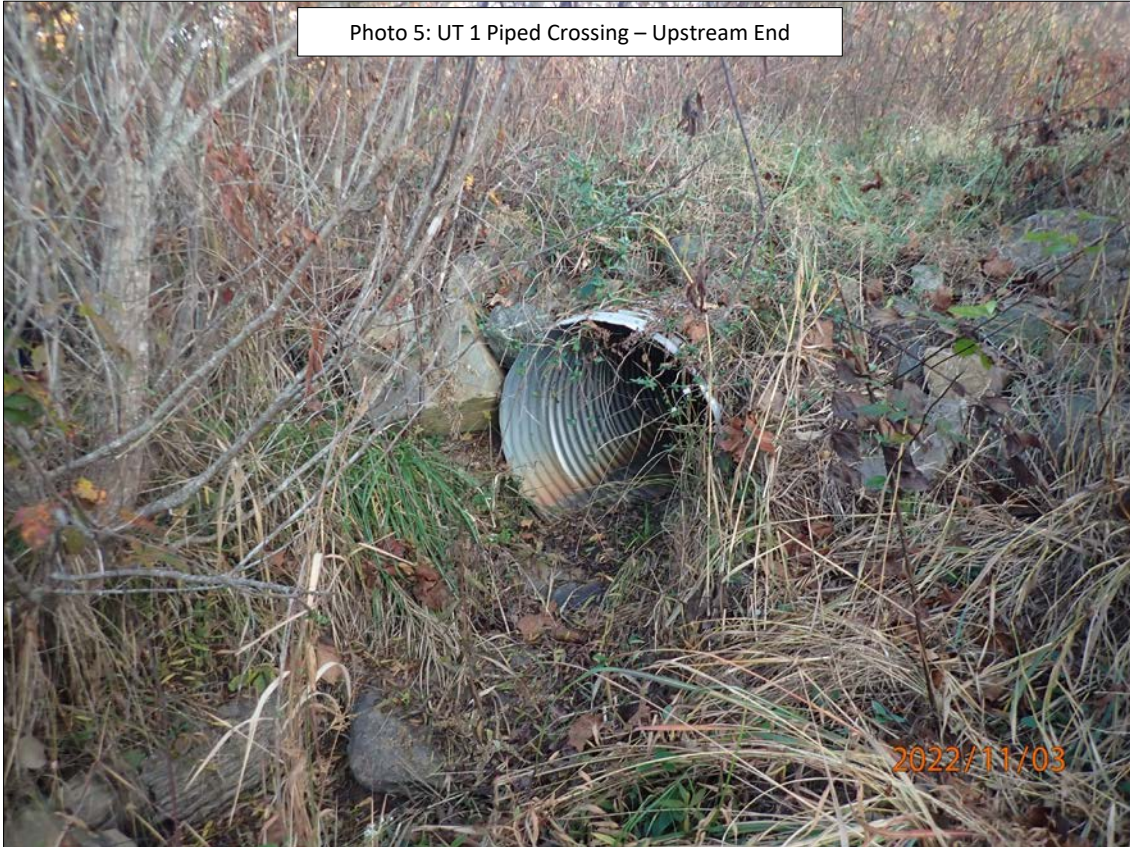
Photo 5: UT 1 Piped Crossing – Upstream End

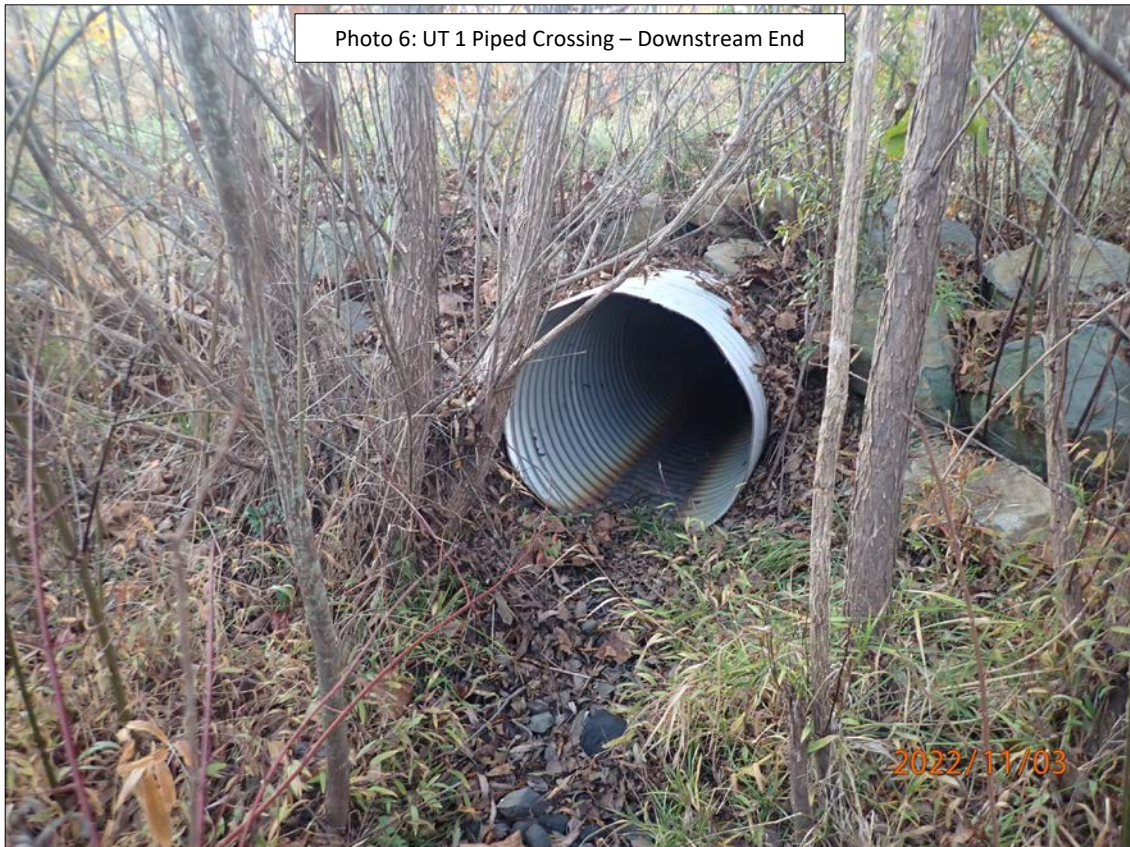
Photo 6: UT 1 Piped Crossing – Downstream End

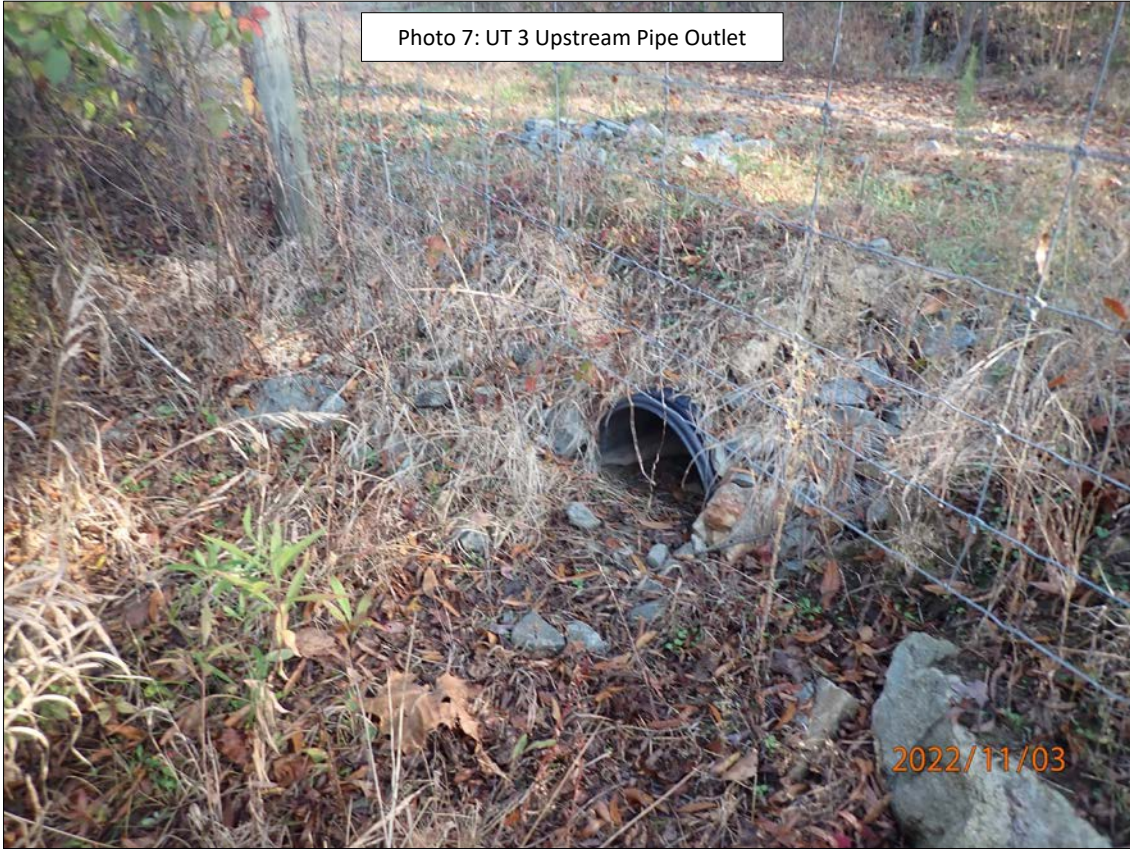
Photo 7: UT 3 Upstream Pipe Outlet
