Back Creek Stream and Wetland Restoration

Project No. 17

2007 Monitoring Report (Final): Year 2 of 5

March 2008

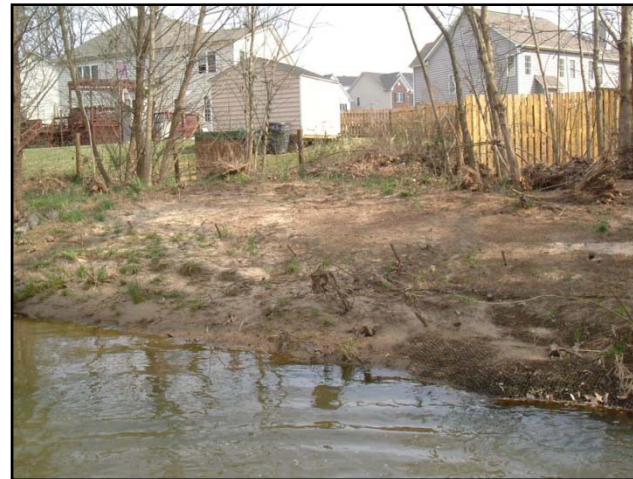
3. Streambank Cover Poor
3/22/2007

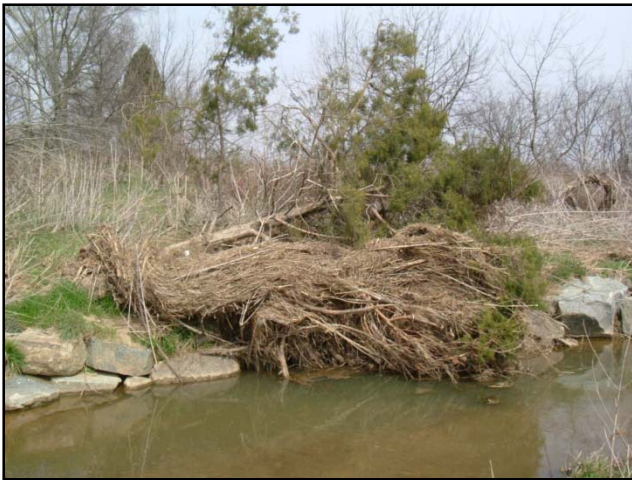
3. Tree Down
3/22/2007
