Back Creek Stream and Wetland Restoration

Project No. 17

2008 Monitoring Report (Final): Year 3 of 5

March 2009

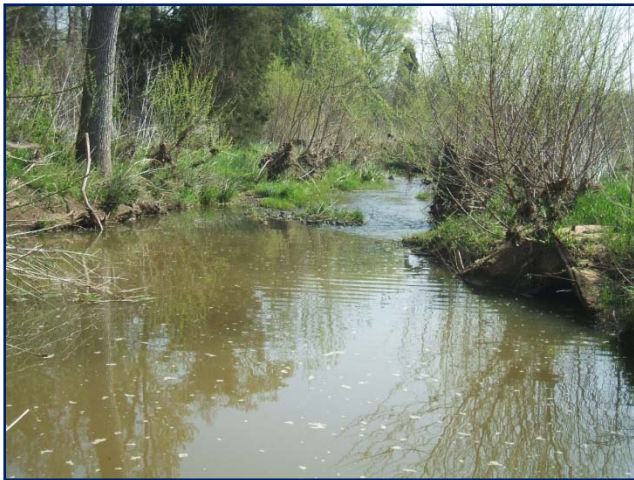
3. Aggradation: Transverse Bar (4/2008)

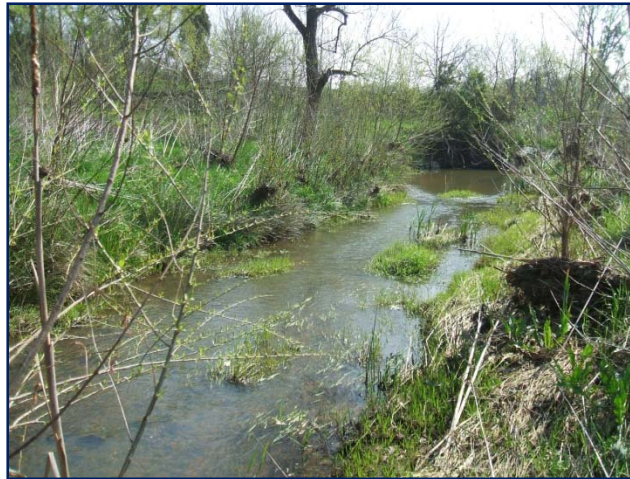
7. In-Stream Vegetation (4/2008)
