BAILEY FORK WETLAND AND STREAM RESTORATION PROJECT (DRAFT)

ANNUAL MONITORING REPORT FOR 2008 (YEAR 3)

Project Number D04006-3

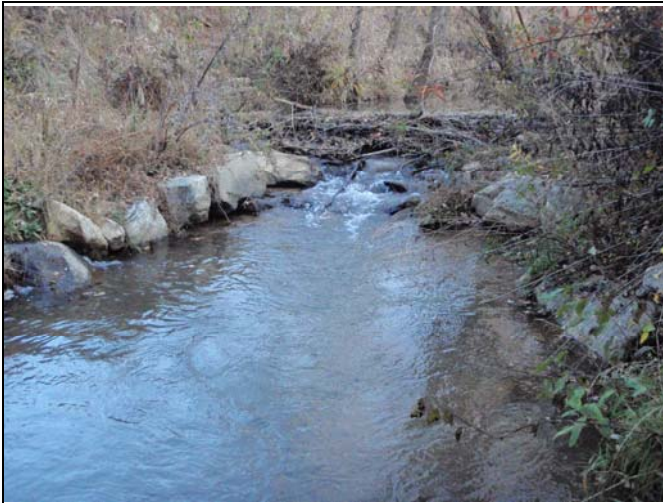
UT3 Photo Point 26

It was also noted that two rock cross vanes on Bailey Fork Creek approximately at stations 17+00 and 28+50 have been impacted by beaver activity. During a site visit in early November 2008 two beaver dams were observed across the rock inverts on top of the cross vanes. Water was flowing around the sides of both dams and over on the arms of the structures. The dams will require removal during the winter of 2008/2009.

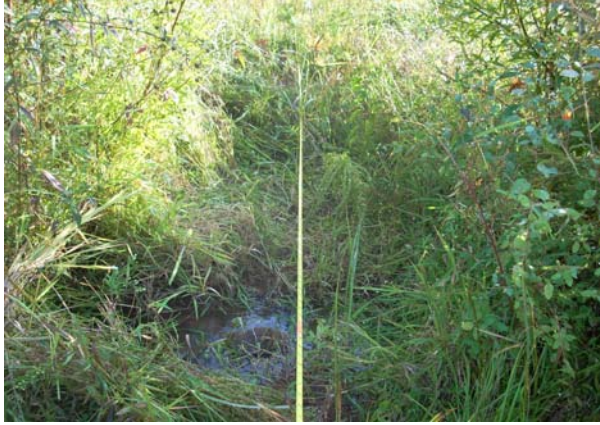
Permanent Cross-section #11 UT2

Looking at the Left Bank

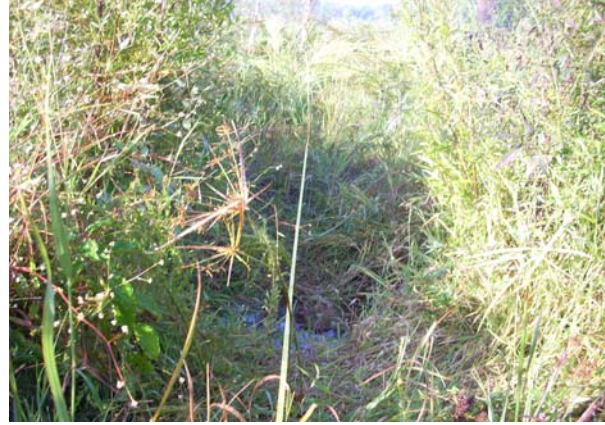
Looking at the Right Bank

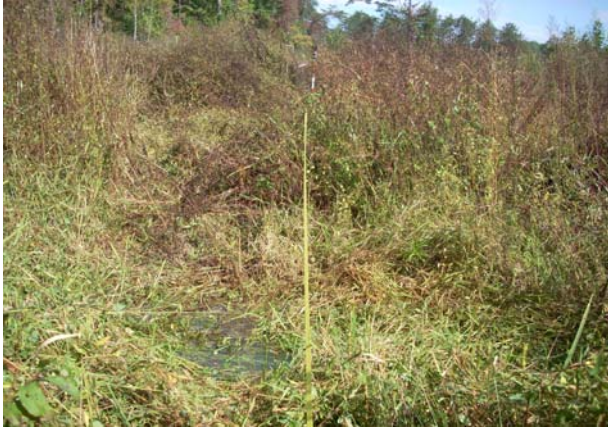
Permanent Cross-section #12 UT1

Looking at the Left Bank

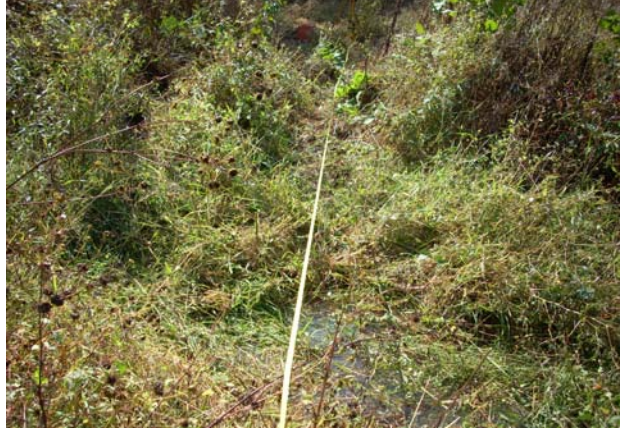
Looking at the Right Bank

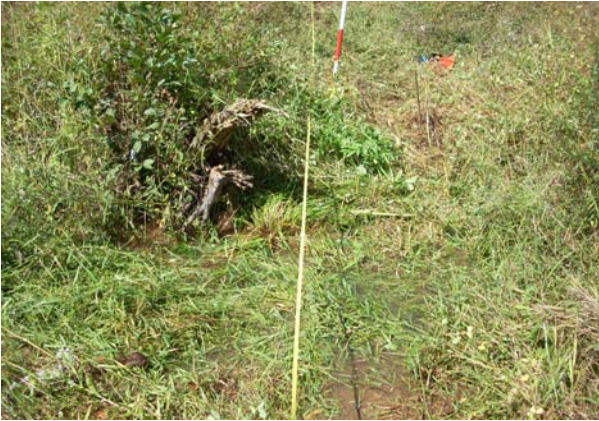
Permanent Cross-section #13 UT1

Looking at the Left Bank

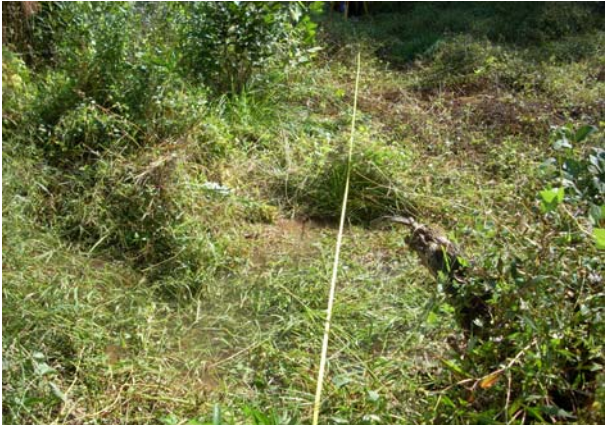
Looking at the Right Bank
