BAILEY FORK WETLAND AND STREAM RESTORATION PROJECT (FINAL)

ANNUAL MONITORING REPORT FOR 2010 (YEAR 5)

Project Number D04006-3

January 2011
FINAL

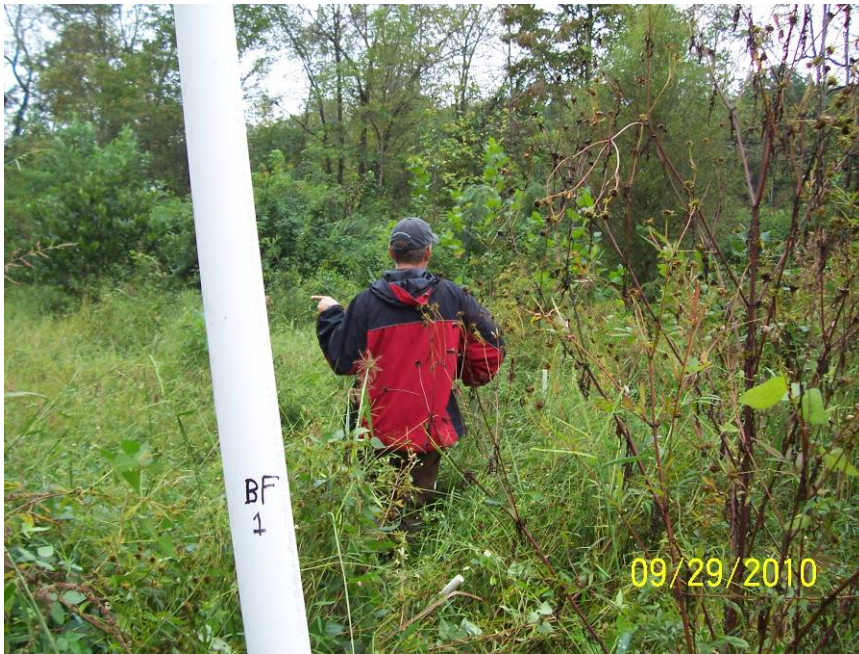
Bailey Fork Vegetation Plot 1

Wetland vegetation is prevalent throughout the Site. Specifically, wetland grasses, herbs and knotweeds are found in the vicinity of Plots 1 and 2. Wetland sedges and herbs are found in the area roughly delineated by Plots 12 through 21. The distribution of hydrophytic vegetation seems to correlate more with the prior land use than the wetness of the Site.

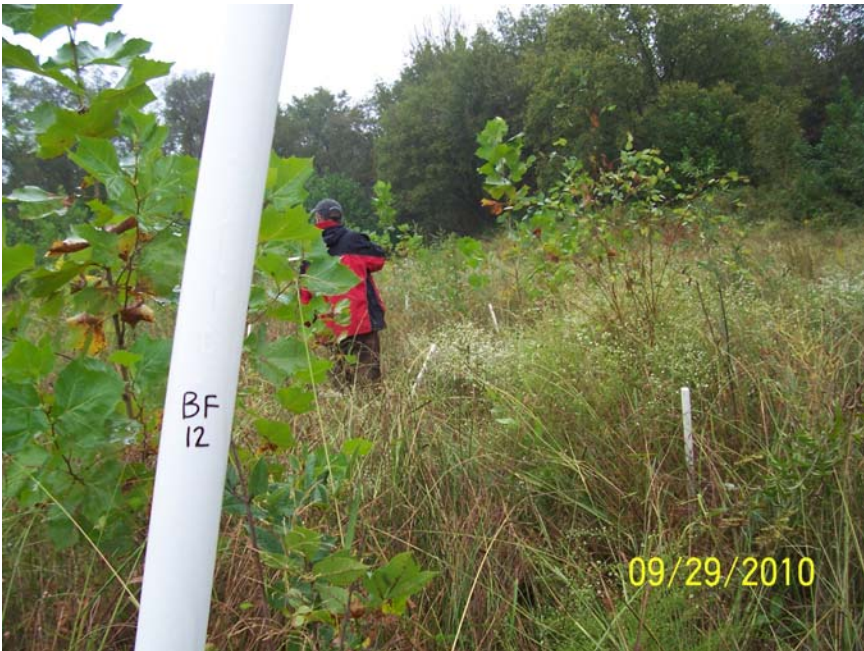
Bailey Fork Vegetation Plot 12

Wetlands associated with Plots 12 through 21 are comprised more of sun tolerant and early successional herbaceous hydrophytic vegetation. Observed vegetation includes; sedges (*Carex spp.*, *Andropogon spp.* and *Cyperus spp.*), rushes (*Juncus effusus* and others), cattail (*Typha latifolia*), spike rush (*Eleocharis obtusa*) and seedbox (*Ludwigia spp.*).

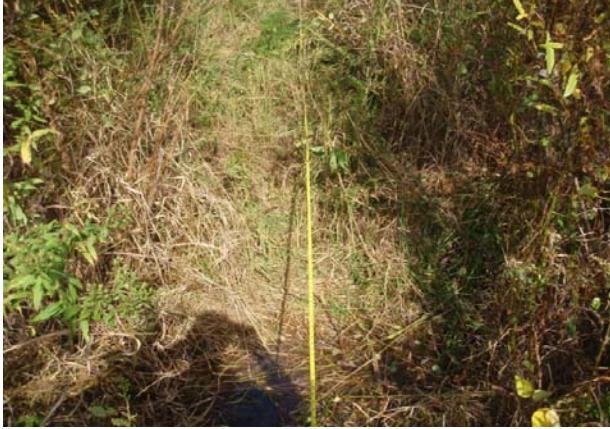
Looking at the Left Bank

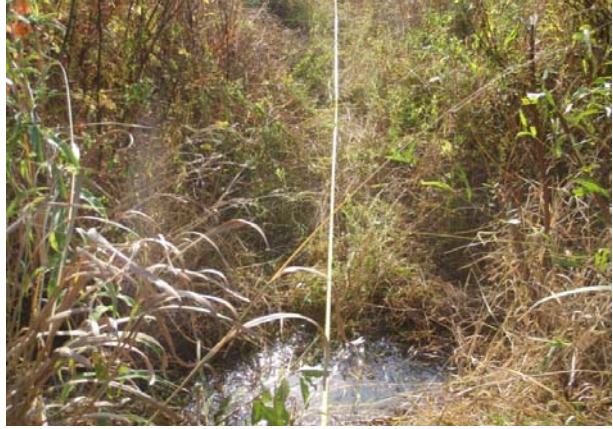
Looking at the Right Bank

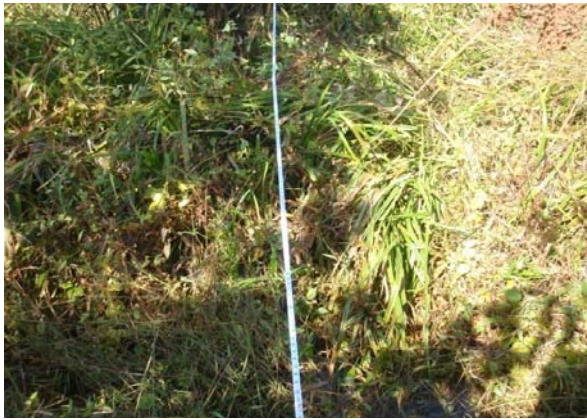
Looking at the Left Bank

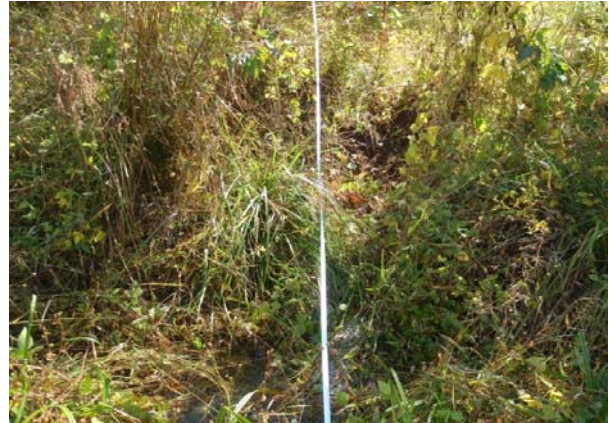
Looking at the Right Bank
