Year 3 Monitoring Report for Stream Restoration of Bailey Fork

Burke County, NC
SCO # D04006-02

Submitted: November 2008

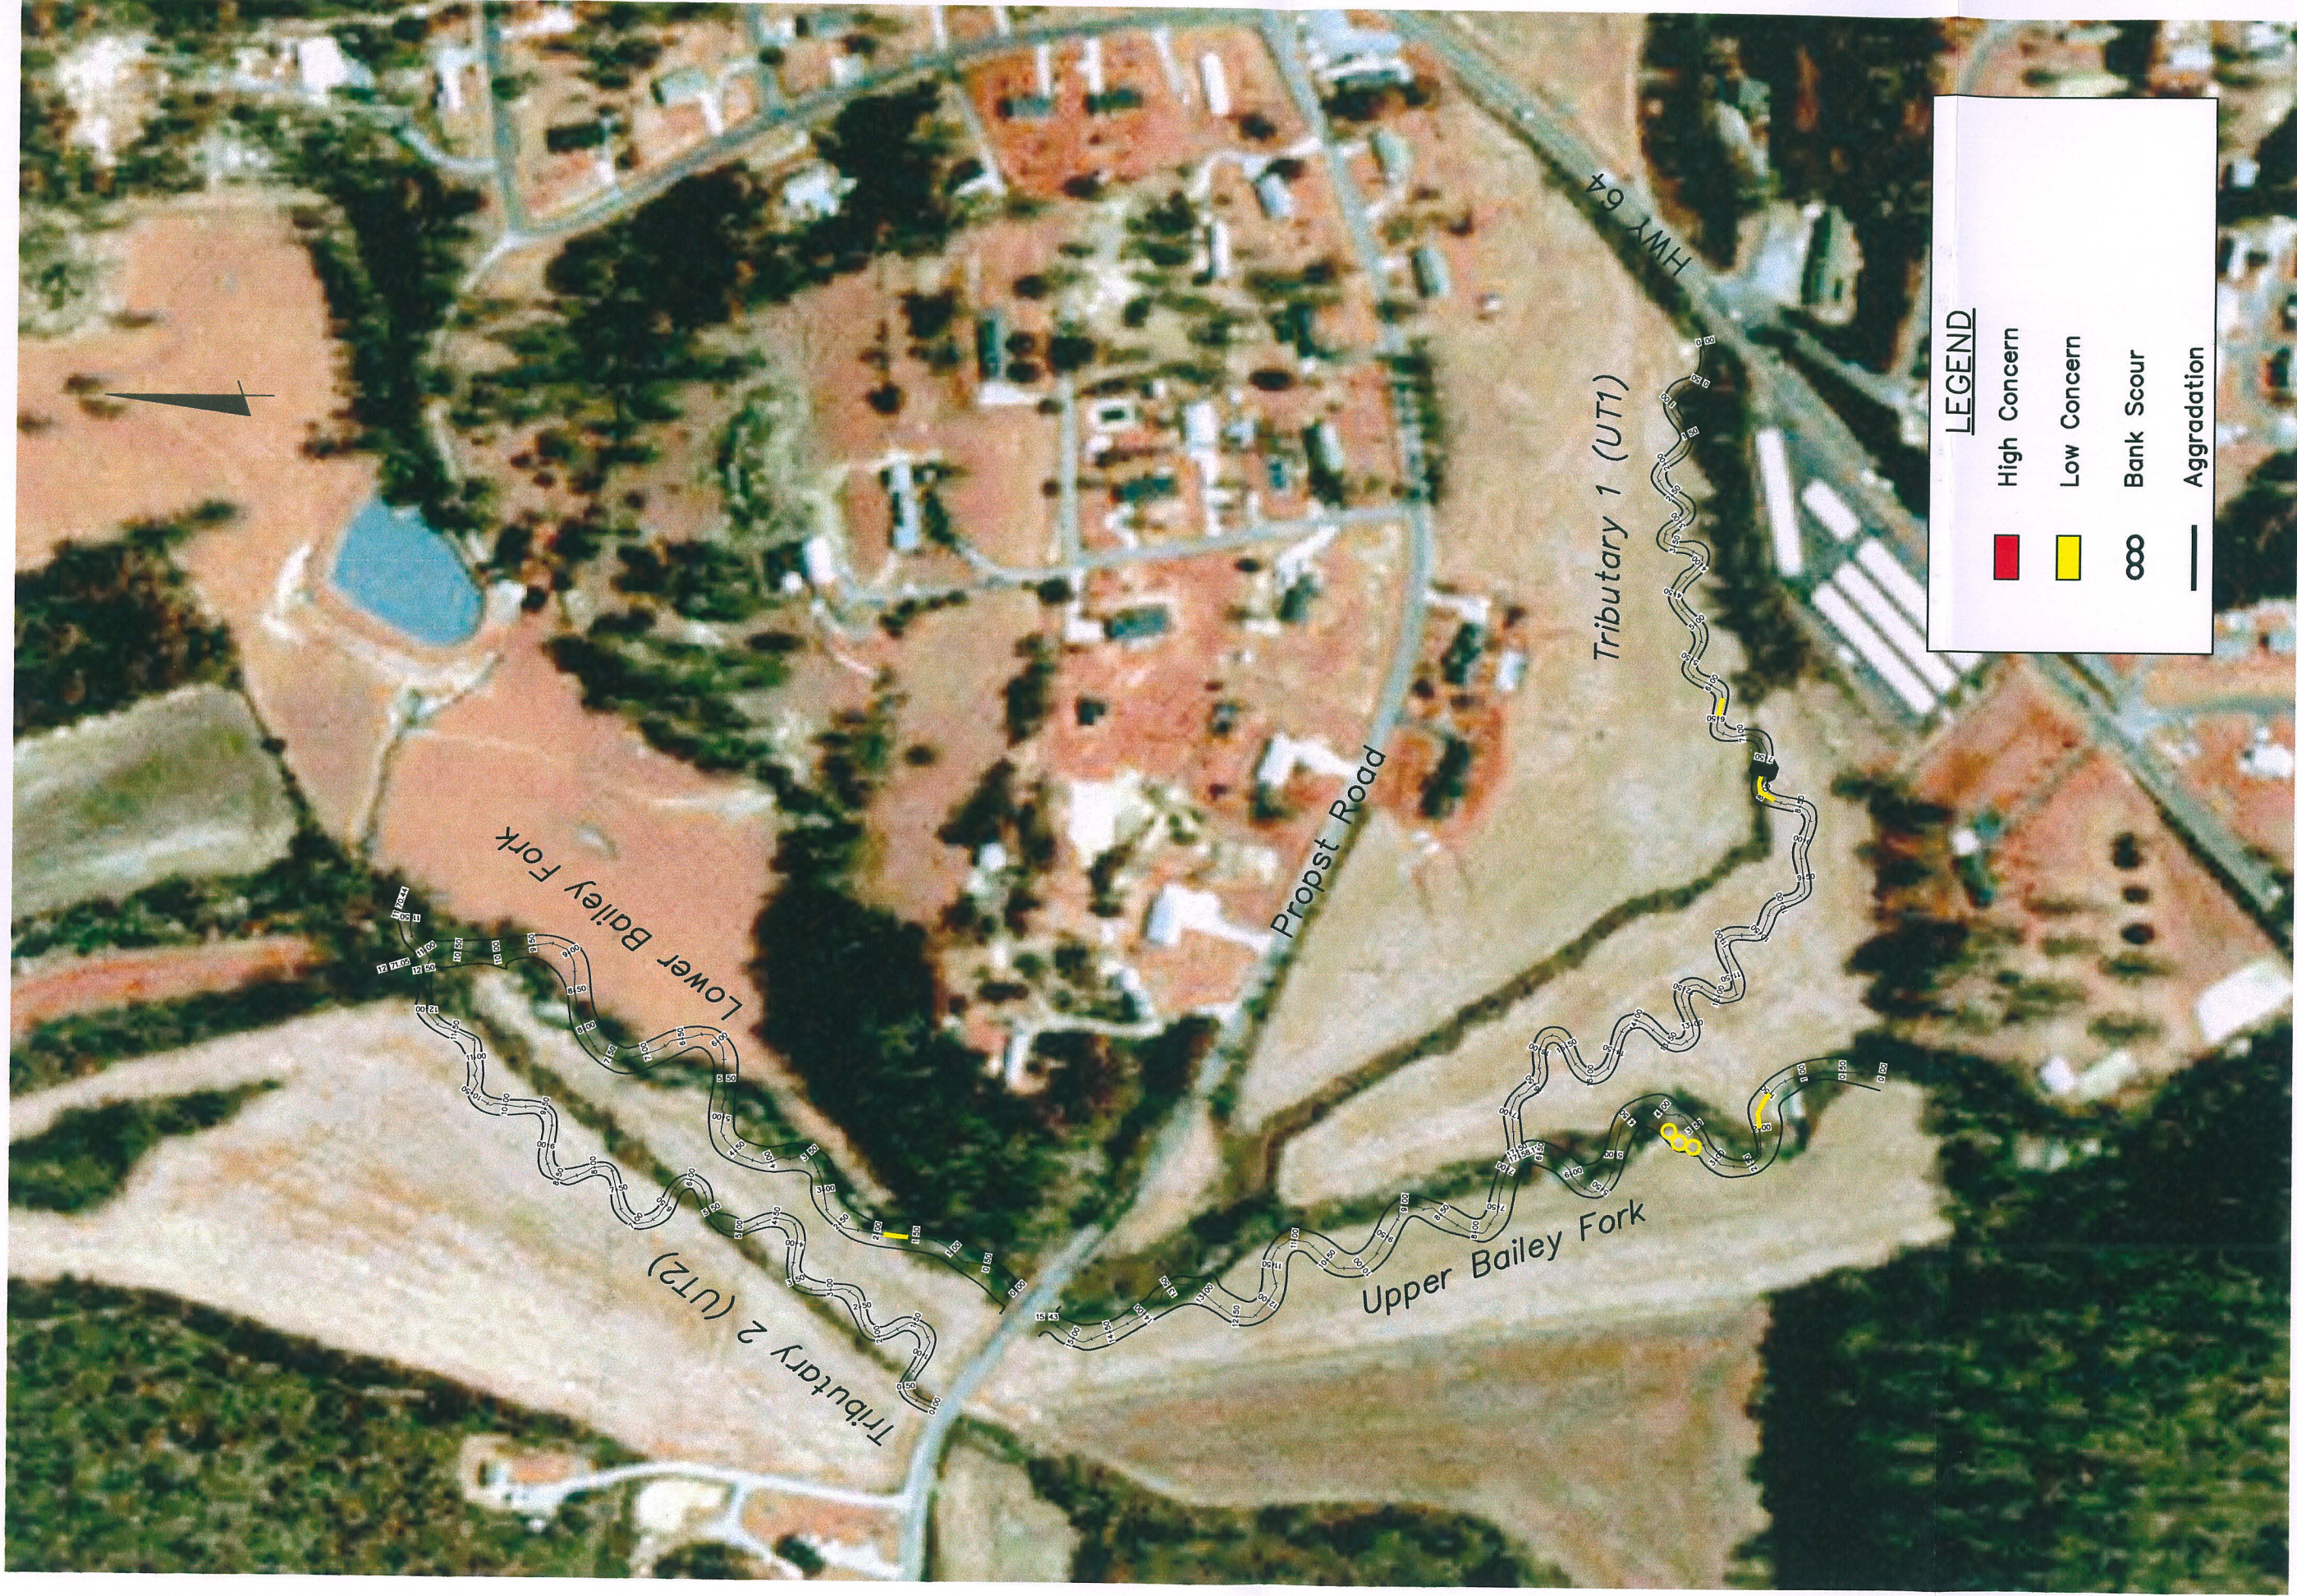
SPA 5

**Bank scour in Year 3 along Upper Bailey Fork at station 3+50.
Close-up of bank shows the heavy vegetation; scour is no longer visible and bank is stable
(EMH&T, Inc. 9/9/08)**

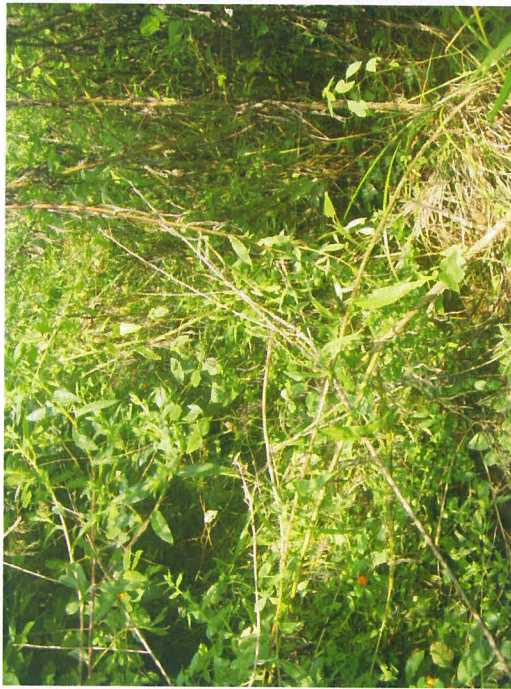
CROSS SECTION: 1
FEATURE: Riffle

**Cross-section photo – looking downstream
 Channel is obscured by vegetation.**

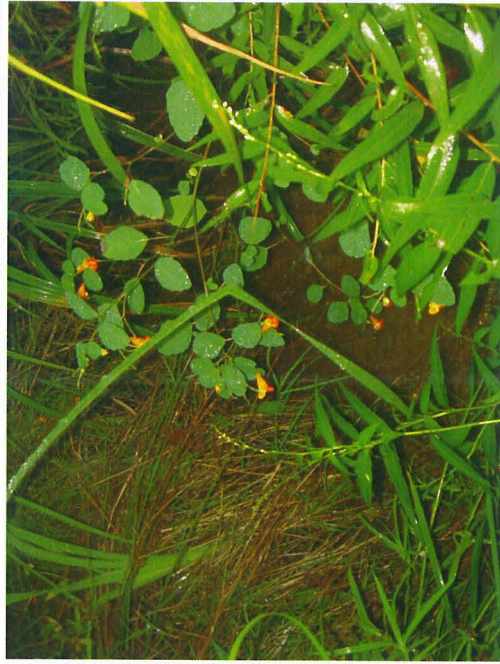
CROSS SECTION: 9
FEATURE: Pool

**Cross-section photo – looking downstream
 Channel is obscured by vegetation.**

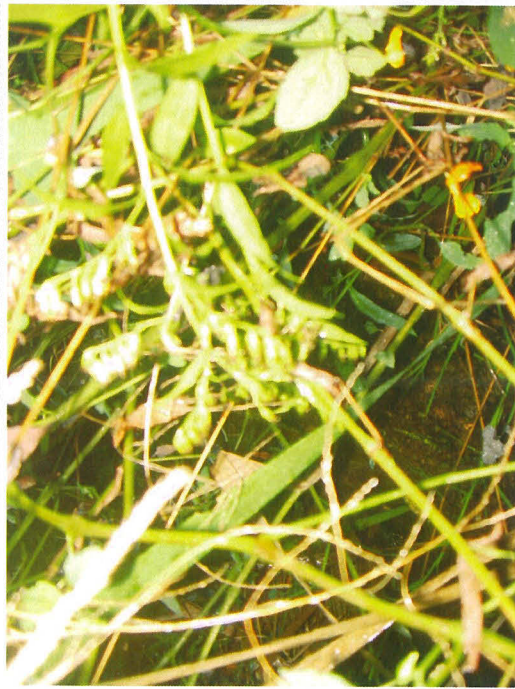
CROSS SECTION: 10
FEATURE: Riffle

**Cross-section photo – looking downstream
 Channel is obscured by vegetation.**

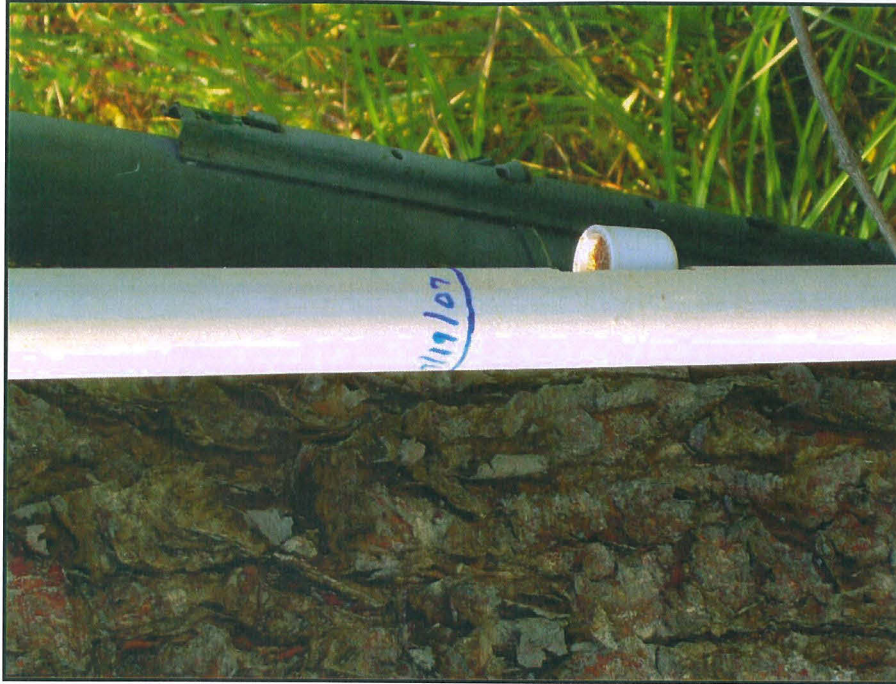
BF 1
Crest Gage 1 on UT1.
(EMH&T, Inc. 7/19/07)

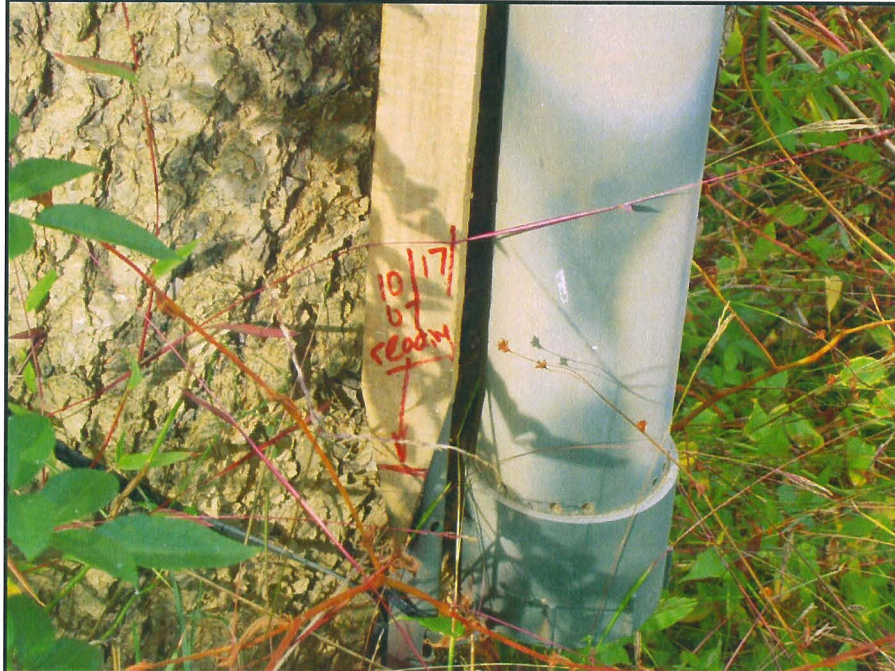
BF 2
Crest Gage 4 on Lower Bailey.
(EMH&T, Inc. 10/17/07)
