Year 4 Monitoring Report for Stream Restoration of Bailey Fork

Burke County, NC
SCO # D04006-02

Submitted: December 2009

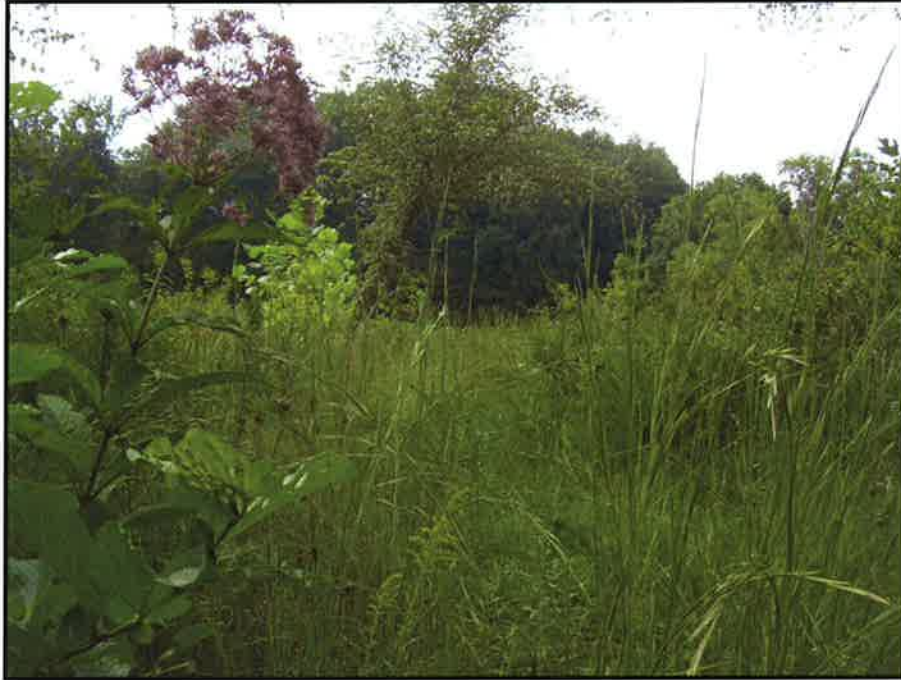
SPA 5

**Scour hole on the right bank of Upper Bailey Fork near station 5+50.
(EMH&T, Inc. 9/15/09)**

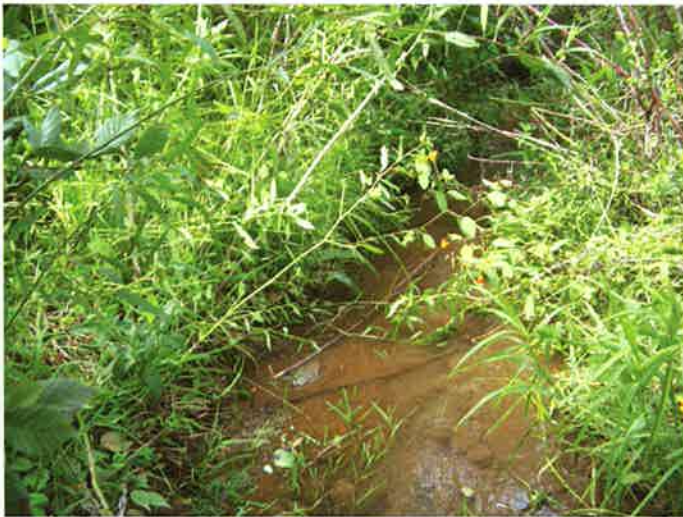
CROSS SECTION: 1
FEATURE: Riffle

**Cross-section photo – looking downstream
 Channel is obscured by vegetation.**

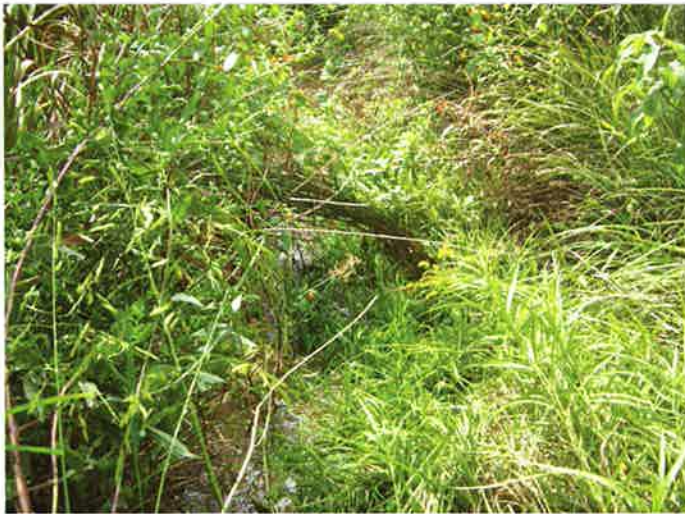
CROSS SECTION: 3
FEATURE: Riffle

**Cross-section photo – looking downstream
 Channel is obscured by vegetation.**

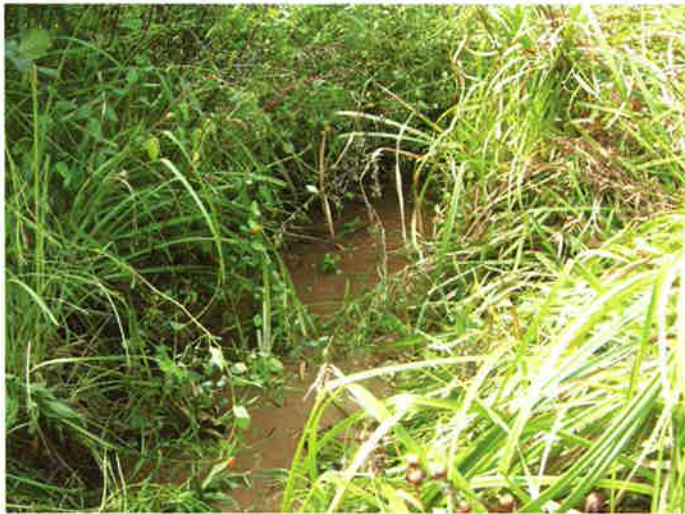
CROSS SECTION: 4
FEATURE: Pool

**Cross-section photo – looking downstream
 Channel is obscured by vegetation.**

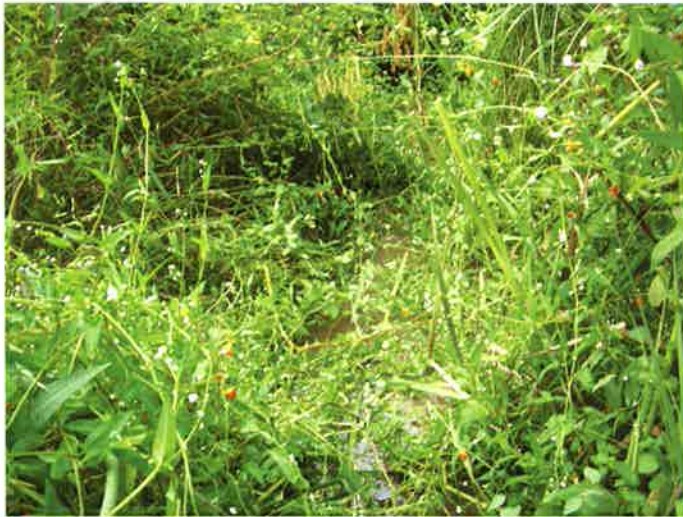
CROSS SECTION: 10
FEATURE: Riffle

**Cross-section photo – looking downstream
 Channel is obscured by vegetation.**
