Year 5 Monitoring Report for Stream Restoration of Bailey Fork

Burke County, NC
SCO # D04006-02

Submitted: February 2011

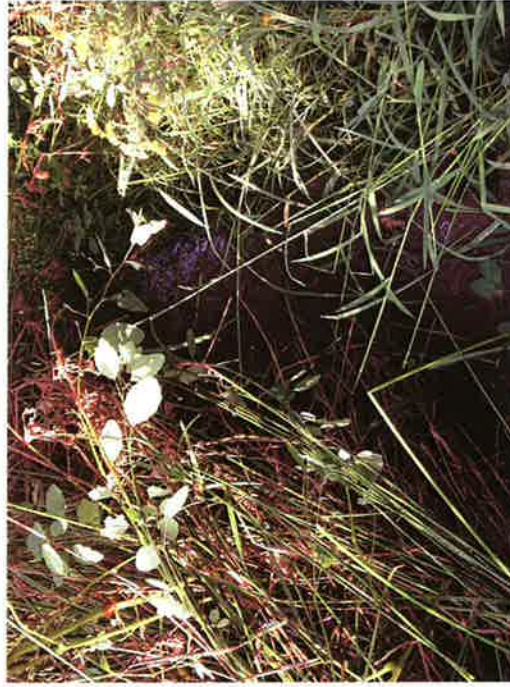
CROSS SECTION: 3
FEATURE: Riffle

Cross-section photo – looking downstream
 Channel is obscured by vegetation.
