MY2 FINAL MONITORING REPORT Banner Branch Mitigation Project Stokes County Roanoke River Basin CU 03010103

DMS Project # 100080

Monitoring Year 2 (MY2) activities occurred during September 2022. This report presents the data for MY2. The Project meets the MY2 success criteria for stream hydrology, stream horizontal and vertical stability, and streambed condition and stability. One of the six flow gauges is not meeting the 30-day flow criteria. Eight of the nine wetlands are meeting success criteria for hydrology. One of the 23 (21 fixed and 2 random transects) vegetation plots is not meeting interim success criteria. Based on these results, the Project is on trajectory to meet interim and final success criteria. For more information on the chronology of the project history and activity, refer to Appendix E. Relevant project contact information is presented in Appendix E and project background information is presented in Table 3.

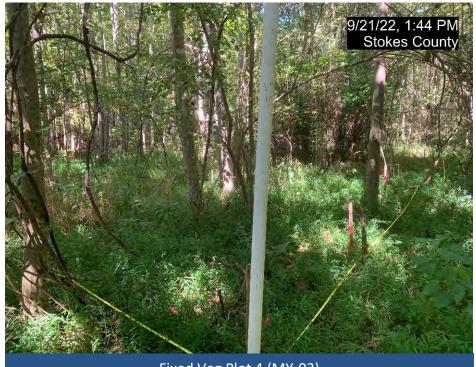
Fixed Veg Plot 4 (MY-02)

*Year Plot 4 stems/acre is only including 4 stems per DMS guidance. There are 6 stems of willow oak and a single species can only account for up to 50% of the veg plot. Without the 50% dominance the veg plot would have 283 stems/acre.
