MY3 FINAL MONITORING REPORT
Banner Branch Mitigation Project
Stokes County
Roanoke River Basin
CU 03010103

DMS Project # 100080
DMS Contract # 7610 and 7701
DMS RFP # 16-007405
USACE Action ID Number SAW-2018-01760
DWR Project # 18-1154
Calendar Year of Data Collection: 2023

USACE
Current Conditions Plan View
Monitoring Year 3

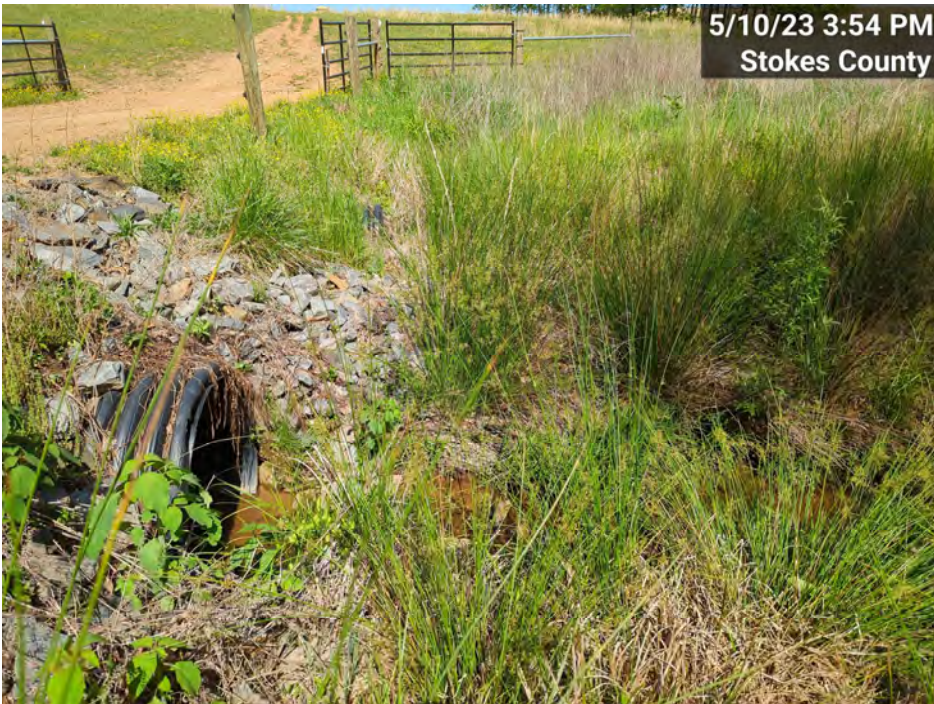
PS-9 – UT4-R1 Culvert Crossing, Upstream Left Bank(MY-03)

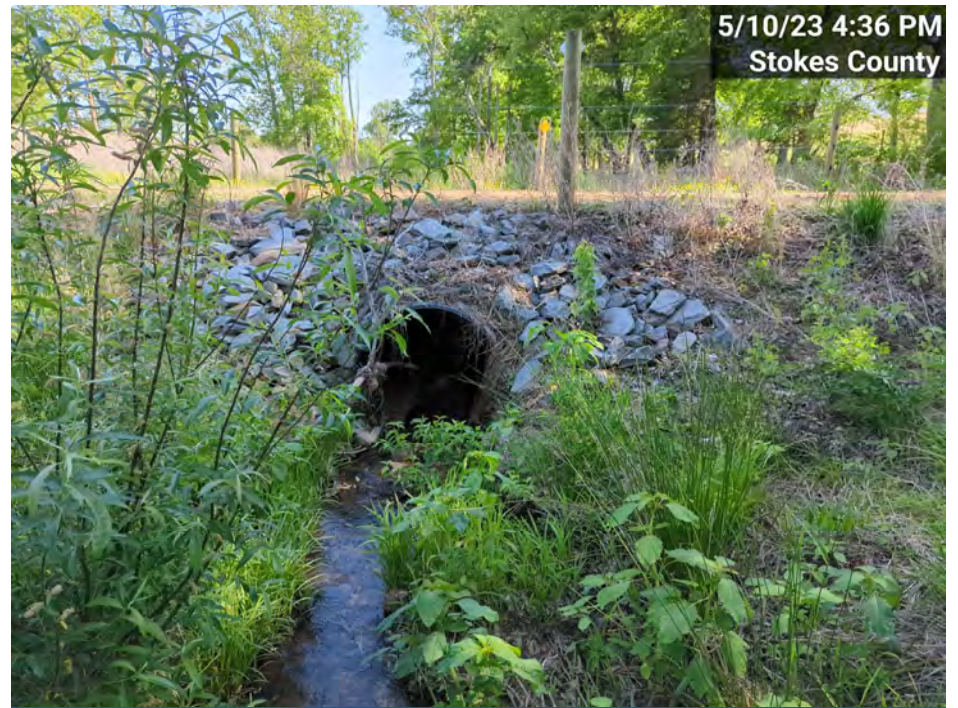
PS-9 – UT4-R1 Culvert Crossing, Downstream (MY-03)

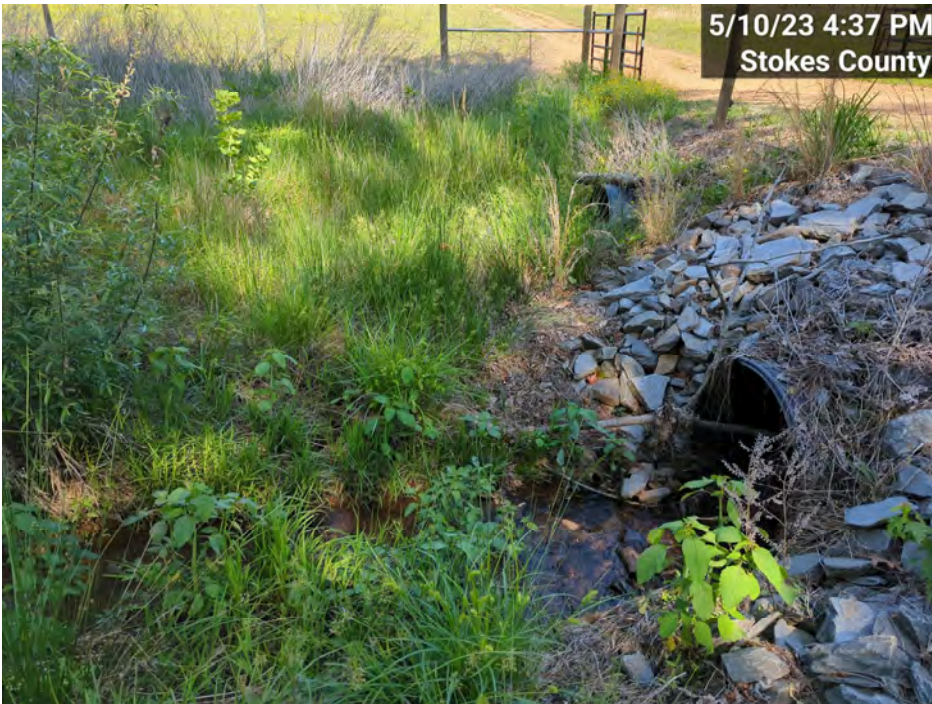
PS-9 – UT4-R1 Culvert Crossing, Downstream Left Bank (MY-03)

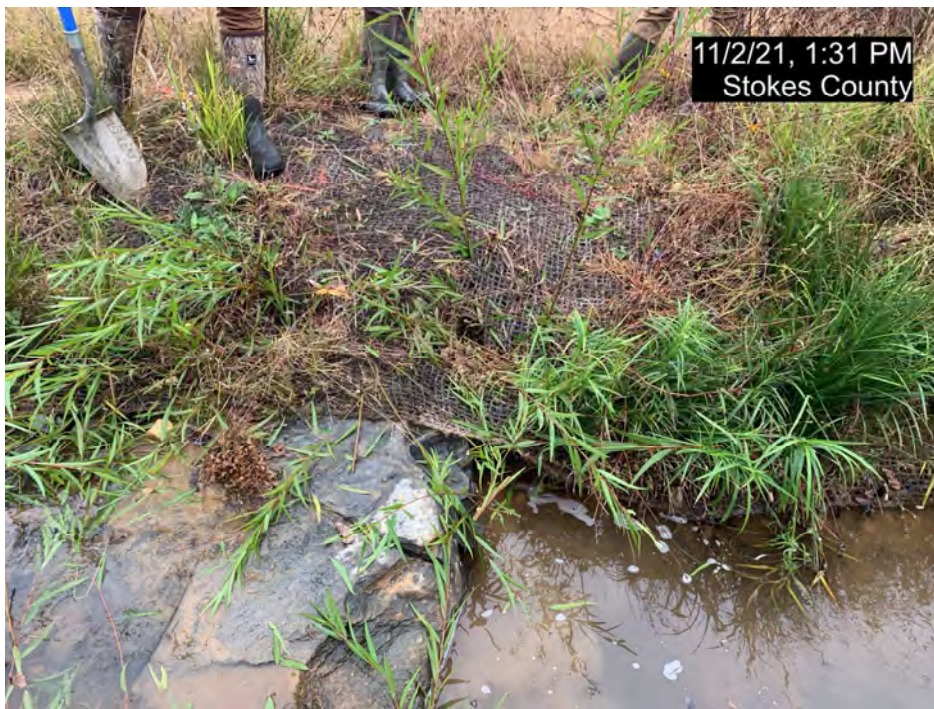
SPA-1 – BB-R1, Piping around rock structure @ STA 44+00 (MY-01)

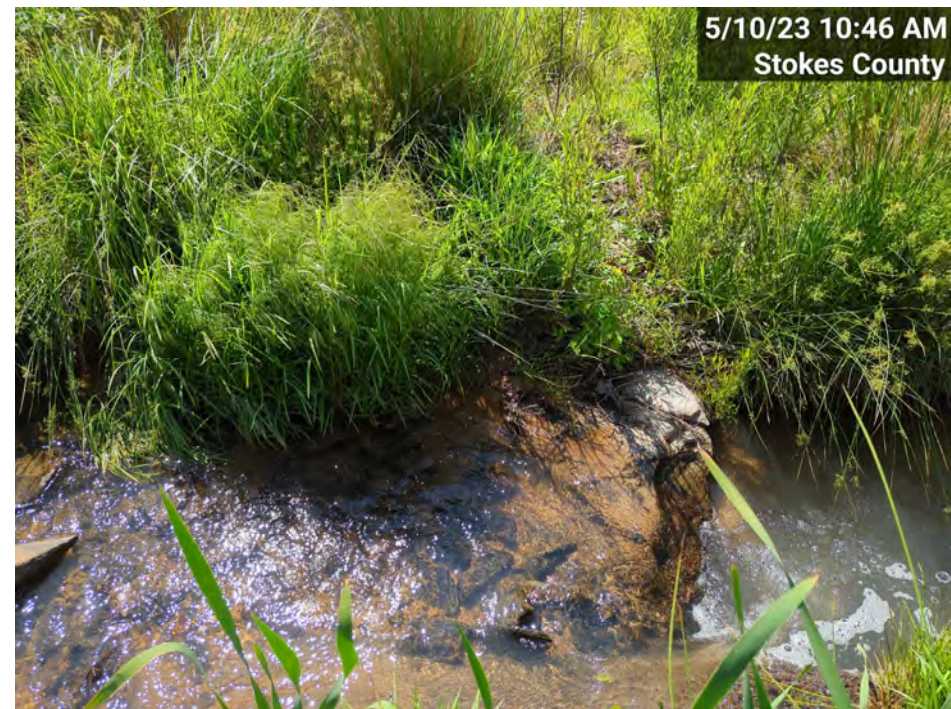
SPA-1 – BB-R1, Piping around rock structure @ STA 44+00 (MY-03)

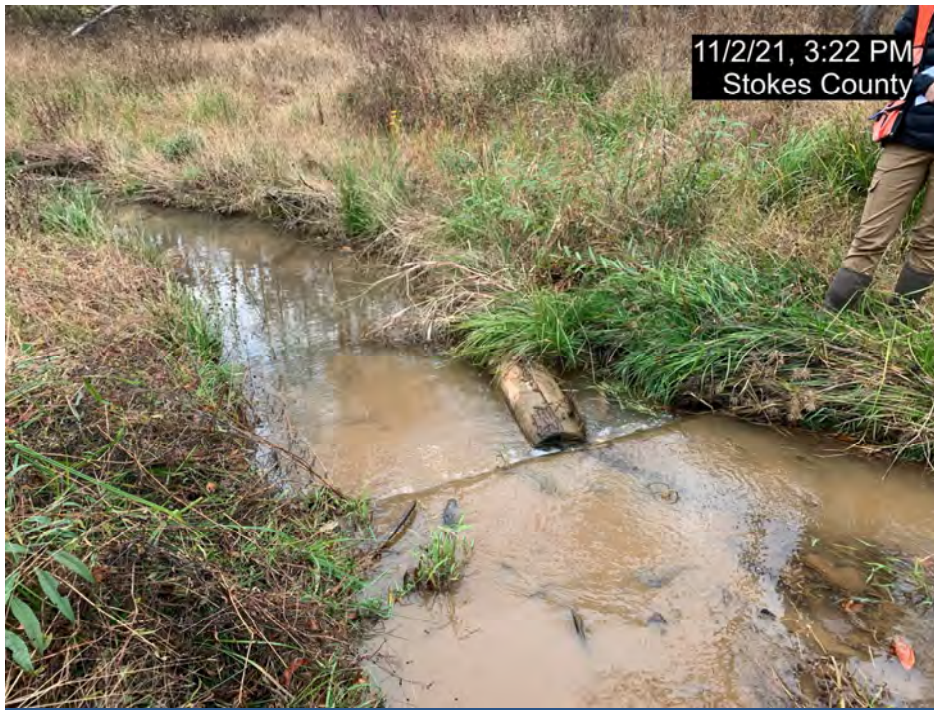
SPA-2 – BB-R3, Erosion around log vane @ STA 70+50 (MY-01)

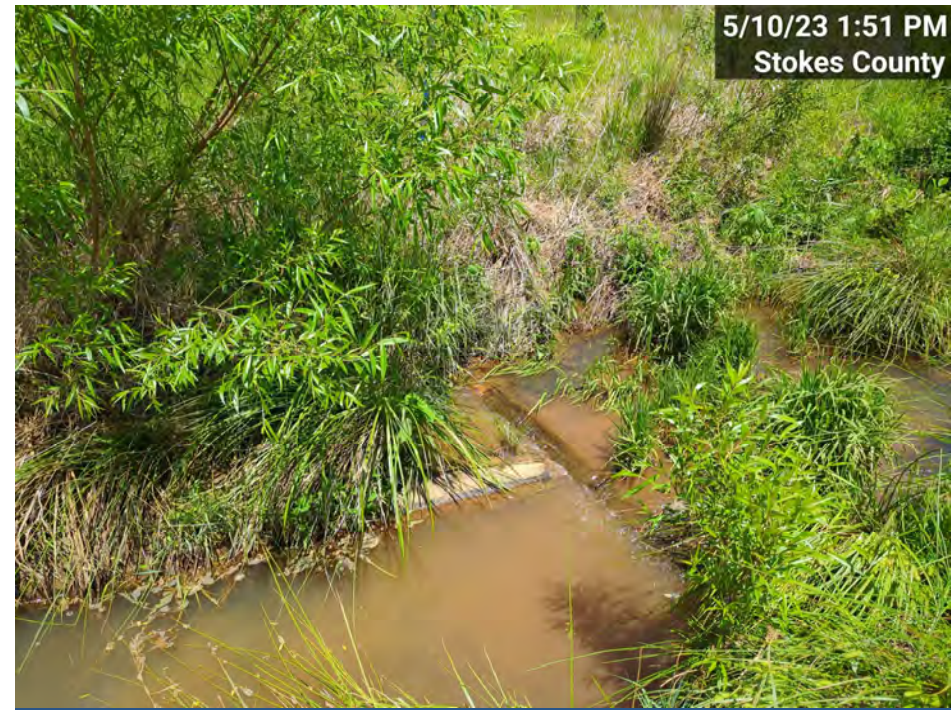
SPA-2 – BB-R3, Erosion around log vane @ STA 70+50 (MY-03)

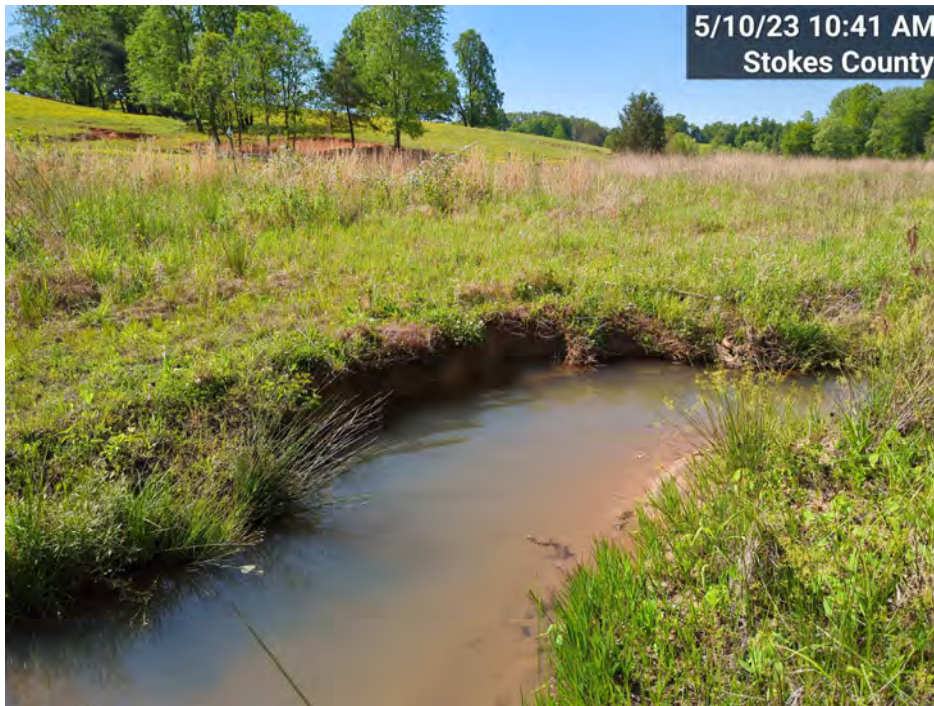
SPA-4 – BB-R1, Bank scour & erosion @ STA 47+25 (MY-03)

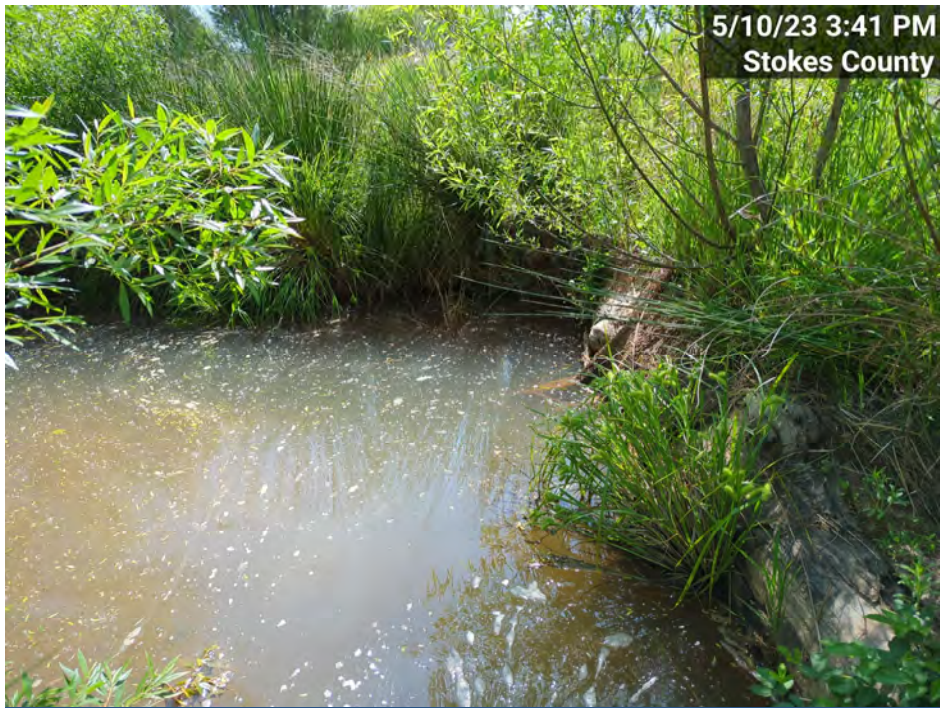
SPA-5 – UT4-R1, Minor erosion downstream of log vane @ STA 51+80 (MY-03)

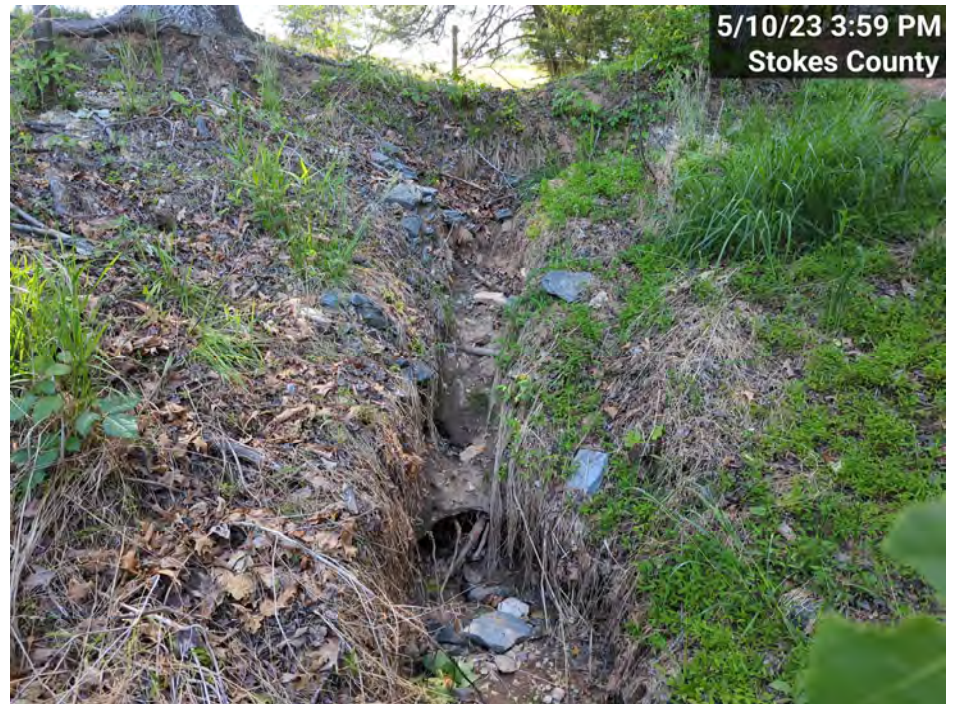
SPA-6 – UT4-R1, Minor erosion on hillside @ STA 34+00 (MY-03)

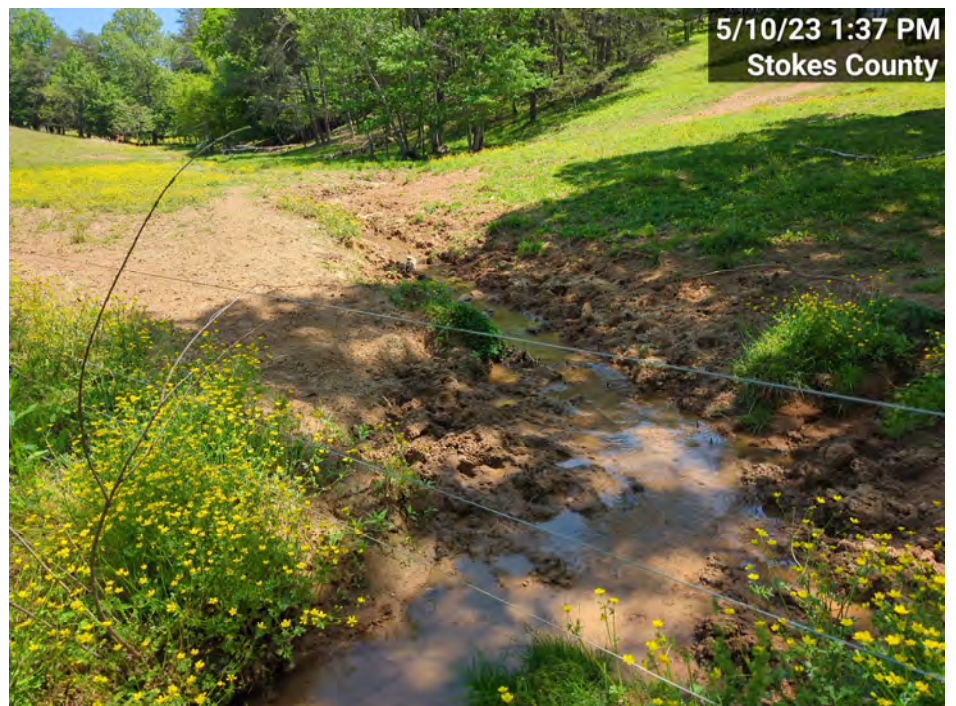
SPA-7 - UT3 Additional photos - Erosion outside easement (MY-03)

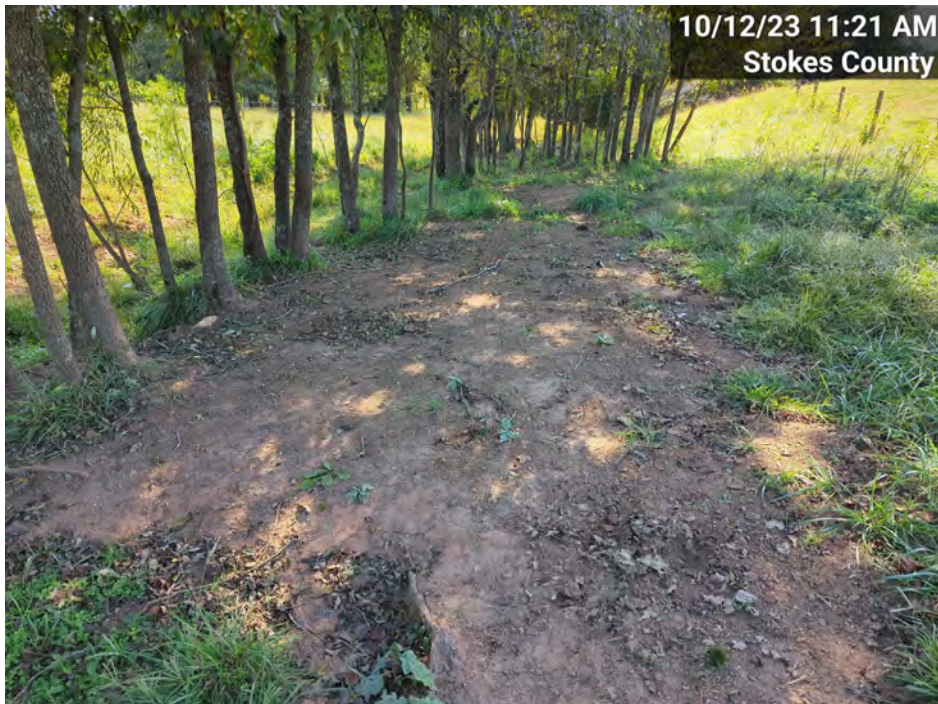
Evidence of cow access inside easement near UT-2 (MY-03)

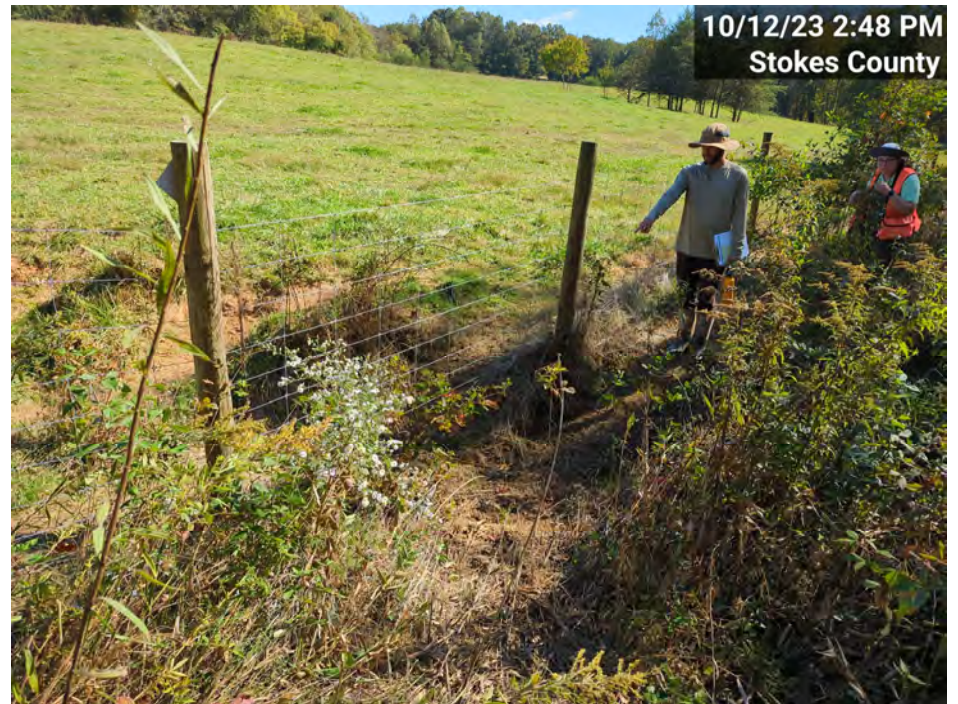
Cattle access point located on UT1 (MY-03)

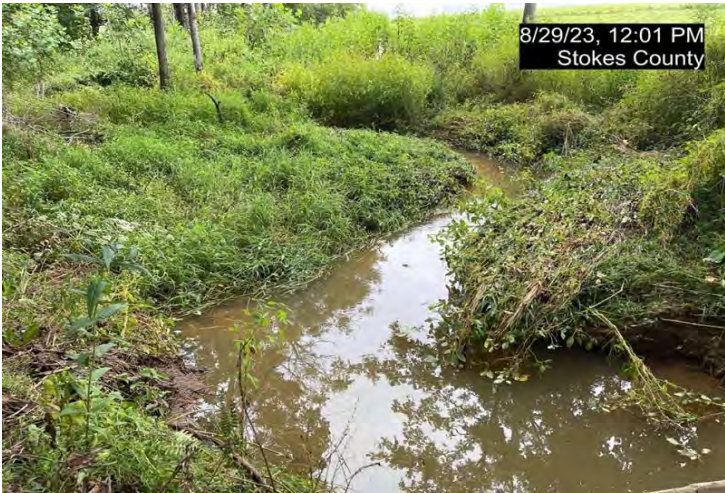
UT4-R2 Evidence of Bankfull Event

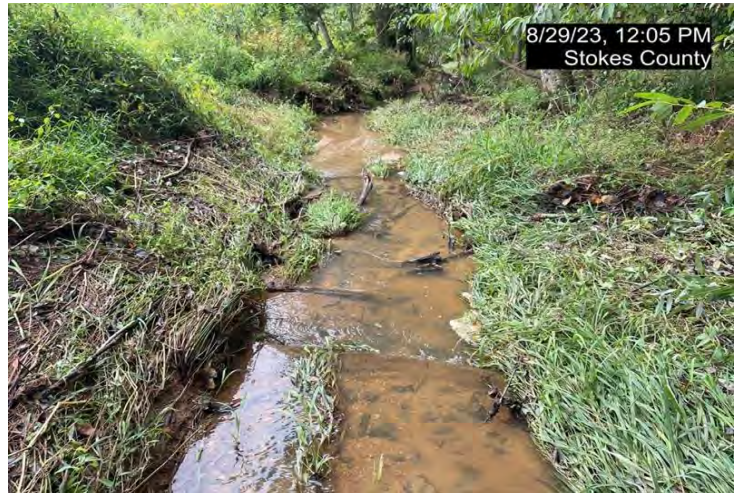
UT4-R2 Evidence of Bankfull Event

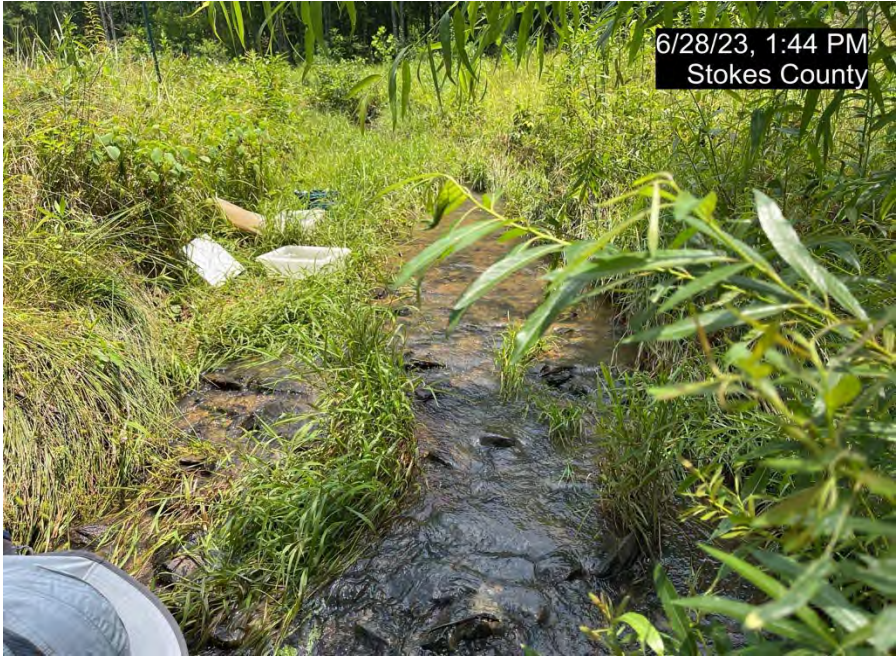
BB1 (BB-R3) - Banner Branch Mitigation Site			
Monitoring Year	MY0	MY3	
Biotic Index Score	5.94	5.19	
Water Quality Level	Fair	Good-Fair

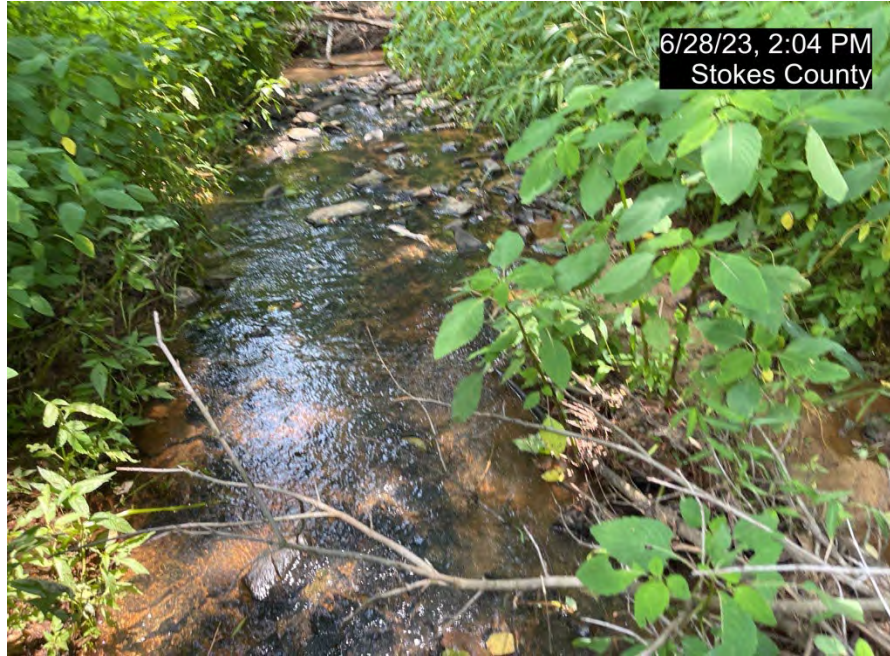
BB2 (UT4-R2) - Banner Branch Mitigation Site			
Monitoring Year	MY0	MY3	
Biotic Index Score	6.65	4.90	
Water Quality Level	Poor	Good-Fair
