# **Year 1 Monitoring Report for Stream Restoration of Beaverdam Creek and Unnamed Tributaries**

Union County, NC  
SCO # D06054-C

**Submitted:** December 2009

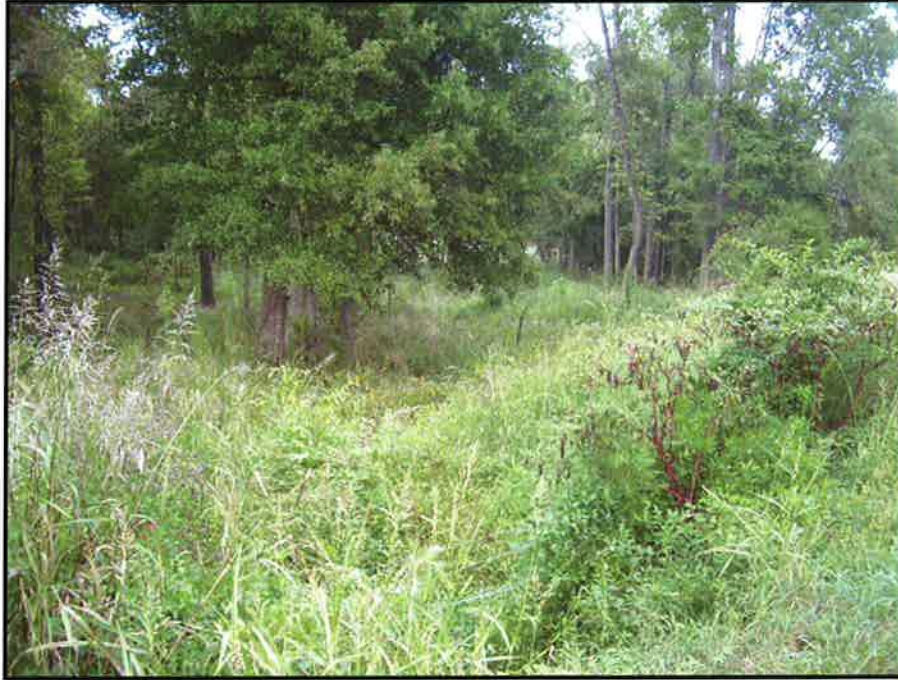
**Steep banks along an outer meander bend on UT2 near station 1+60. Concern for stability if vegetation does not develop.**
