Subject: Year 2 Monitoring Report for Stream Mitigation of Beaverdam Creek
SCO# D06054-C

Year 2 Monitoring Report for Stream Restoration of Beaverdam Creek and Unnamed Tributaries

Union County, NC
SCO # D06054-C

Submitted: December 2010

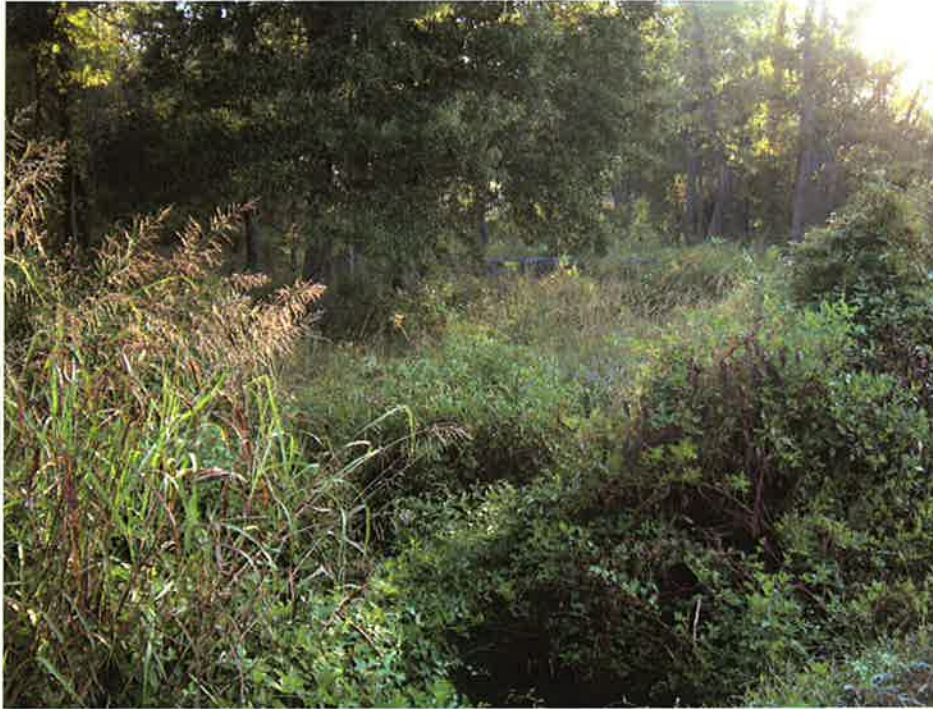
Fixed Station 1
Overview of Beaverdam Creek, looking downstream.
(EMH&T, Inc. 9/19/10)

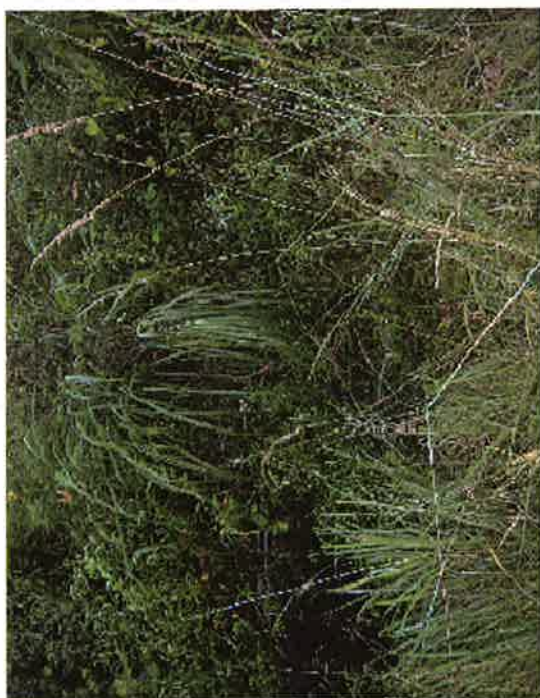
CROSS SECTION: 8
FEATURE: Riffle

Cross-section photo – looking left bank to right bank
