Subject: Year 3 Monitoring Report for Stream Mitigation of Beaverdam Creek  
SCO# D06054-C

# **Year 3 Monitoring Report for Stream Restoration of Beaverdam Creek and Unnamed Tributaries**

Union County, NC  
SCO # D06054-C

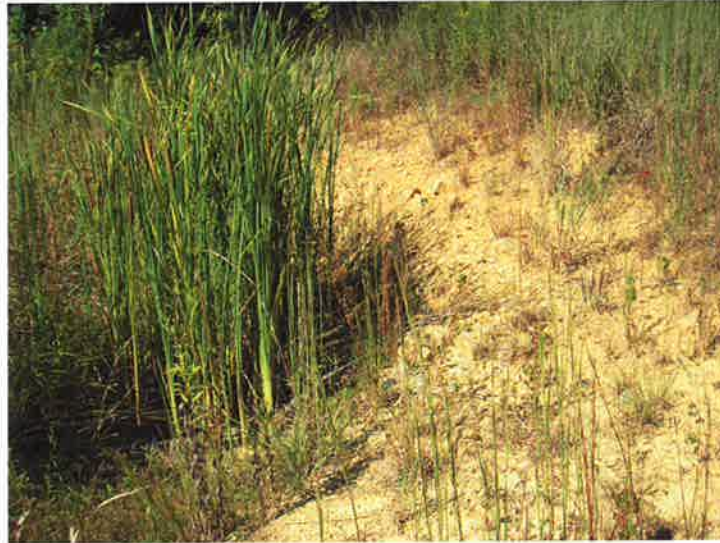
**VPA 1**

**Sparse vegetation along the left bank of UT2 at station 2+50.  
(EMH&T, 9/13/11)**

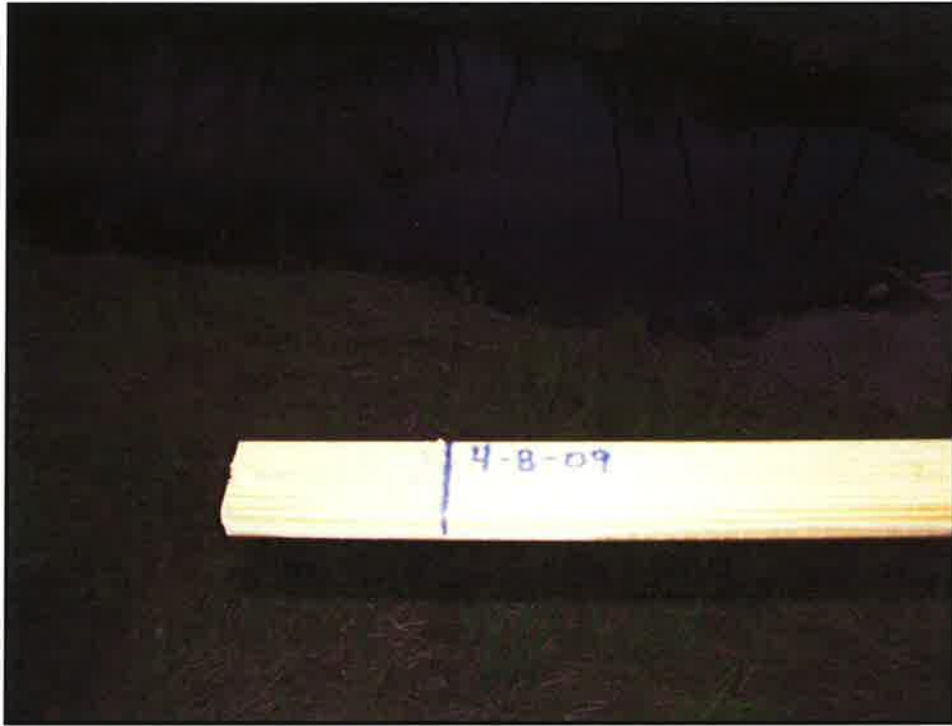
**BF 1**  
Crest gage at 5+50 on UT1 (Year 1).  
(EMH&T, 4/8/09)

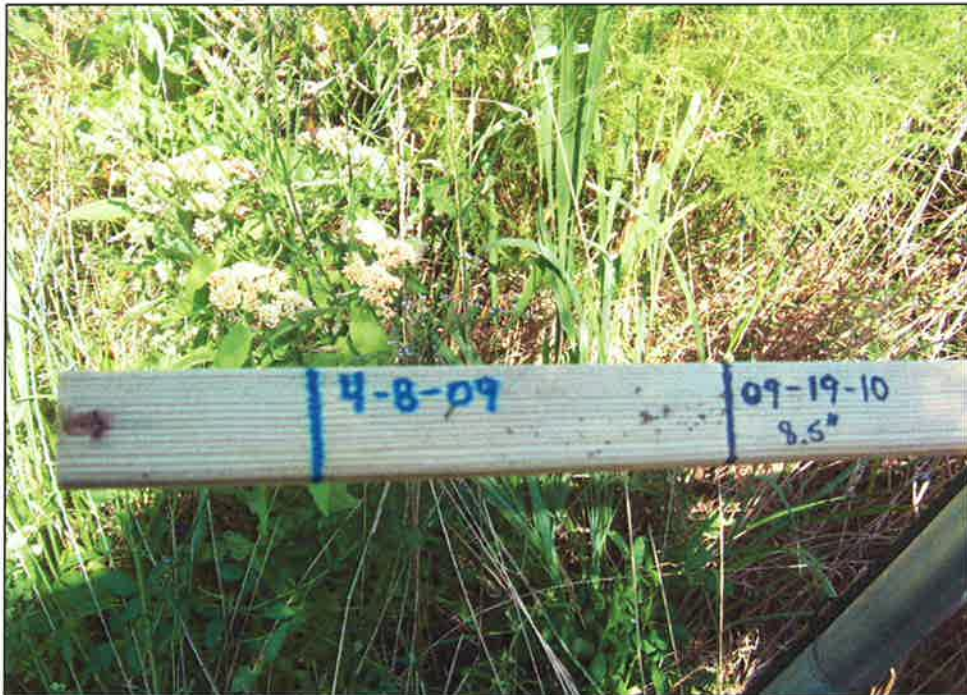
**BF 2**  
Crest gage at 5+50 on UT1 (Year 2).  
(EMH&T, 9/19/10)

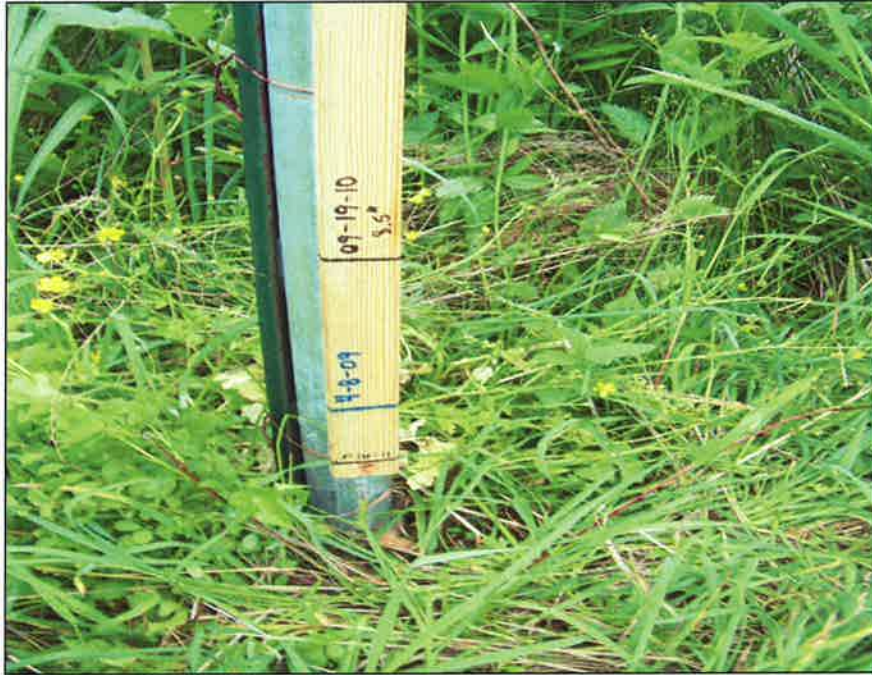
**BF 3**  
Crest gage at 5+ 50 on UT1 (Year 3).  
(EMH&T, 5/16/11)

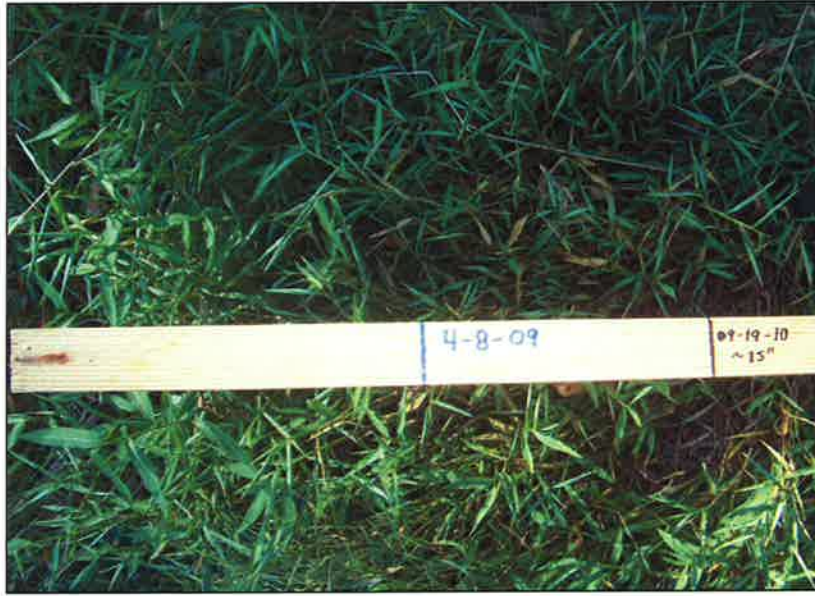
**BF 5**

**Crest gage at 3+80 on Beaverdam Creek Mainstem and 22+75 on UT1, at the confluence of the two reaches (Year 2).  
(EMH&T, 9/19/10)**

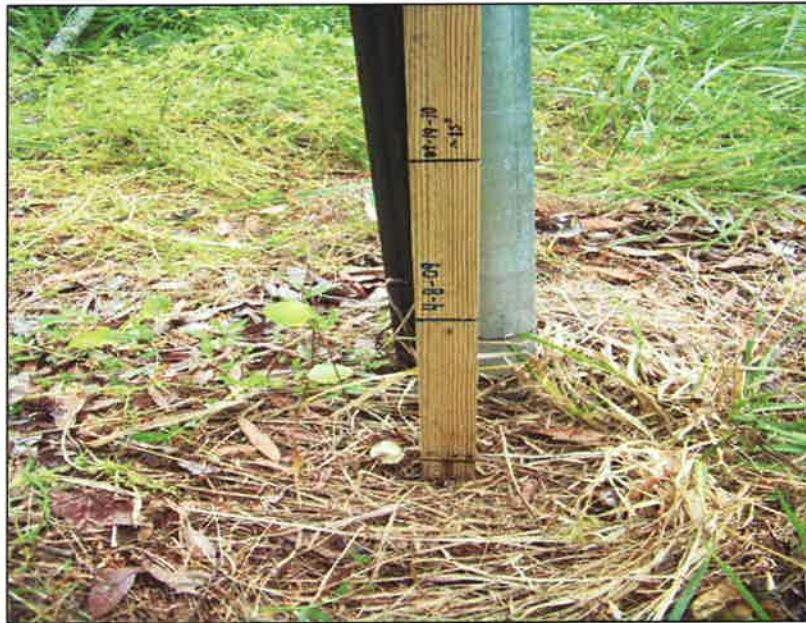
**BF 6**

**Crest gage at 3+80 on Beaverdam Creek Mainstem and 22+75 on UT1, at the confluence of the two reaches (Year 3).  
(EMH&T, 5/16/11)**
