**Benbow Park  
Stream Restoration Monitoring Report  
EEP Project # 29  
Monitoring Year – 04  
2008**

**March 2009**

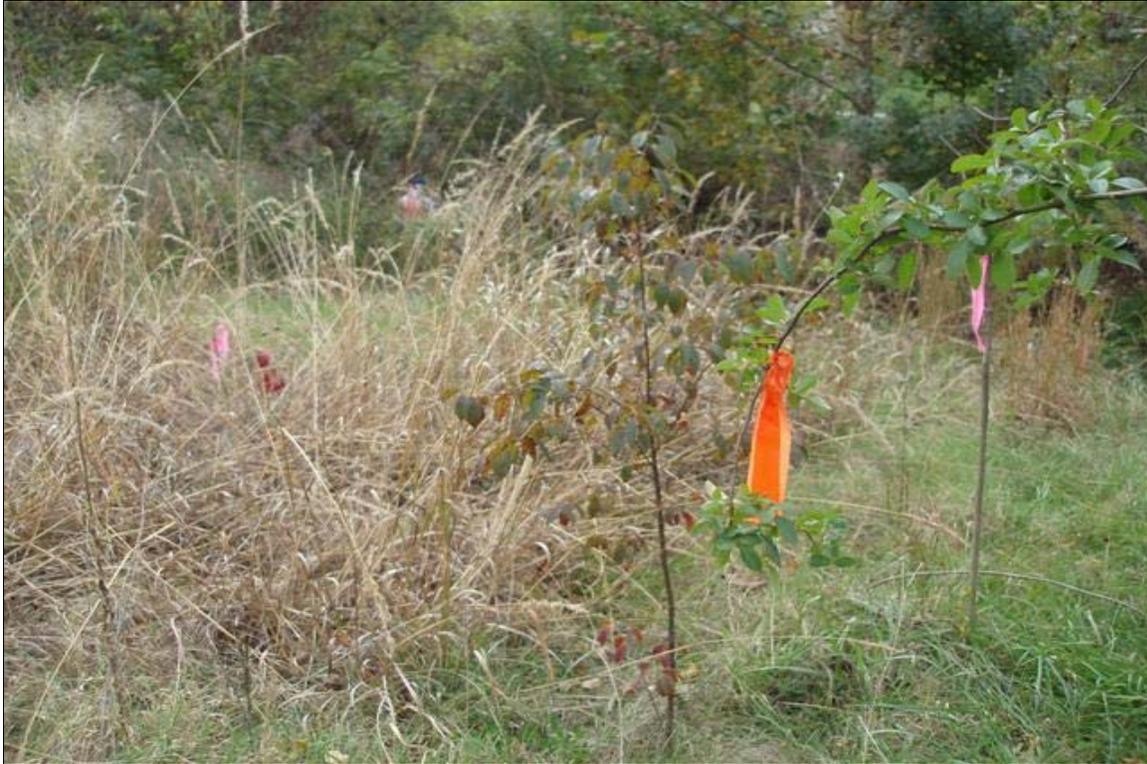
Plot 1 Photo – Taken looking south from the north corner. 10/29/08 - MY 04

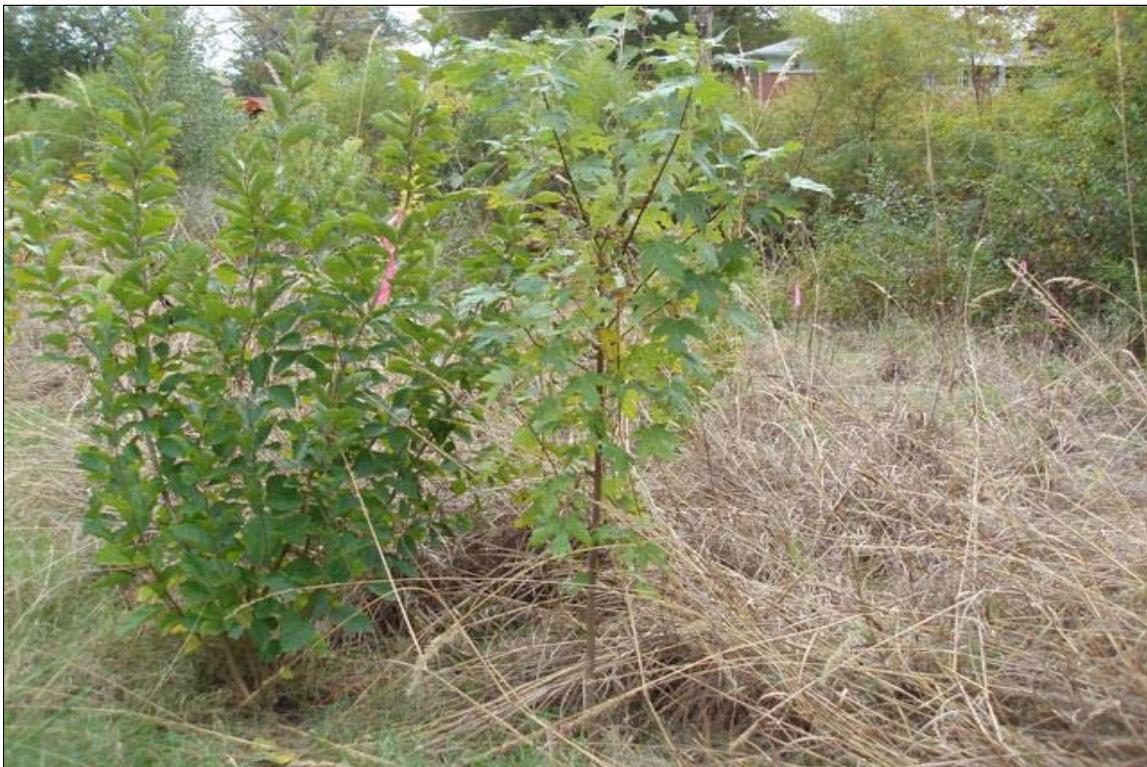
Plot 2 Photo – Taken looking south from the north corner. 10/29/08 - MY 04

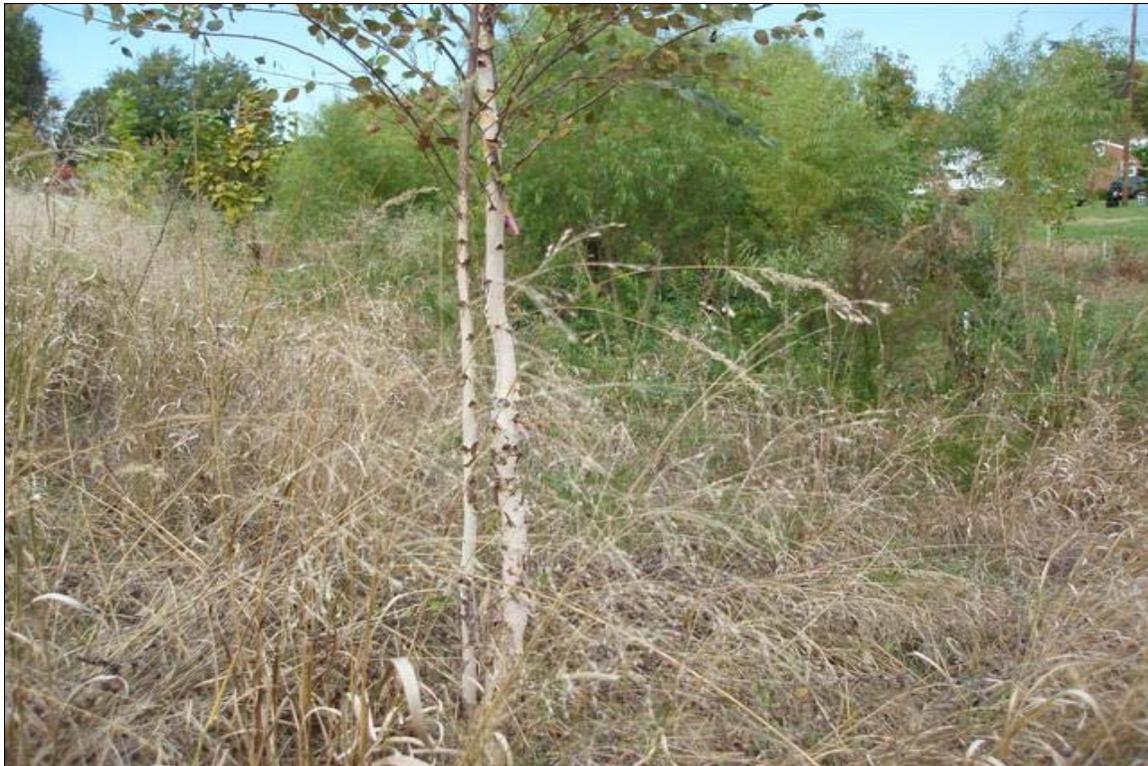
Plot 3 Photo – Taken looking north from the south corner. 10/29/08 - MY 04

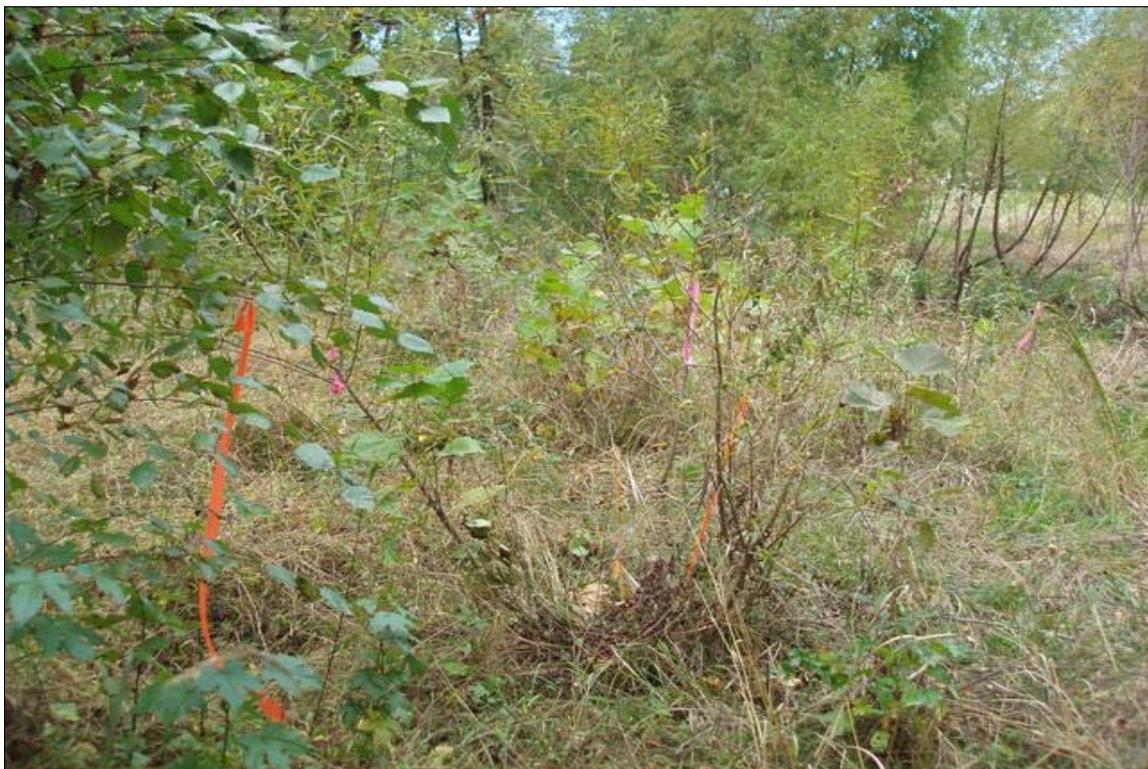
Plot 4 Photo – Taken looking northwest from the southeast corner. 10/29/08 - MY 04

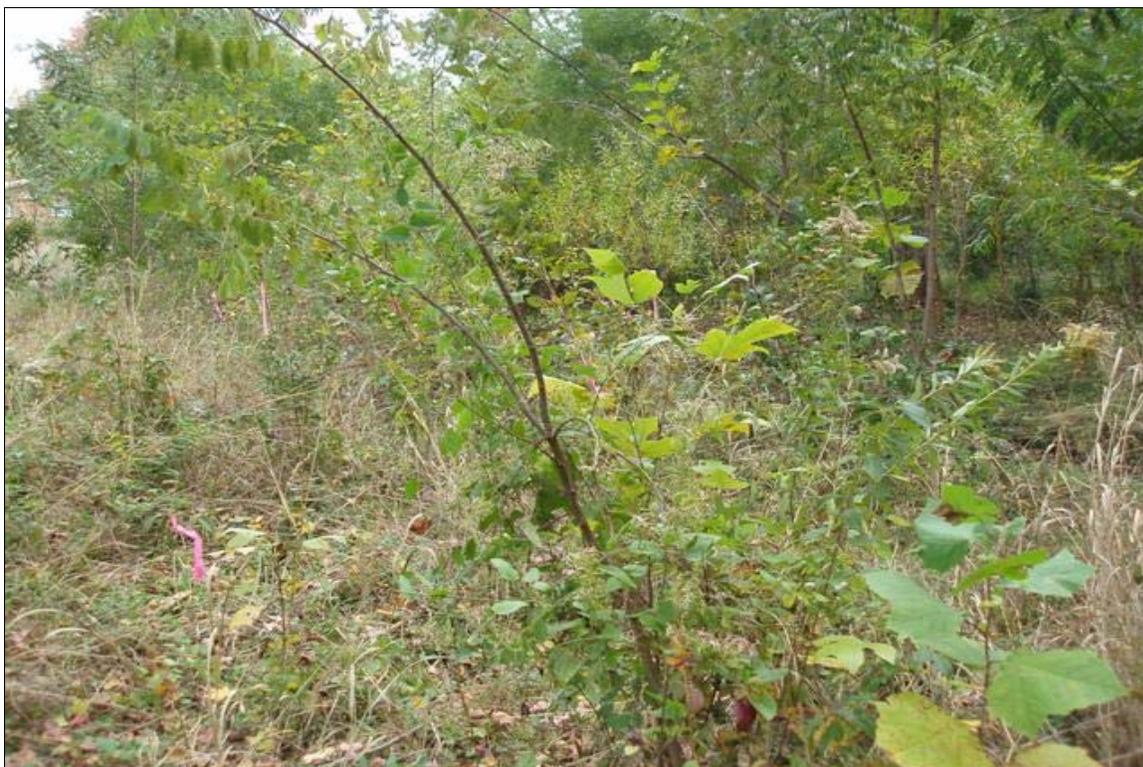
Plot 5 Photo – Taken looking east from the west corner. 10/29/08 - MY 04
