**BEST STREAM AND WETLAND RESTORATION PROJECT
MONITORING REPORT
MONITORING YEAR 1**

DUPLIN COUNTY, NORTH CAROLINA
CONTRACT NO. 004631 - PROJECT NO. 95353

March 2016

**Best
Duplin County, North Carolina
DMS Project ID 95353**

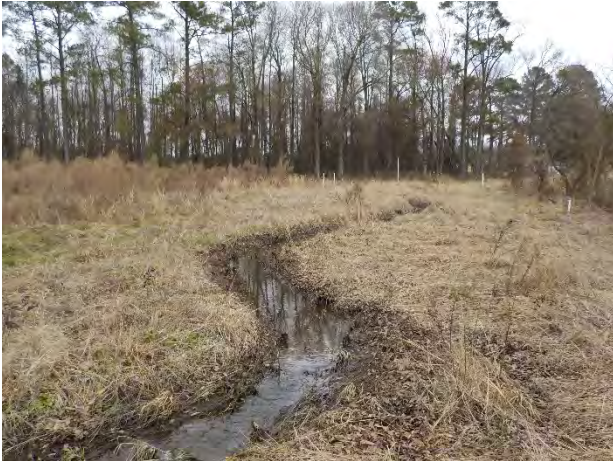
UT1/Wetland Area 1 Looking Upstream (2/9/2016)

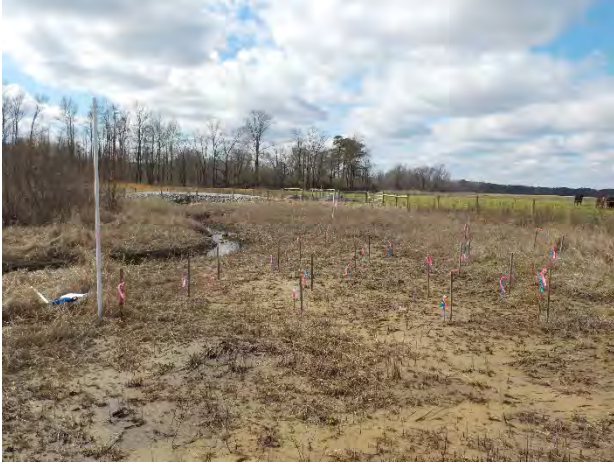
Table 8. Vegetation Problem Areas			
Best Stream and Wetland Restoration Project - Project # 95353			
Feature Category	Station Numbers	Suspected Cause; Repair	Photo Number
Sparse Herbaceous Coverage	UT1- Sta. 11+00 to 12+50	Low Soil Fertility and compaction; Re-seed area	VPA1
Low Stem Density	UT3- Sta 6+50 to 8+42	Low Soil Fertility and compaction; Re-plant area with bare root stems	VPA2
Low Stem Density	UT8- Sta. 4+67 to 7+00	Low Soil Fertility and compaction; Re-plant area with bare root stems	VPA3

VPA1- Sparse Herbaceous Cover- UT1 @ Sta.
11+50 to 12+50

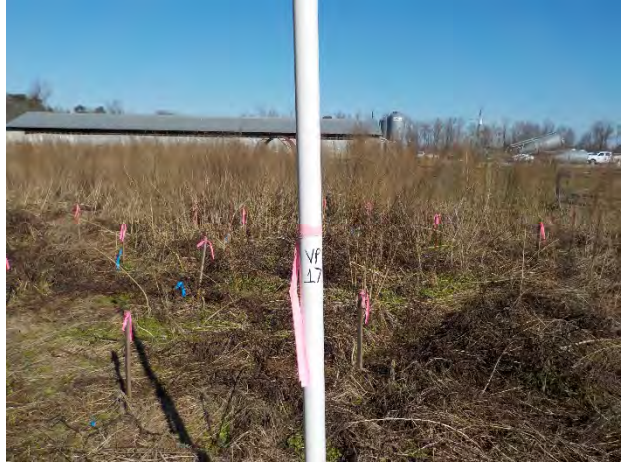
VPA2- Low Stem Density- UT3 @ Sta 6+50 to
8+00

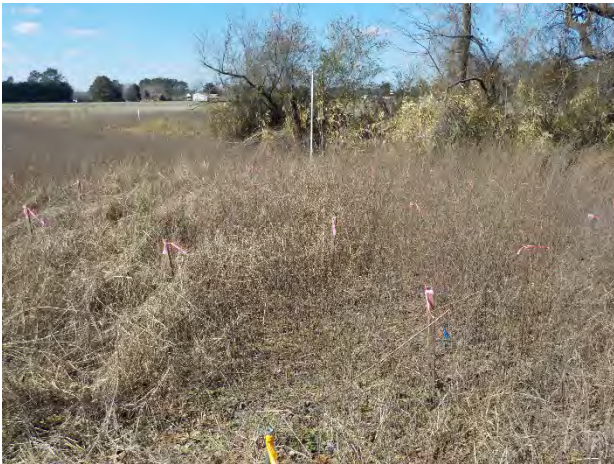
VPA3- Low Stem Density- UT8 @ Sta 5+50 to
6+50
