**BEST STREAM AND WETLAND RESTORATION PROJECT  
MONITORING REPORT  
MONITORING YEAR 3  
FINAL**

DUPLIN COUNTY, NORTH CAROLINA  
CONTRACT No. 004631 - PROJECT No. 95353  
USACE Action ID No. 2012-01384 -NCDWR Project No. 13-0865

RE: Best Stream and Wetland Restoration Site: MY3 Monitoring Report (NCDMS ID 95353)

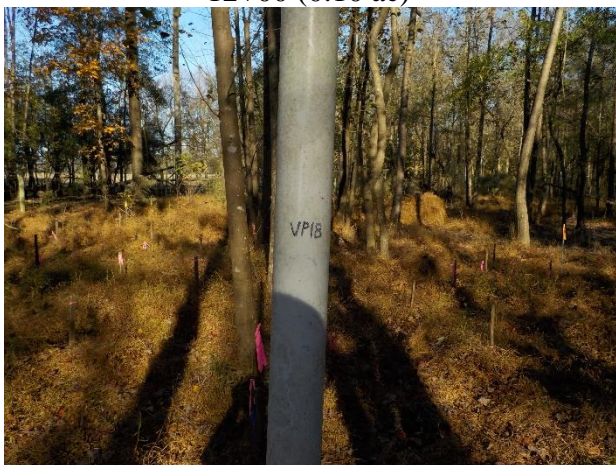
<b>Table 8. Vegetation Problem Areas</b>			
<b>Best Stream and Wetland Restoration Project - Project # 95353</b>			
<b>Feature Category</b>	<b>Station Numbers</b>	<b>Suspected Cause; Repair</b>	<b>Photo Number</b>
<b>Low Stem Density</b>	UT1- Sta. 3+00 to 8+50 (0.47 ac)	Low Soil Fertility and compaction; Re-plant area with gallon containerized trees.	VPA 1
<b>Invasives present</b>	UT1 - Sta. 0+00 (0.13 ac)	Invasives present in easement due to offsite seed source; remove invasive by cutting down and herbiciding	VPA 2
<b>Low Stem Density</b>	UT1 - Sta. 4+00 to 6+00 (0.49 ac)	Low Soil Fertility, compaction, and competition with native weeds; Re-plant area with gallon containerized trees.	VPA 3
<b>Poor Growth/Vigor</b>	UT1 - Sta. 11+00 to 13+00 (0.21 ac)	Low Soil Fertility and compaction; continue to monitor	VPA 4
<b>Encroachment</b>	UT2 - Sta. 25+00 to 26+50 (0.04 ac)	Oversprary from farming operation; continue to monitor	VPA 5

VPA 8 – Low Stem Density UT3 @ Sta. 0+50 to 8+42 (0.96 ac)

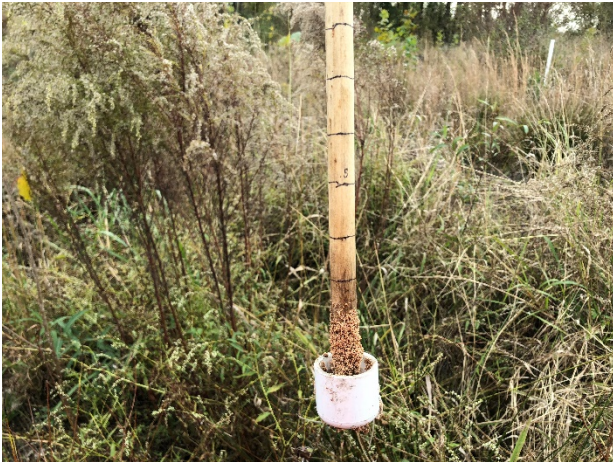
Crest Gauge 1 Reading 0.25' (9/21/2017)

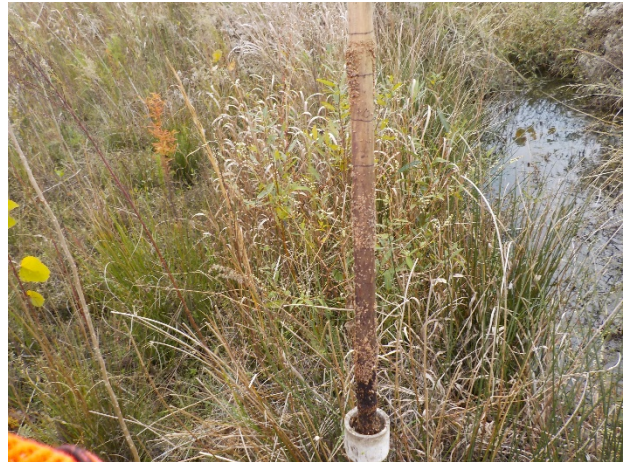
Crest Gauge 2 Reading 1.19' (9/21/2017)

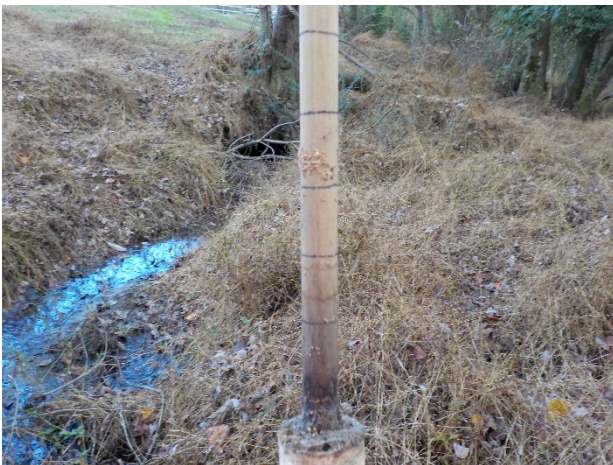
Crest Gauge 3 Reading 0.55' (8/13/2017)

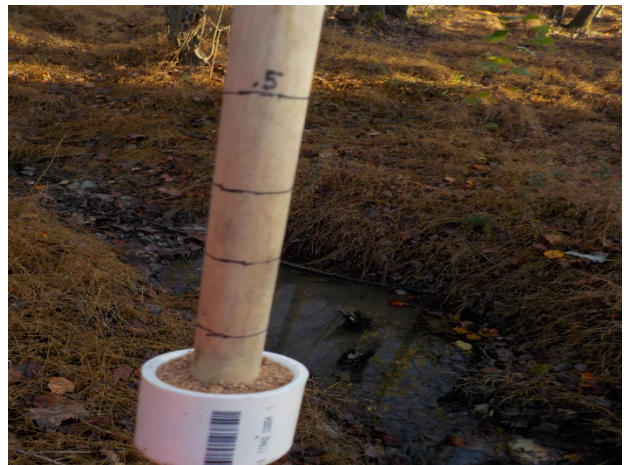
Crest Gauge 4 Reading 0' (11/16/2017)

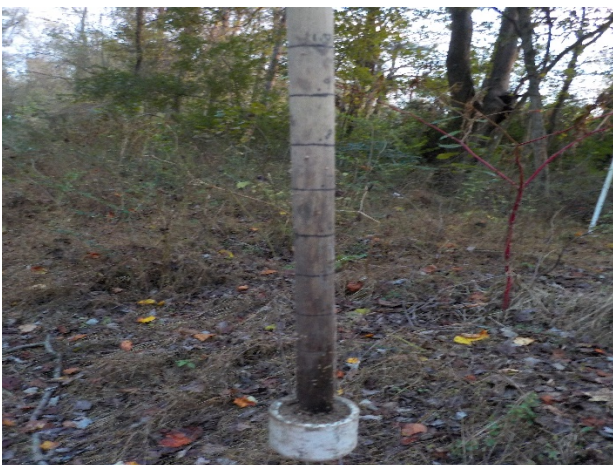
Crest Gauge 5 Reading 1.2' (8/13/2017)

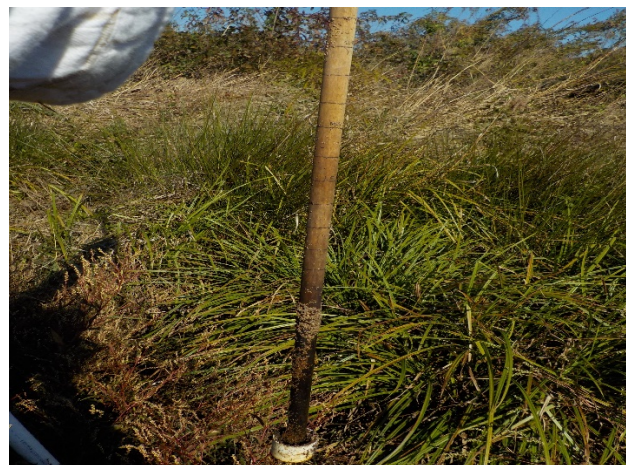
Crest Gauge 6 Reading 2.15' (8/13/2017)
