Big Cedar Creek Stream Restoration Final Year 2 Monitoring Report (2010) Stanly County, North Carolina

EEP Project Number D06054-D

Data Collection Period: November 2010

Submission Date: December 2010

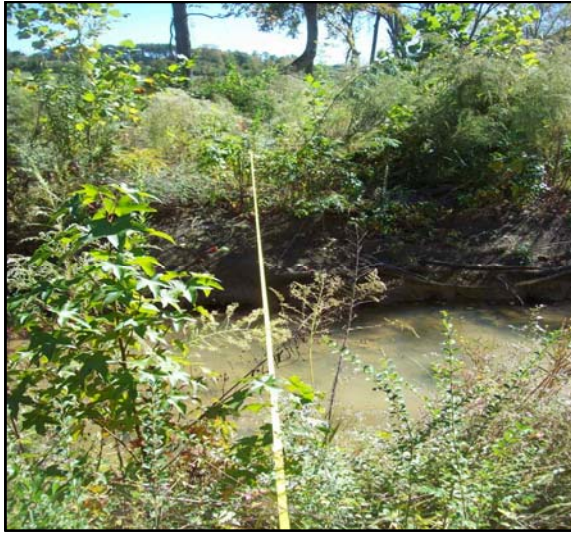
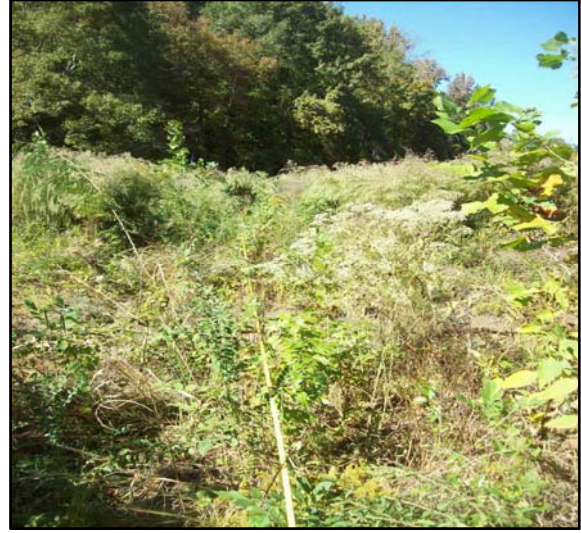
Permanent Cross Section X5
(Year 2 Monitoring Data - collected October 2010)

Riffle Cross-sections 5, 7, 9, and 28 have experienced bed degradation during Year 2. Cross-section 5 has experienced extensive downcutting. The bed scour at cross-sections 7, 9, and 28 is located along the side of channel that receives the flow vectors from upstream outer meander bends.

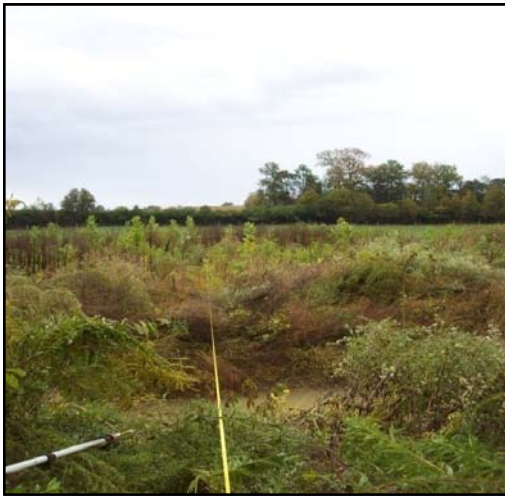
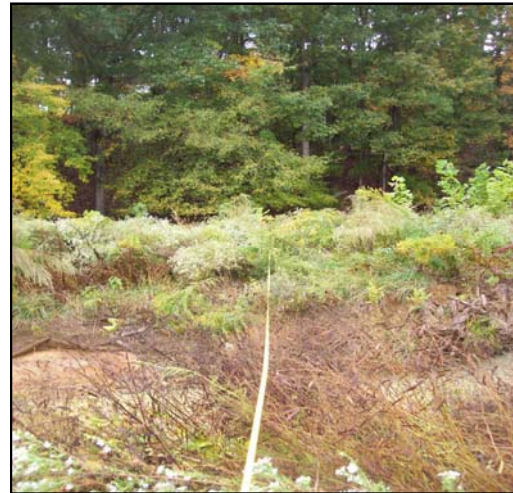
Permanent Cross Section X8
(Year 2 Monitoring Data - collected October 2010)

Pool Cross-sections 8 and 27, which are located in the apex of meander bends, show evidence of bed scour. The outside of meanders experience an increase in shear stress during large storm events that can cause scour and deepening. Scour and deepening of some pools is expected.

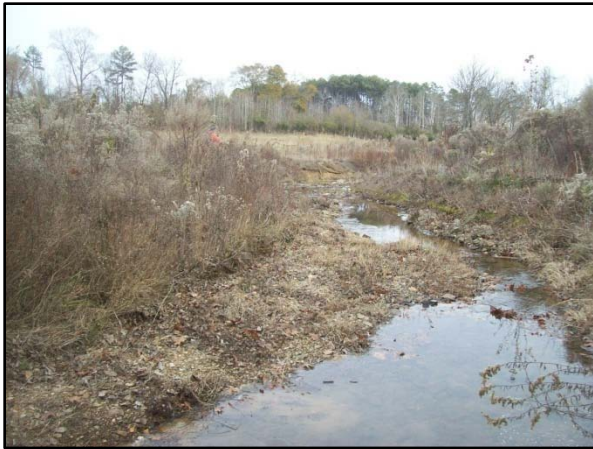
SPA 1 – BCC Deposition from off-site sediment source

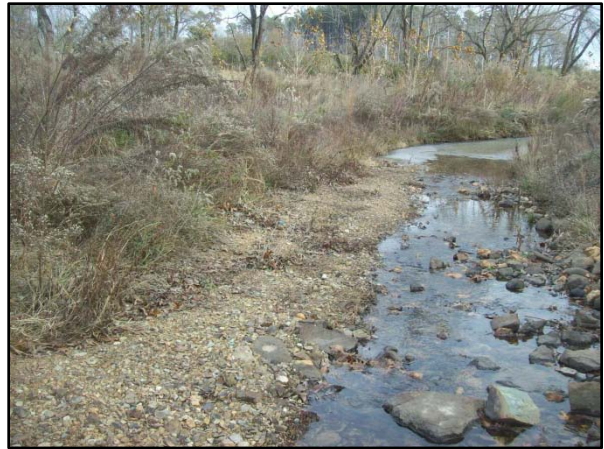
SPA 2 – Aggradation from thalweg shift

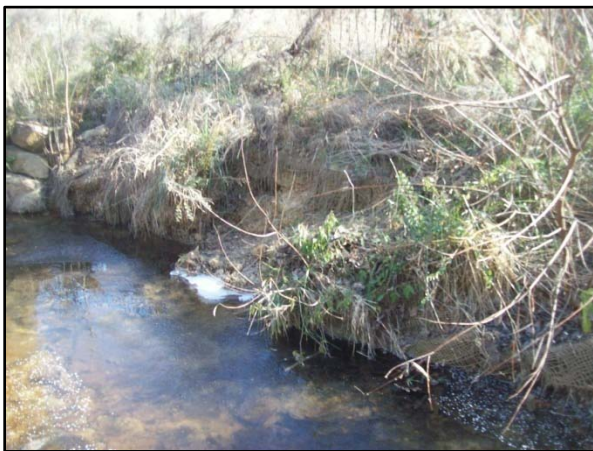
SPA 3 – BCC Bank Slump

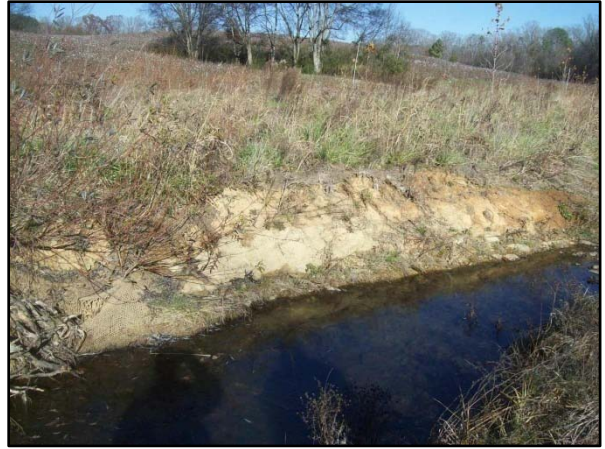
SPA 14 – UT1 Raw Bank

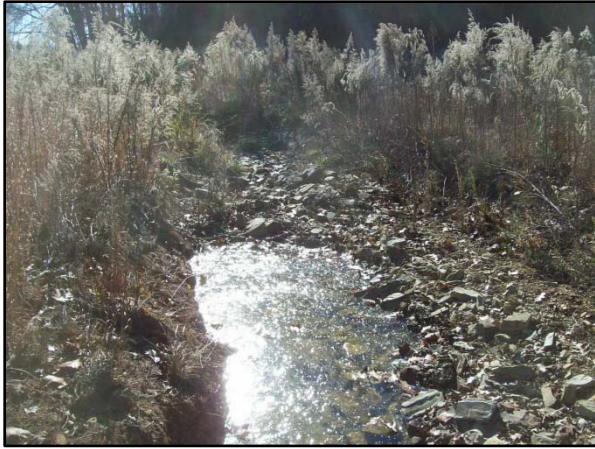
SPA 19 – UT2 Thalweg migration

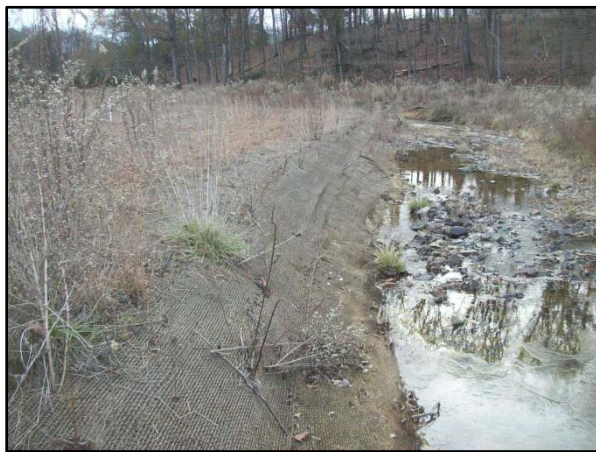
VPA 2 – Bare bank with loss of matting

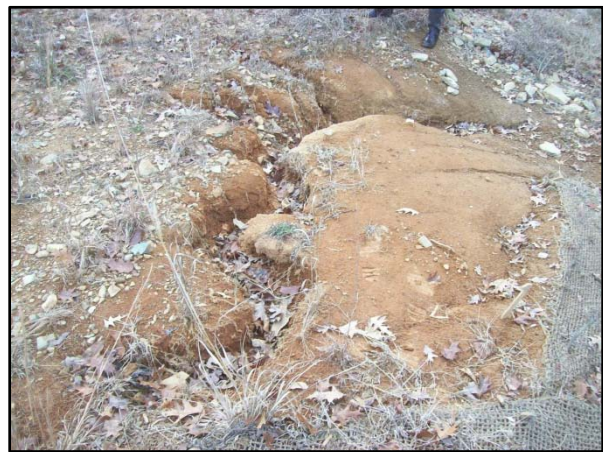
VPA 3 – Bare bank with matting

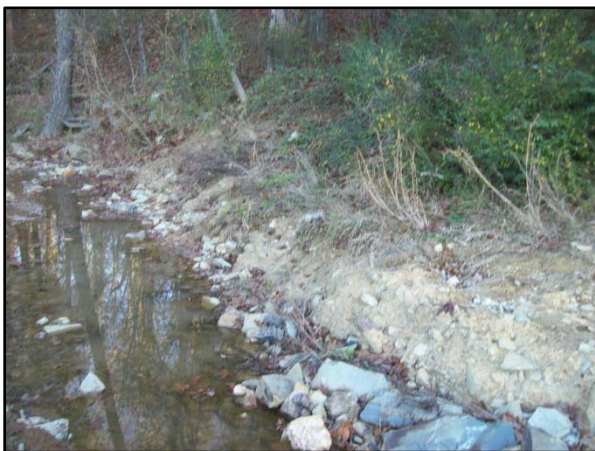
VPA 4 – Bare bank from overland flow

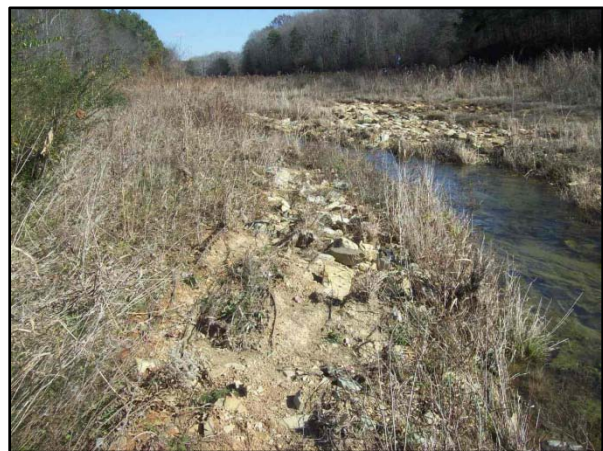
VPA 5 – Invasive species on bank

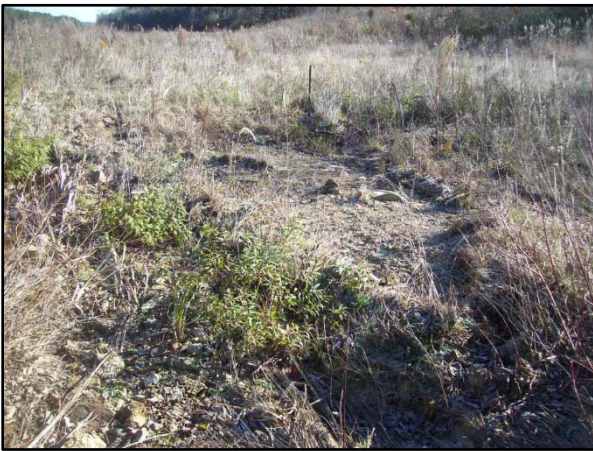
VPA 9 – UT1 Bare Floodplain from rocky soils

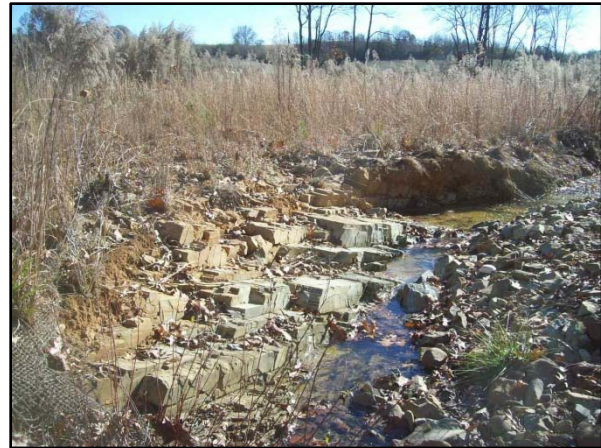
Big Cedar Creek Restoration Site: Project No. D06054-D			
UT2			
Feature/Issue	Station # / Range	Probable Cause	Photo #
Bare Bank	10+25 - 10+60; Left Bank	Bare bank due to poor; rocky soils and loss of matting	VP11; VP12
	10+85 - 11+25; Left Bank		
	12+30 - 12+50; Left Bank		
	13+40 - 13+50; Right Bank		
	13+75 - 14+25; Left Bank		
Bare Bench			-
Bare Floodplain			-
Invasive/Exotic Populations	Above 10+00 but within easement	<i>Ligustrum sinense</i> remaining from pre-construction conditions	VP5
	11+35; Left Bank		
	11 + 80 - 12+25; Left Bank	<i>Ligustrum sinense</i> and <i>Rosa multiflora</i> remaining from pre-construction conditions	
12+00 - 12+25; Right Bank

VPA 12 – UT2 Lack of bank vegetation due to poor rocky soils
