Big Cedar Creek Stream Restoration Final Year 3 Monitoring Report (2011) Stanly County, North Carolina

EEP Project Number D06054-D

Data Collection Period: November 2011 – February 2012

Submission Date: March 2012

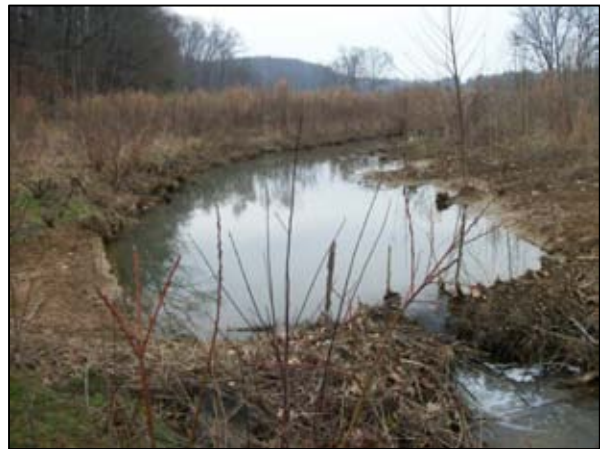
SPA 4 – Abandoned beaver dam

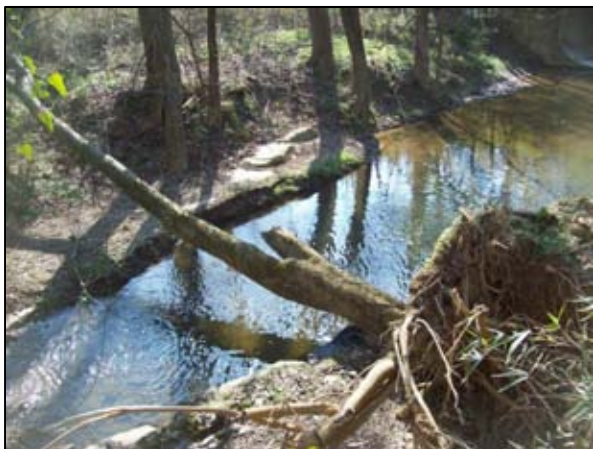
SPA 5 – Uprooted tree along streambank

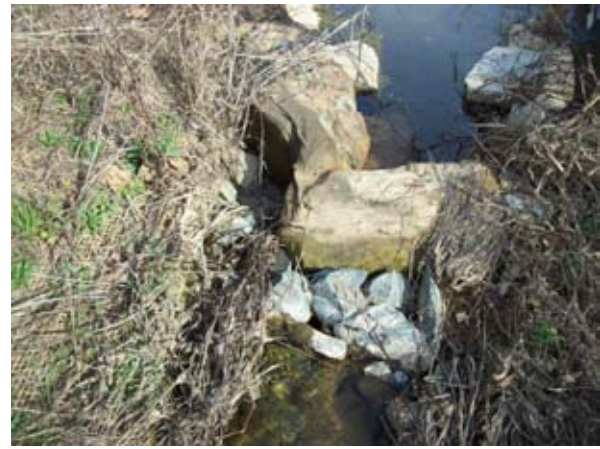
SPA 6 – Streamflow beneath boulder sill

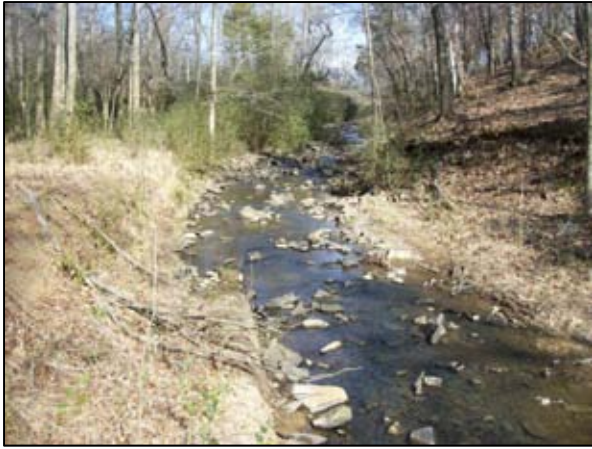
VPA 1 – Invasive species on right bank (BCC)

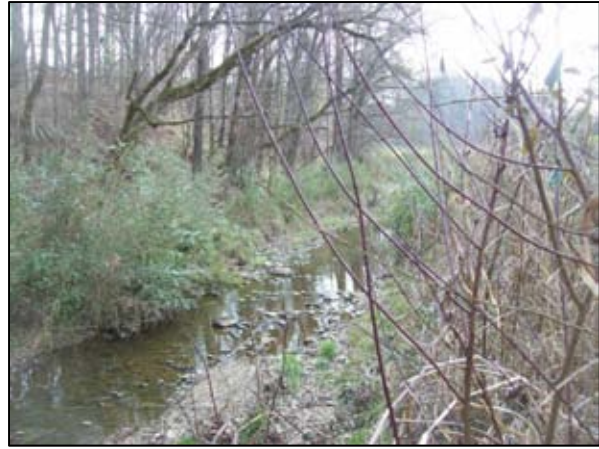
VPA 2 – Invasive species on left bank (UT1)

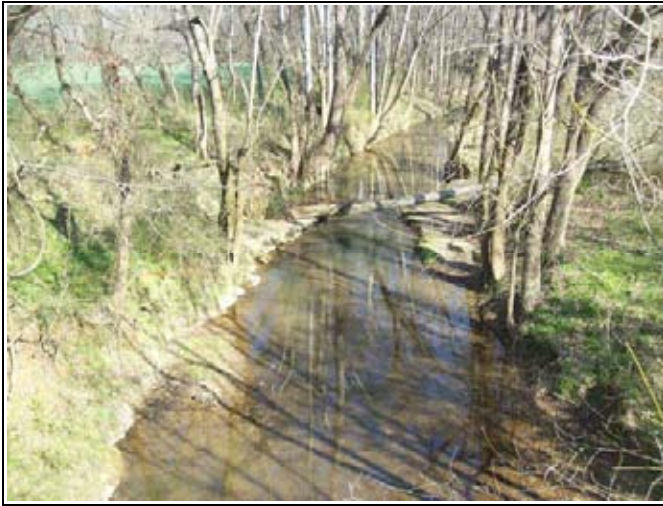
BCC PID 1– Cross Vane, BCC Reach 6 End

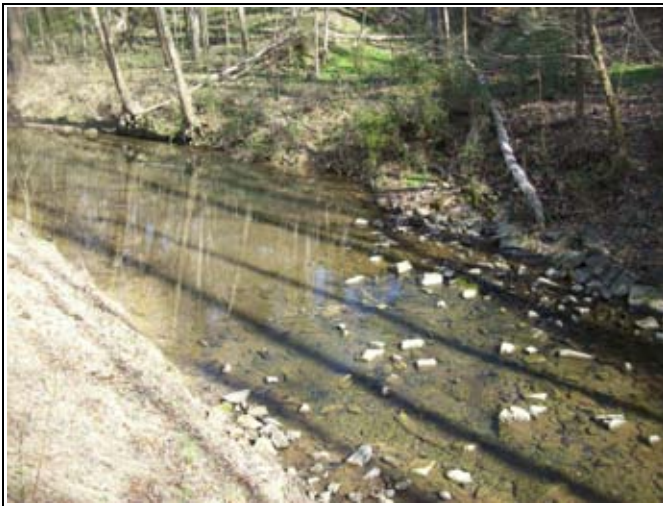
BCC PID 3 –Existing Riffle, BCC Reach 6

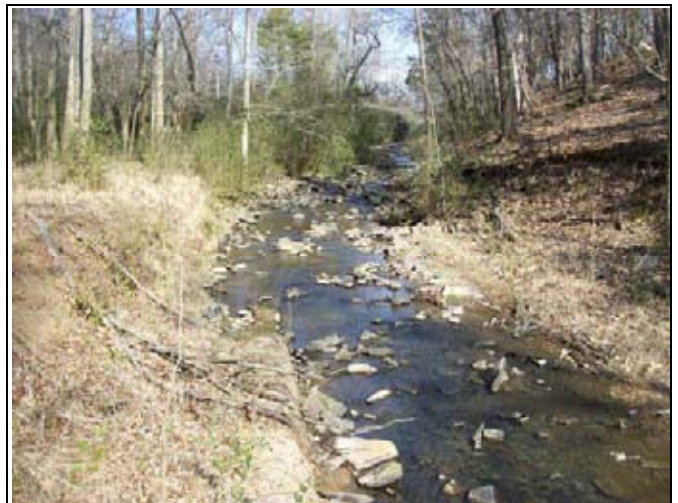
BCC PID 6 – Log Vane in distance, BCC Reach 6 Start

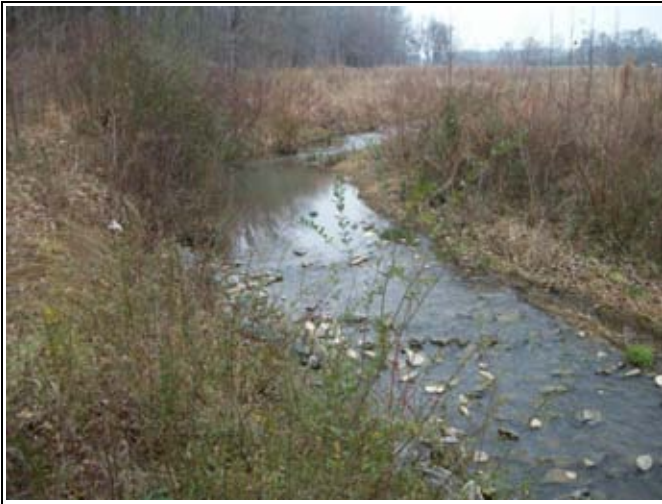
BCC PID 7 – Constructed Riffle, BCC Reach 4 End

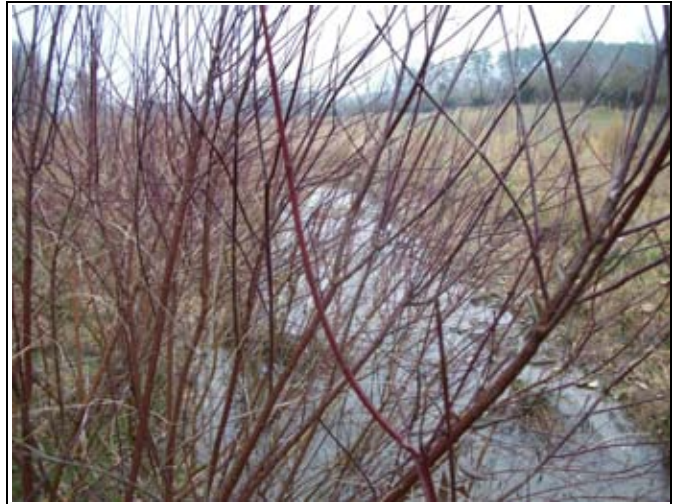
BCC PID 8 – Constructed Riffle, BCC Reach 4
