# Big Cedar Creek Stream Restoration Final Year 4 Monitoring Report (2012) Stanly County, North Carolina

EEP Project ID #92532/EEP Contract #D06054-D

Data Collection Period: November 2012

Submission Date: March 2013

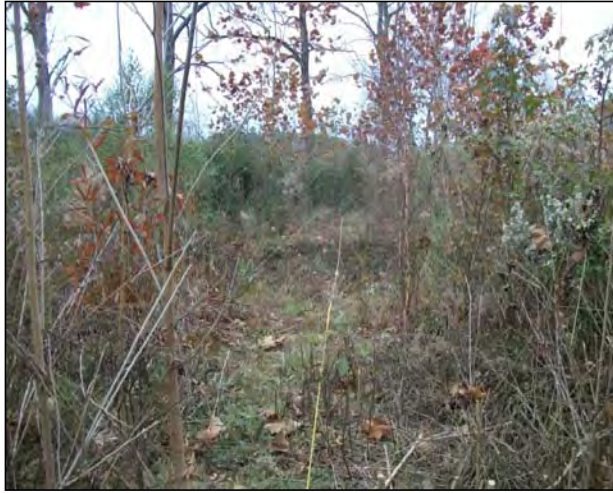
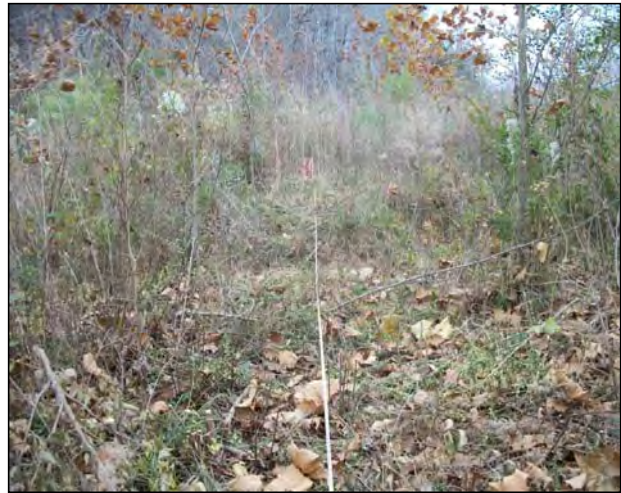
**Permanent Cross Section X5**  
(Year 4 Monitoring Data - collected November 2012)

The 33 permanent cross-sections along the restored channels were re-surveyed to document stream dimension at the end of monitoring Year 4. Channel geometries for Cross-Sections 5, 9, 13, 22, and 32 were impacted by maintenance work completed during 2011 and noted in the Year 3 monitoring report. All completed maintenance items addressed in 2011 were resurveyed in the fall of 2012 and are shown to be functioning as anticipated.

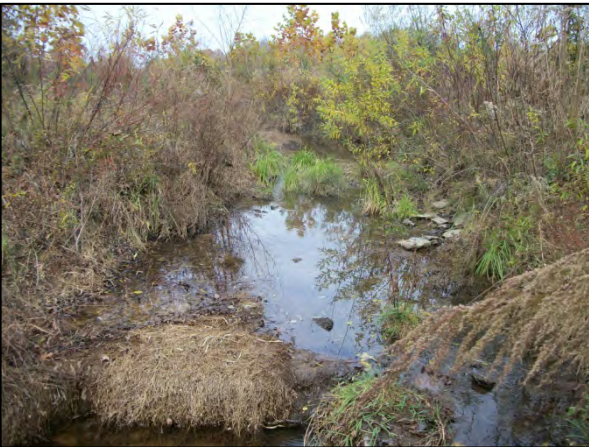
SPA 3 – Vegetation in BCC channel near Station 37+00

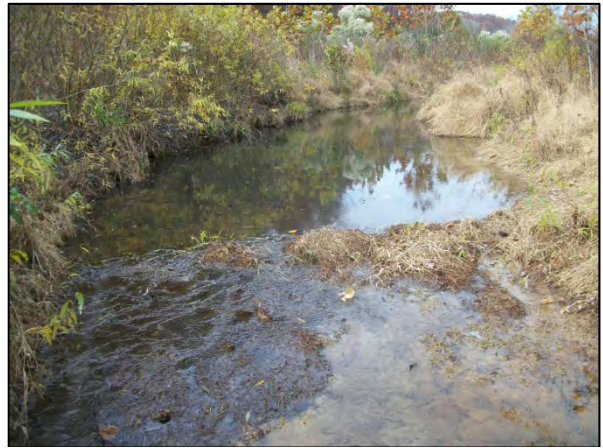
SPA 4 – Abandoned beaver dam remnant at Station 46+90, BCC

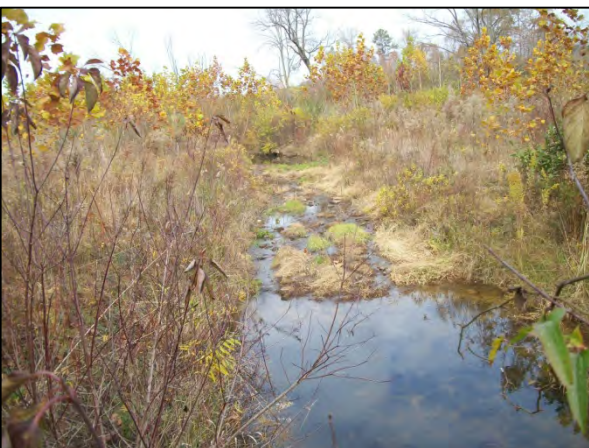
SPA 5 – Vegetation in BCC channel near Station 49+00

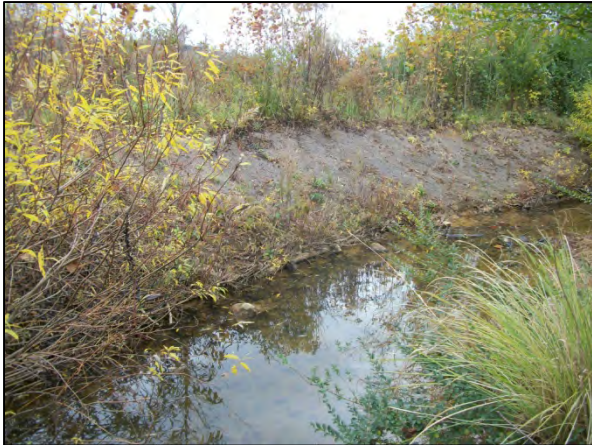
VPA 1 – Bare bank along BCC at Station 24+80, left bank

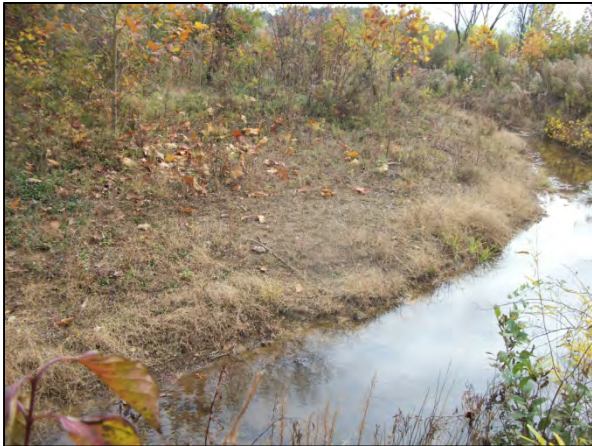
VPA 3 – Bare bank along BCC at Station 29+00, left bank

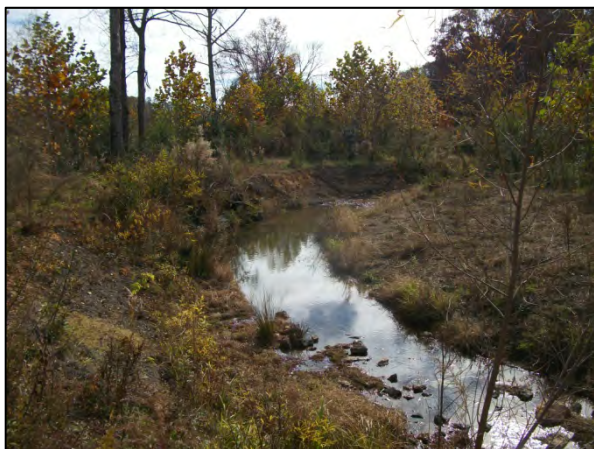
VPA 5 – Bare bank along BCC at Station 33+00, left bank

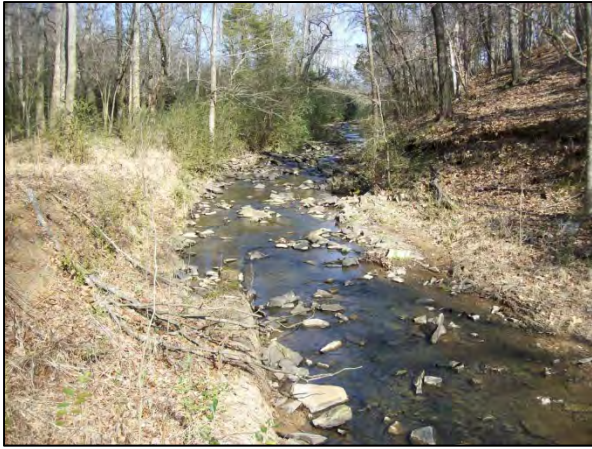
VPA 7 – Invasive species on BCC Station 65+00 to 67+00, right bank

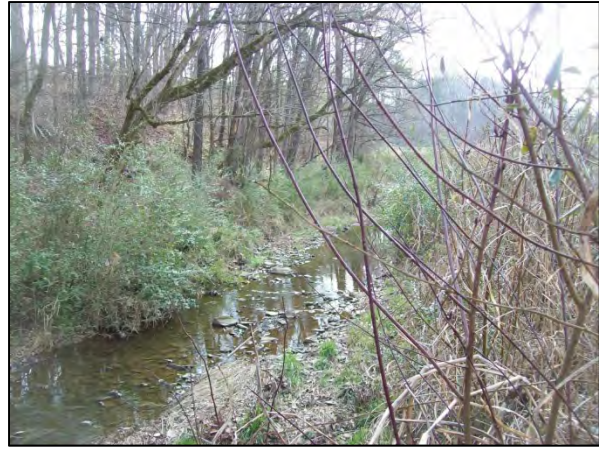
VPA 8 – Invasive species on UT1 Station 62+50 to 63+50 right bank

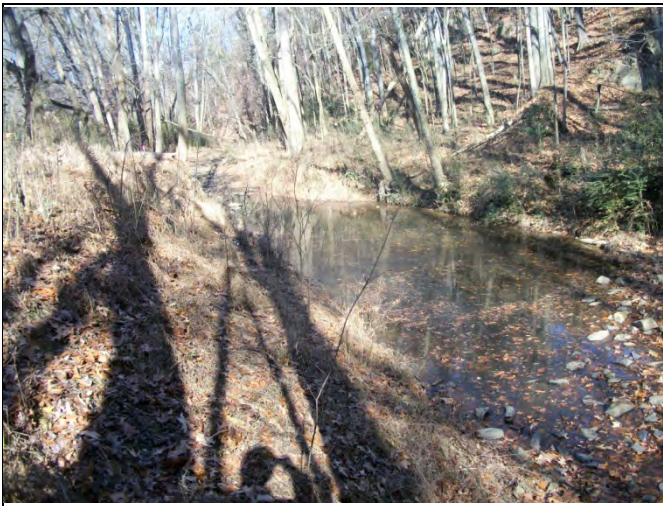
BCC PID 3 –Existing Riffle, BCC Reach 6

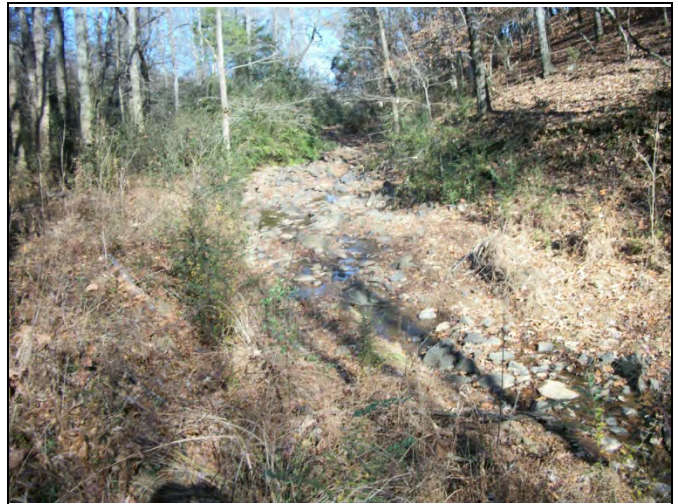
BCC PID 6 – Log Vane in distance, BCC Reach 6 Start

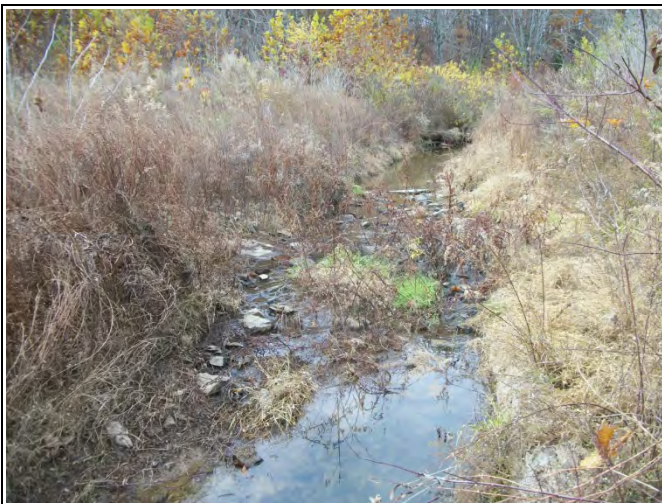
BCC PID 11 – Log J-Hook & Constructed Riffle, BCC Reach 3 End

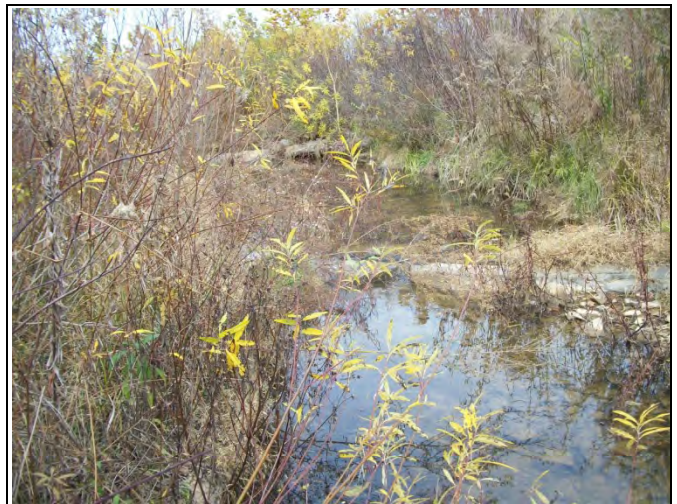
BCC PID 12 – Log J-Hook Step Pool, BCC Reach 3

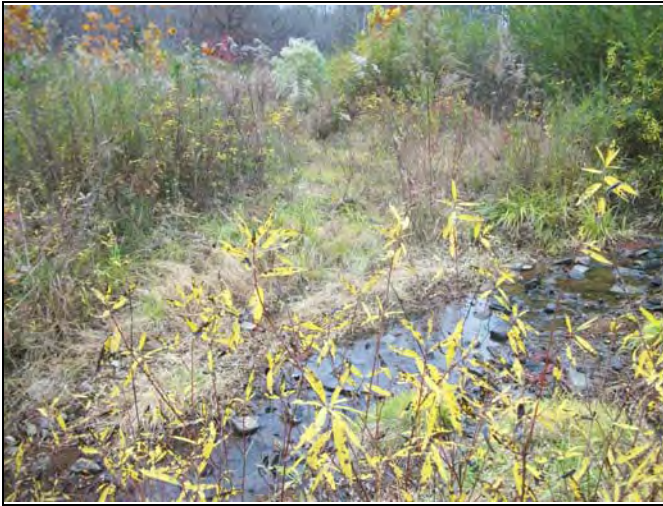
UT2 PID 1 – Constructed Riffle, UT2 End

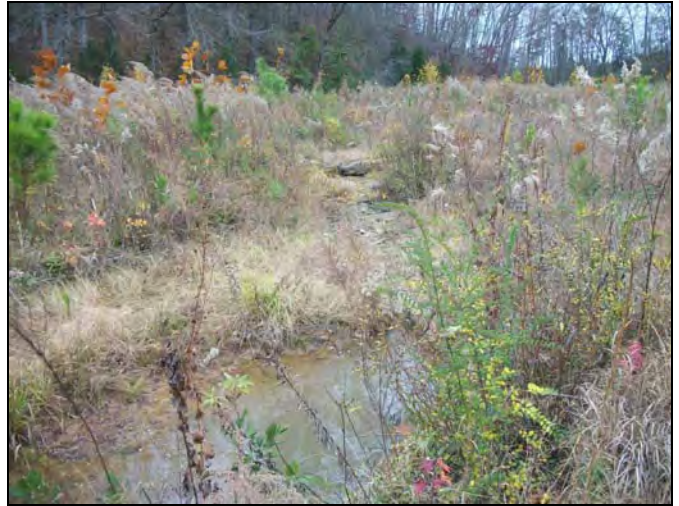
UT2 PID 2 – Constructed Riffle

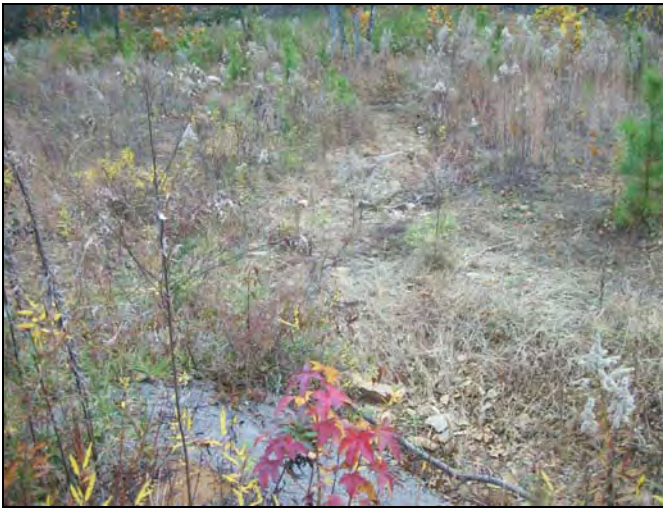
UT2 PID 3 – Constructed Riffle

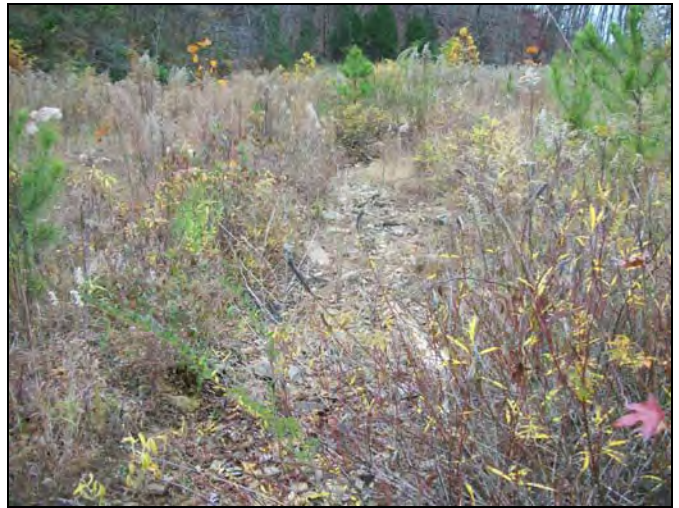
UT2 PID 4 – Constructed Riffle

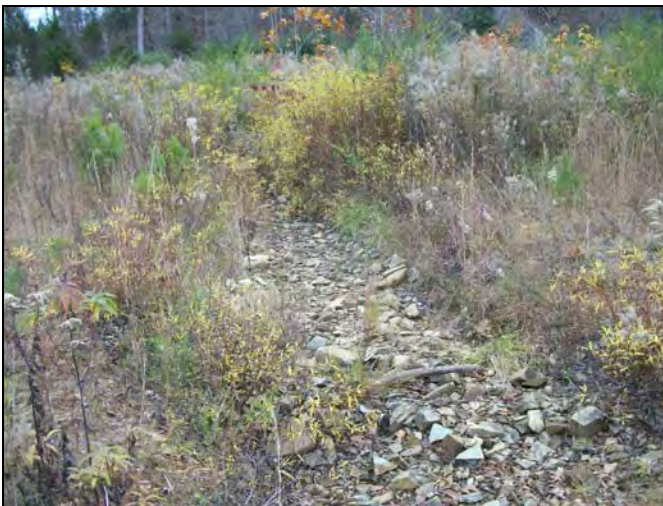
UT2 PID 5 – Constructed Riffle

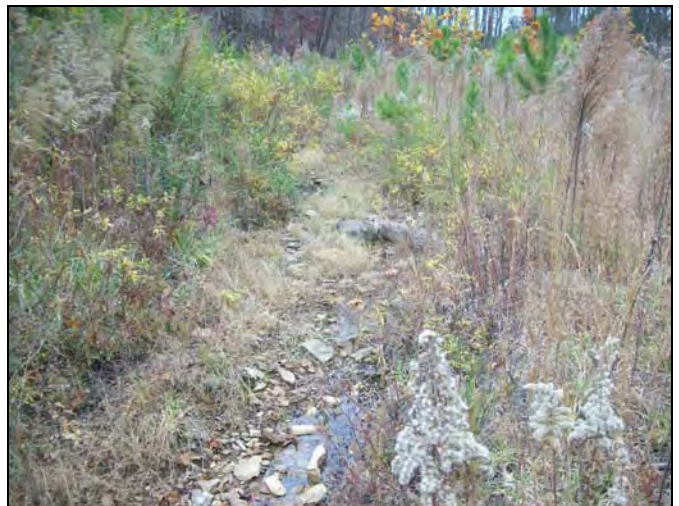
UT2 PID 6 – Constructed Riffle

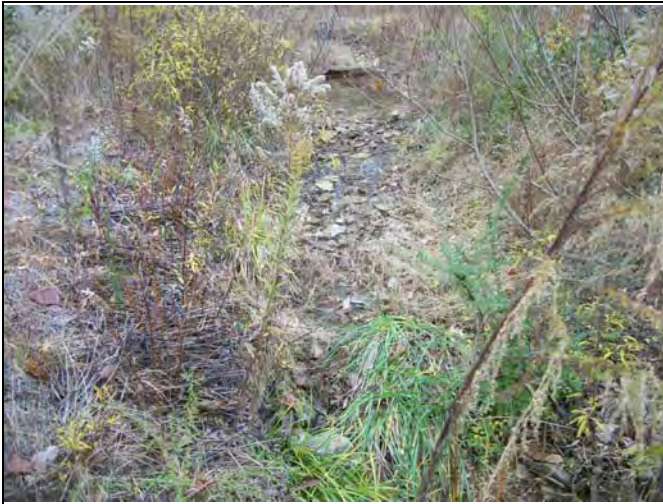
UT2 PID 7 – Constructed Riffle
