Big Cedar Creek Stream Restoration FINAL Year 5 Monitoring Report (2013) Stanly County, North Carolina

EEP Project ID #92532/EEP Contract #D06054-D

Data Collection Period: October - December 2013

Submission Date: May 2014

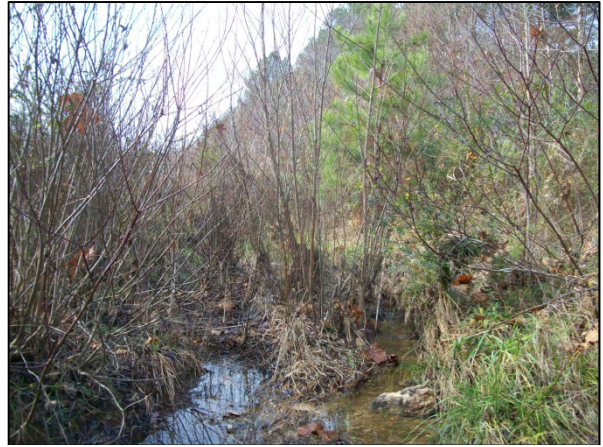
UT1 Reach 4			
Feature Issue	Station No.	Suspected Cause	Photo Number
Minor bank erosion	56+60, Left Bank	Loose matting/sparse vegetation	SPA 1
Mid-channel bar	43+25 - 43+75	Large willow & vegetation in channel backing up sediment	SPA 2
BCC Reach 4			
Feature Issue	Station No.	Suspected Cause	Photo Number
Minor bank erosion	59+60 - 60+00, Left Bank	Sparse woody vegetation	SPA 3
BCC Reach 3			
Feature Issue	Station No.	Suspected Cause	Photo Number
Minor bank erosion	46+90 - 47+30, Left Bank	Loose matting/sparse vegetation	SPA 4
Riffle degradation	51+60 - 52+02	Unknown (Degradation not apparent during field walk. Noted from profile survey.)	N/A
BCC Reach 2			
Feature Issue	Station No.	Suspected Cause	Photo Number
Debris across channel	21+25; 33+00	Remnant Beaver Dam	SPA 5

SPA 2 – Mid-channel bar on UT1 at Station 43+25 to 43+75

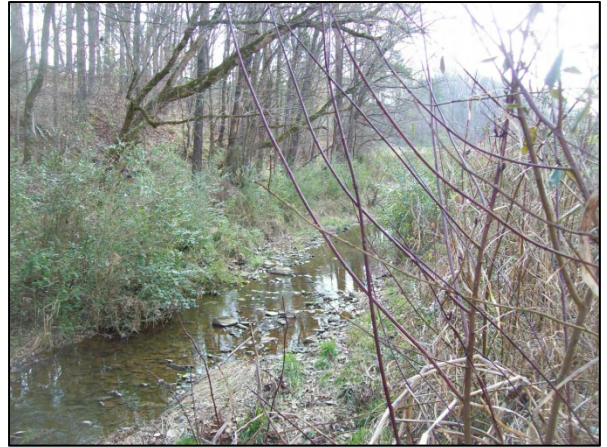
VPA 1 – Privet on Big Cedar

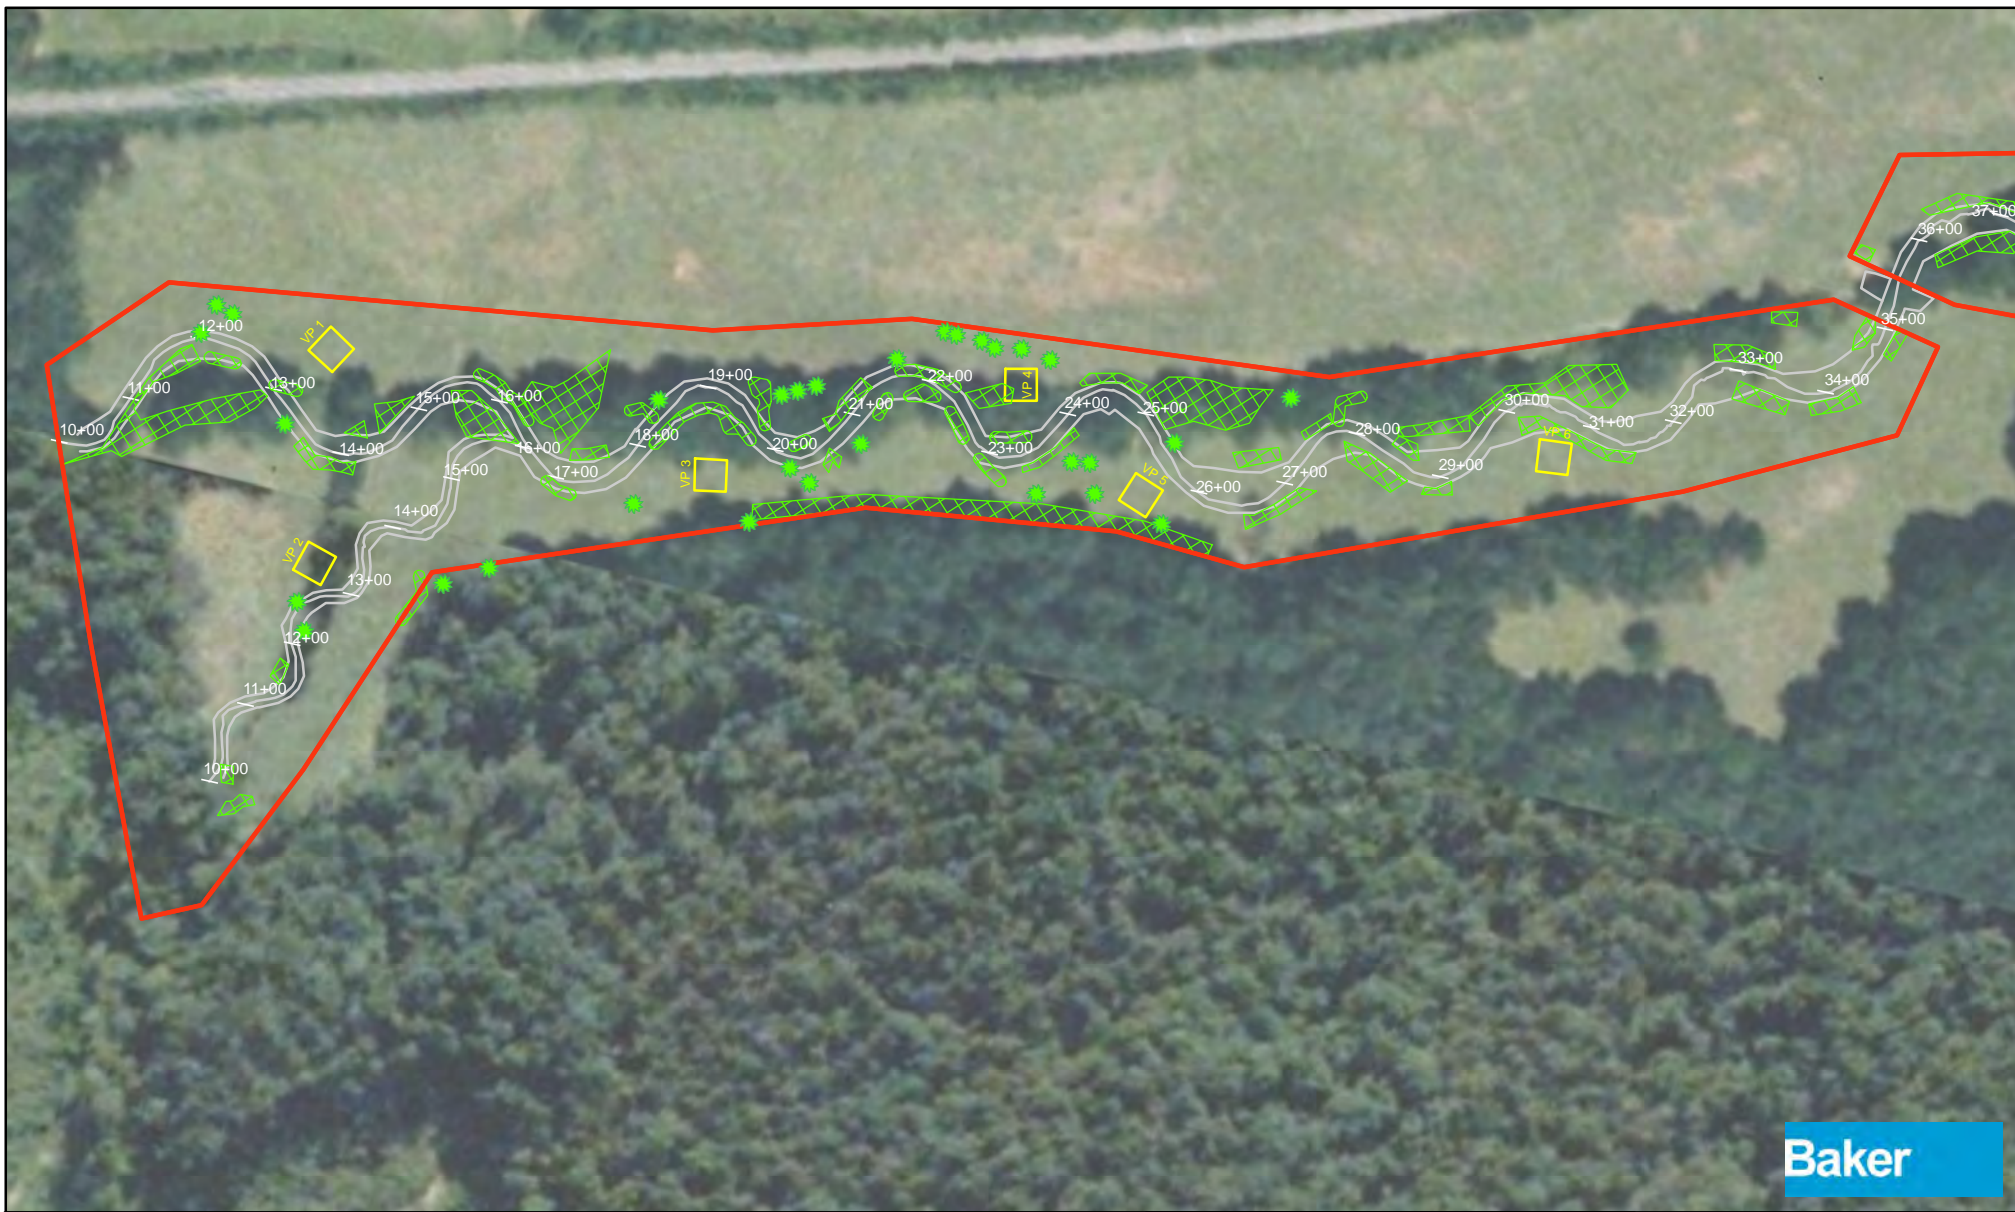
VPA 2 – Privet on UT1

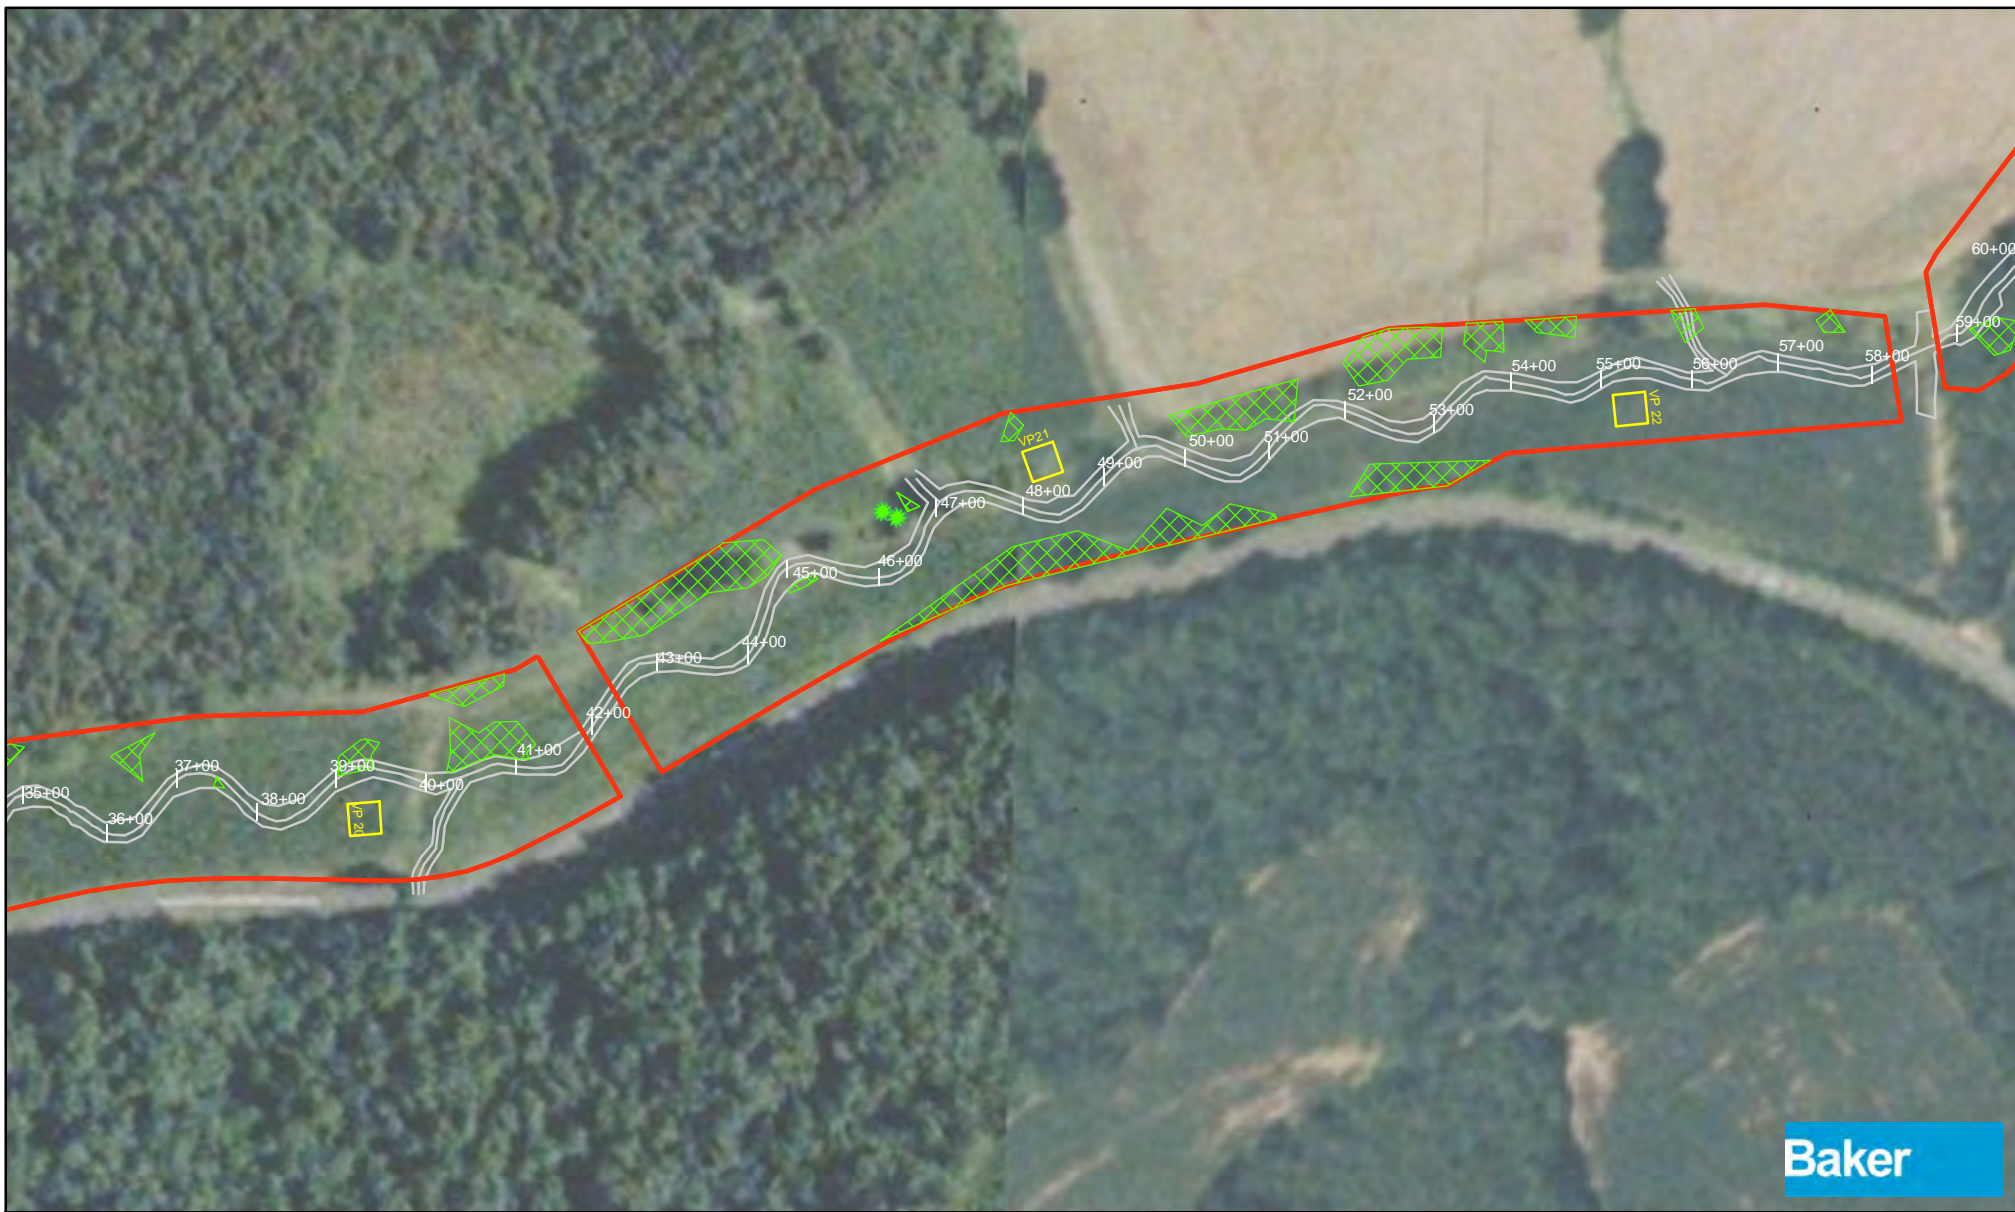
**Figure C4: Vegetation Problem Areas
UT1 (Station 35+00 to 59+00)**

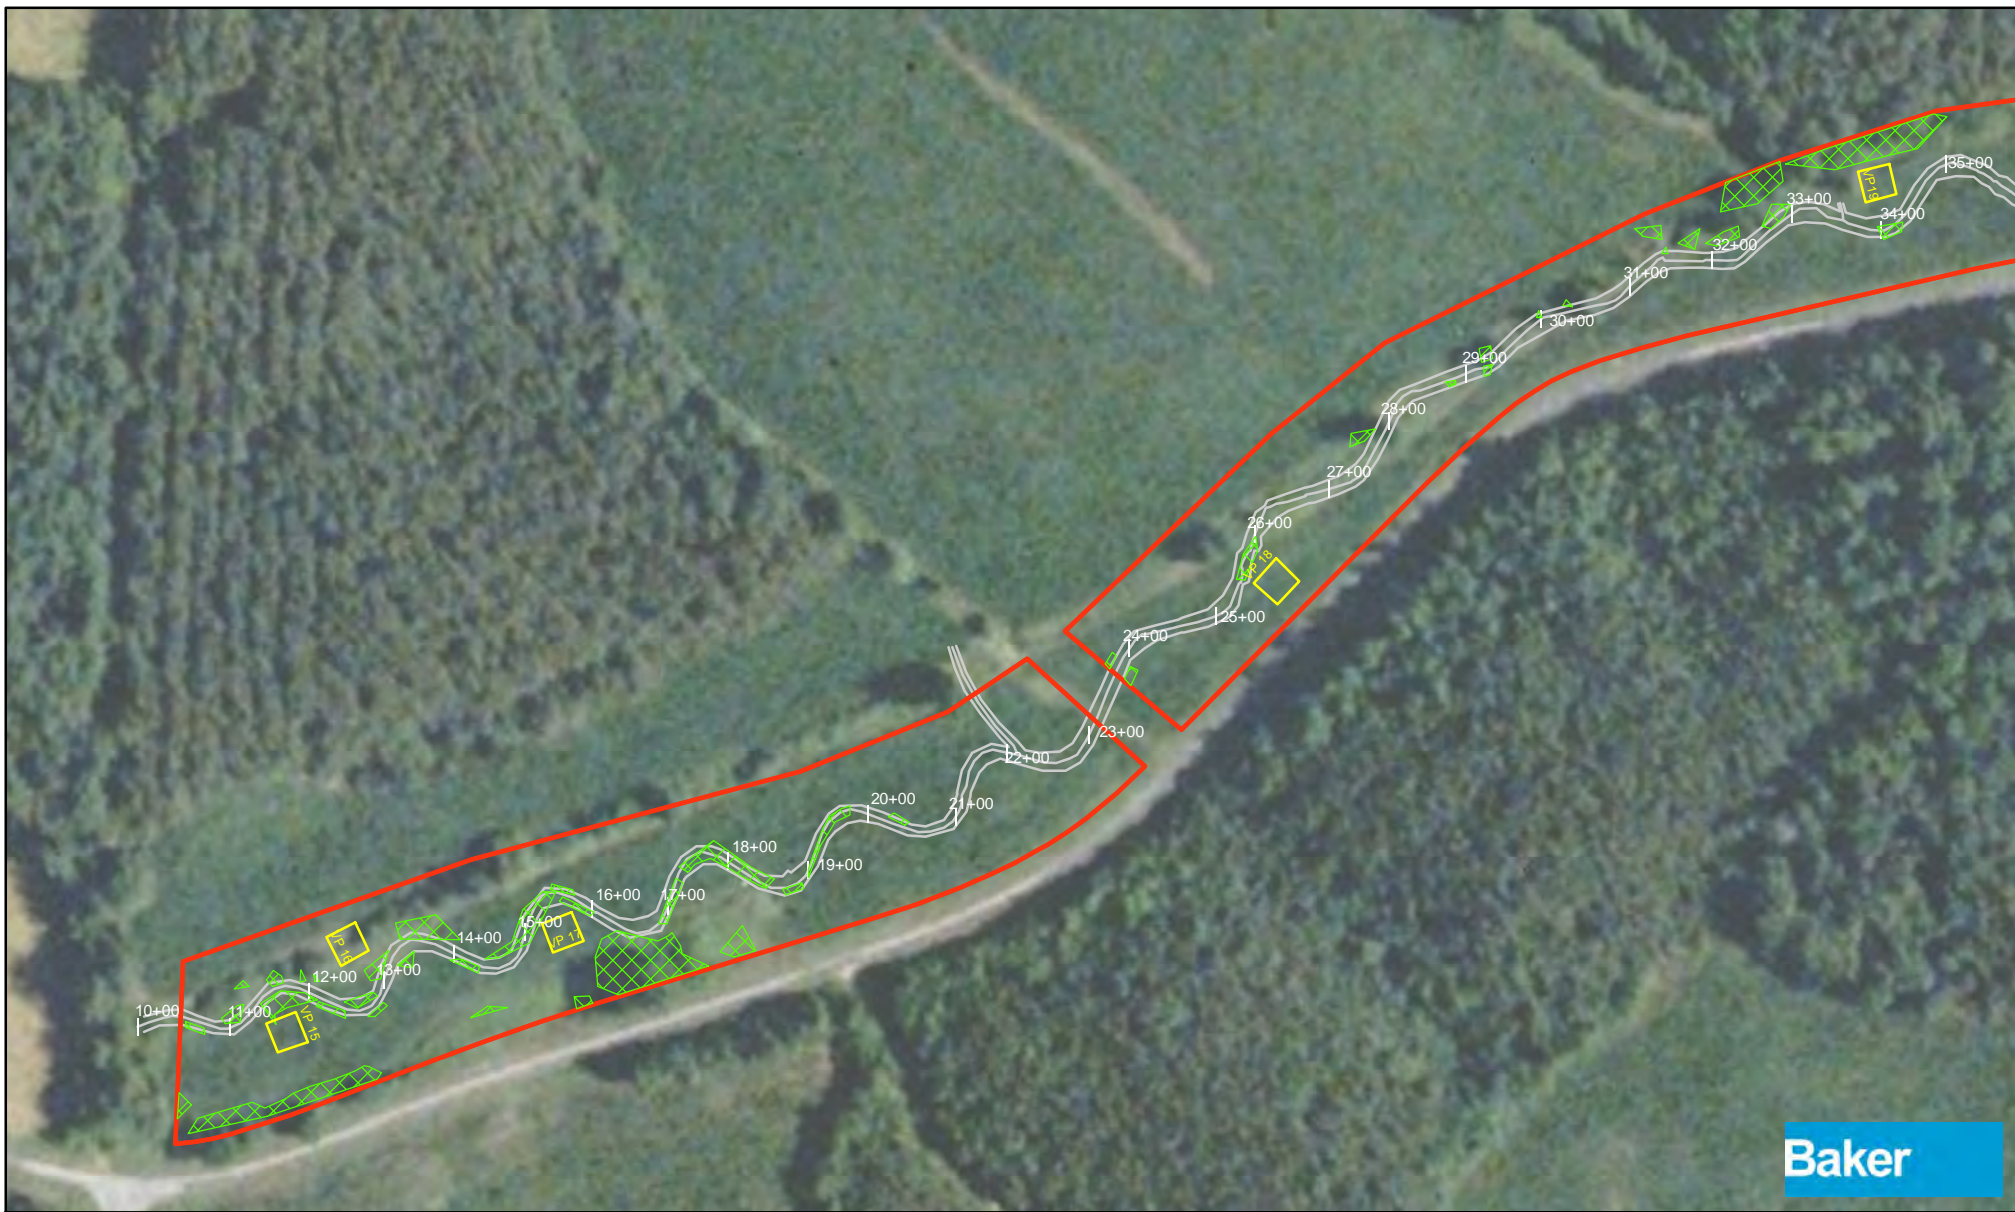
**Figure C5: Vegetation Problem Areas
UT1 (Station 10+00 to 35+00)**

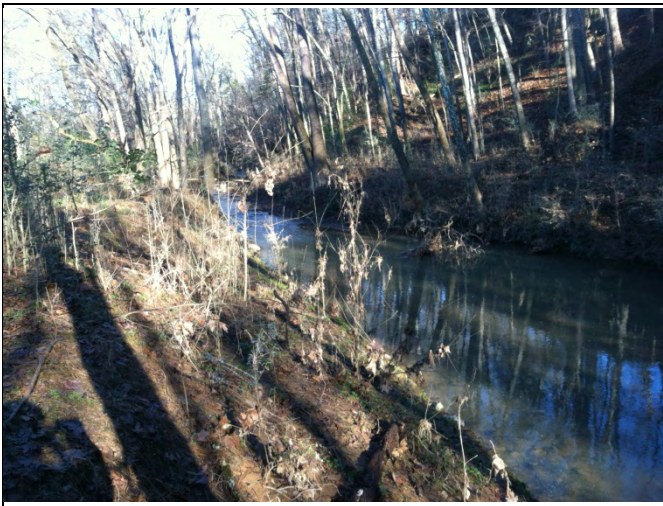
BCC PID 3 –Existing Riffle, BCC Reach 6

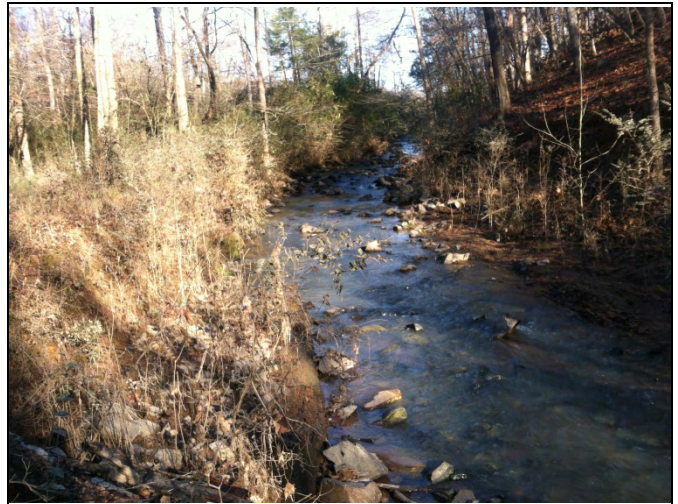
BCC PID 6 – Log Vane in distance, BCC Reach 6 Start

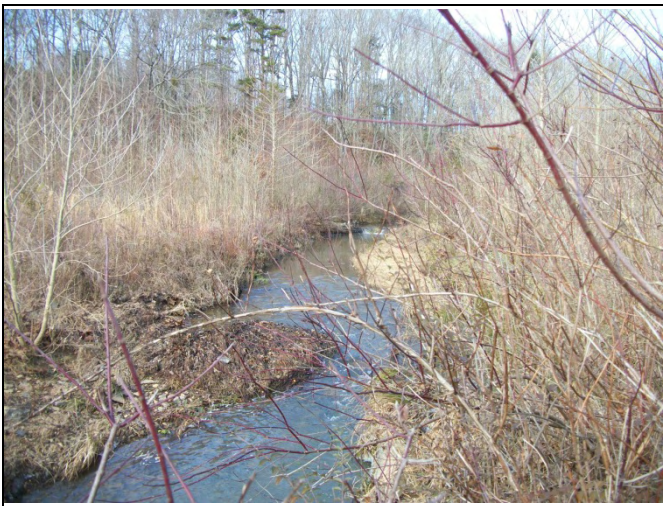
BCC PID 11 – Log J-Hook & Constructed Riffle, BCC Reach 3 End

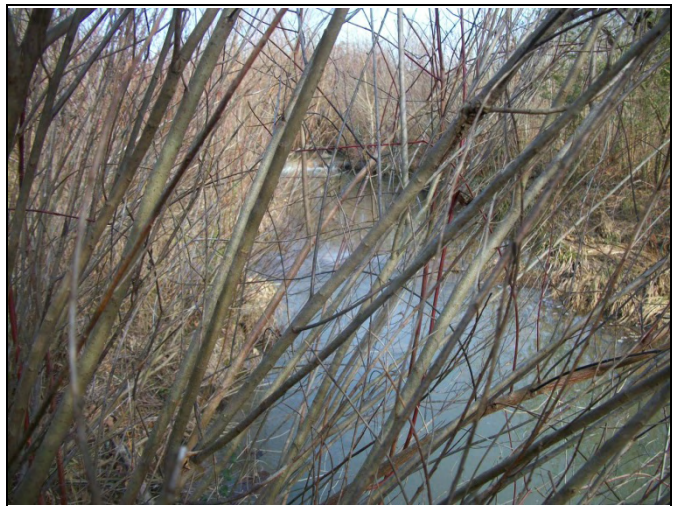
BCC PID 12 – Log J-Hook Step Pool, BCC Reach 3

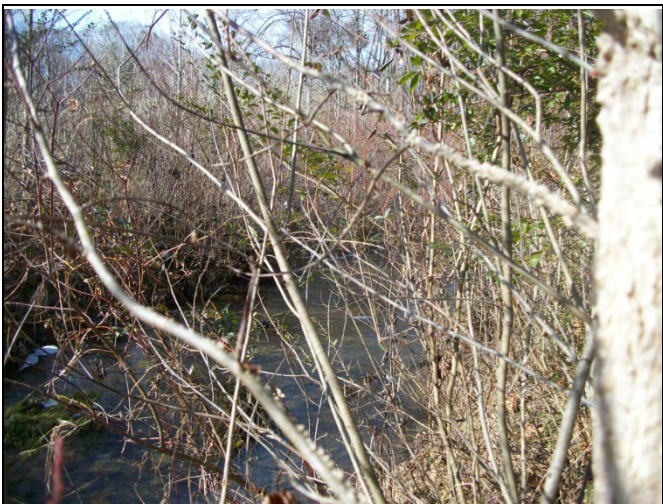
BCC PID 17 – Constructed Riffle, UT1 Reach 3

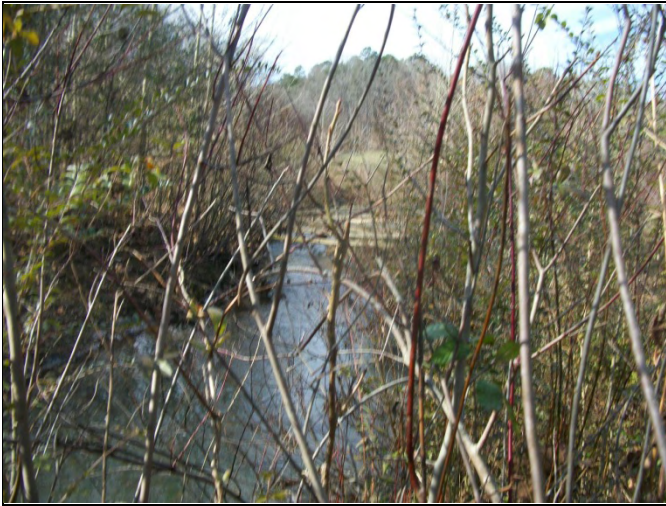
BCC PID 25 – Riffle Crossing, BCC Reach 2

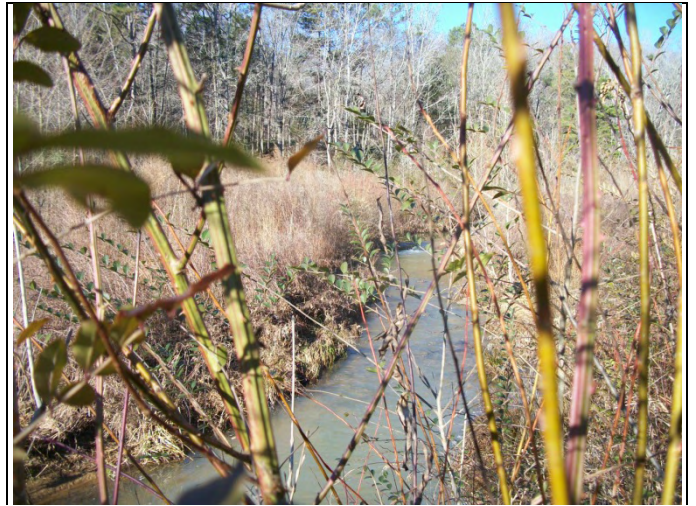
BCC PID 28 – Log J-Hook & Constructed Riffle,
BCC Reach 2

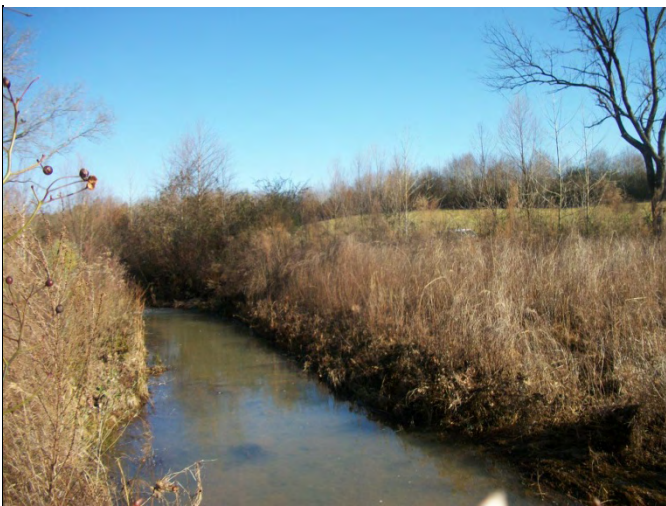
BCC PID 29 – Log J-Hook & Constructed Riffle,
BCC Reach 2

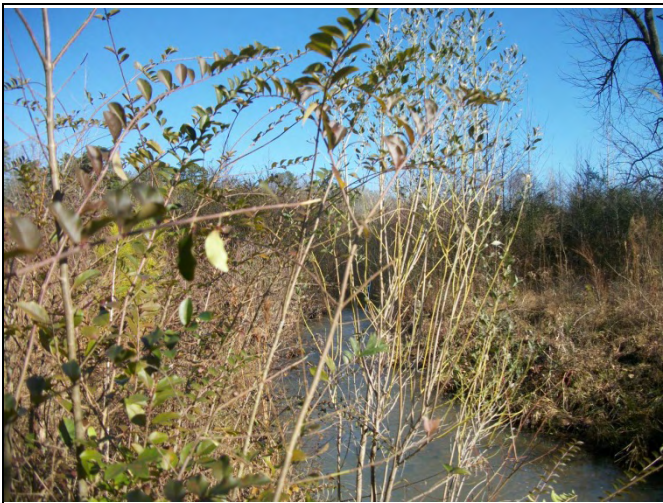
BCC PID 38 – Constructed Riffle, BCC Reach 2

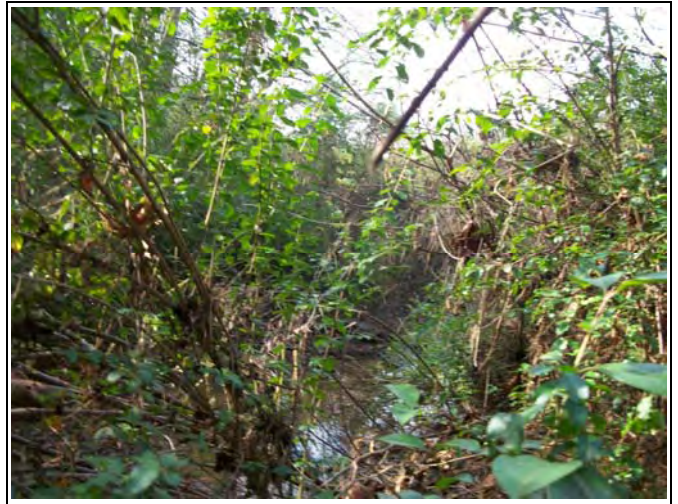
UT1 PID 1 – Constructed Riffle, UT1 Reach 4 End

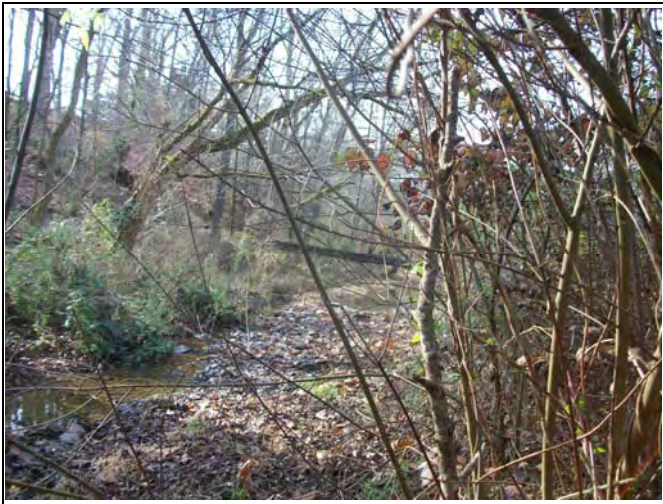
UT1 PID 2 –Constructed Riffle, UT1 Reach 4

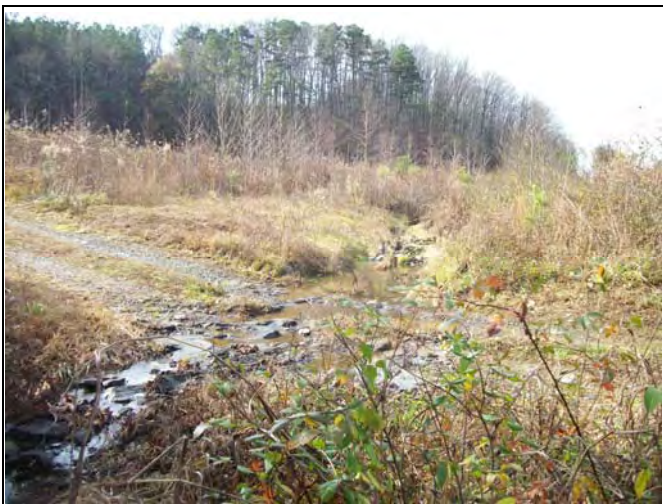
UT1 PID 4 – Constructed Riffle, UT1 Reach 4

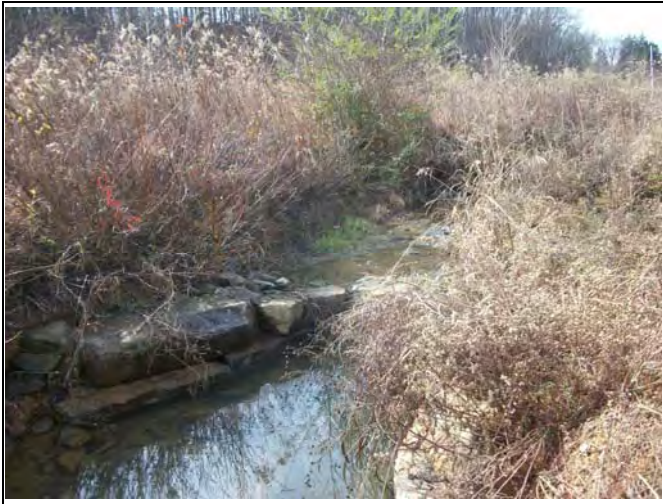
UT1 PID 6 – Constructed Riffle, UT1 Reach 4

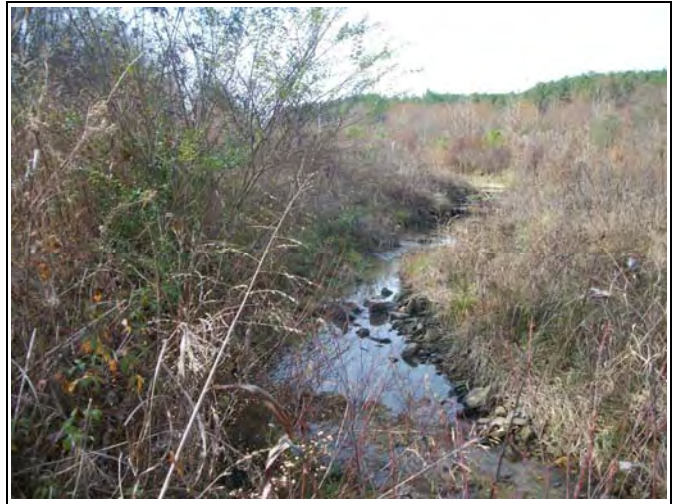
UT1 PID 7 – Constructed Riffle, UT1 Reach 4

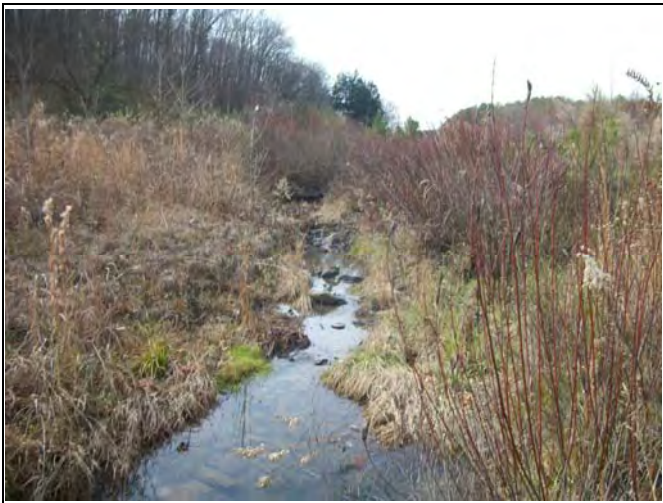
UT1 PID 8 – Constructed Riffle, UT1 Reach 4

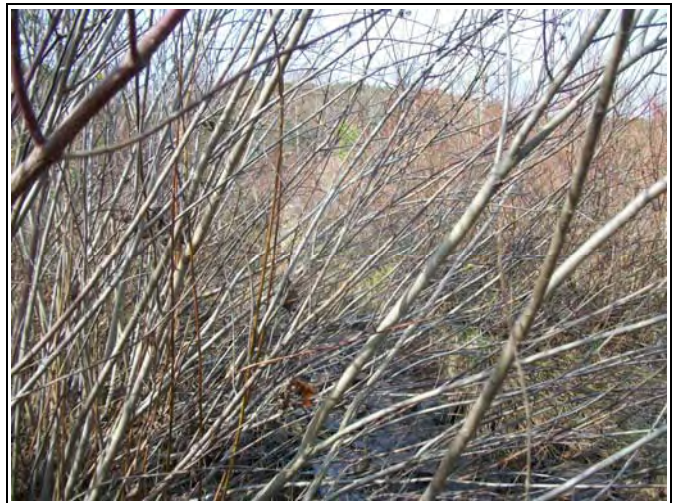
UT1 PID 9 – Constructed Riffle, UT1 Reach 4

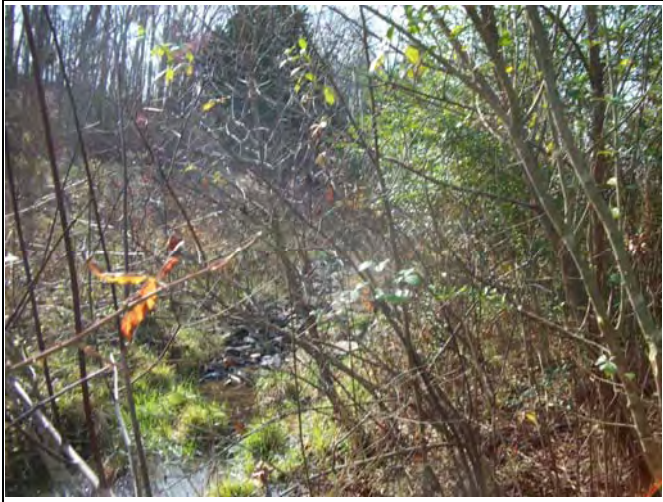
UT1 PID 12 – Constructed Riffle, UT1
Reach 3 End

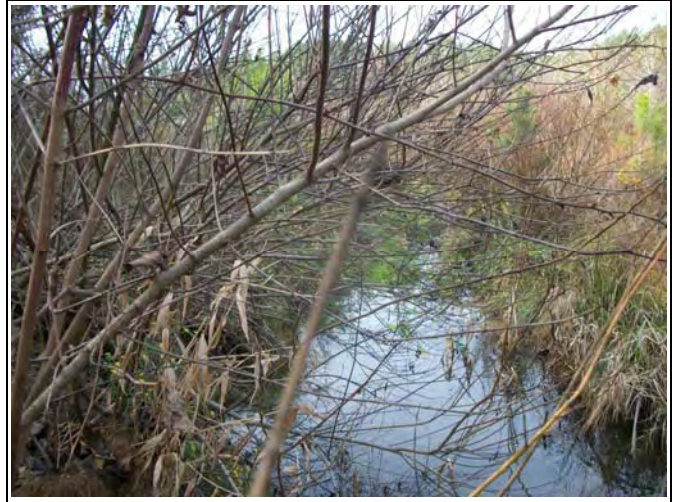
UT1 PID 13 – Constructed Riffle, UT1 Reach 3

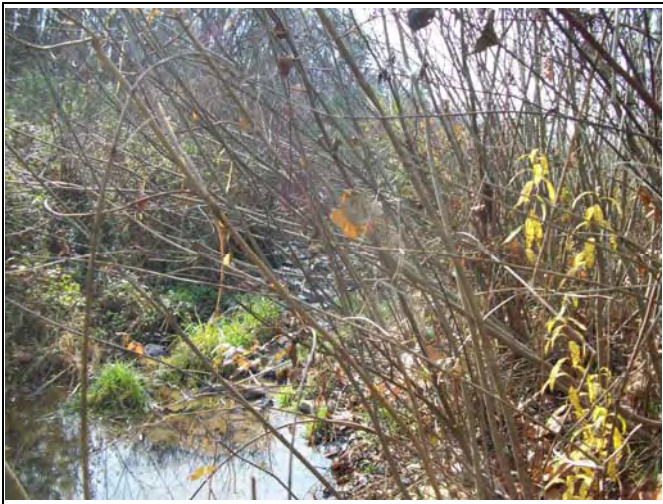
UT1 PID 14 – Constructed Riffle, UT1 Reach 3

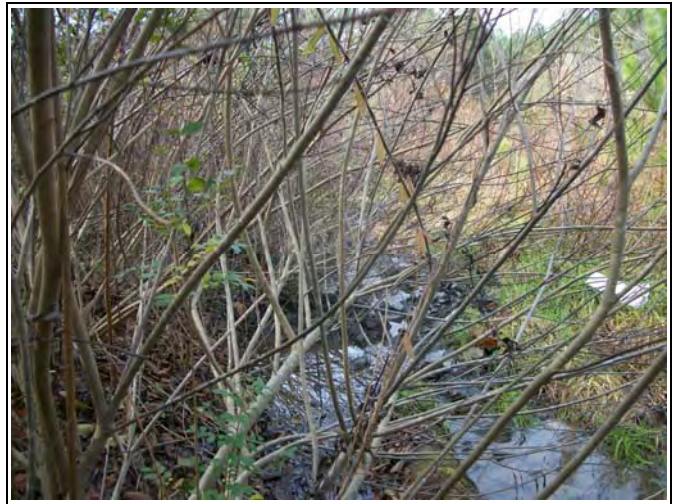
UT1 PID 15 – Constructed Riffle, UT1 Reach 3

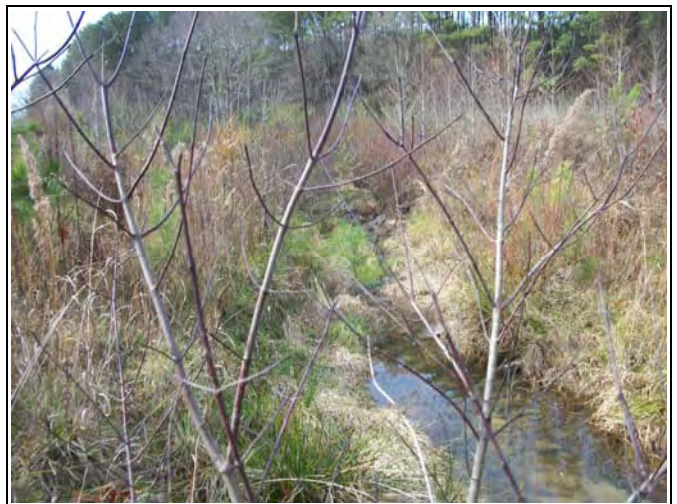
UT1 PID 17 – Constructed Riffle, UT1 Reach 3

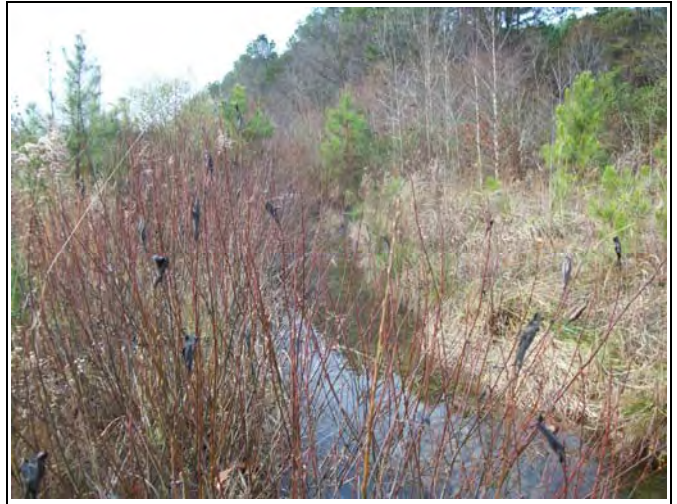
UT1 PID 19 – Constructed Riffle, UT1 Reach 3

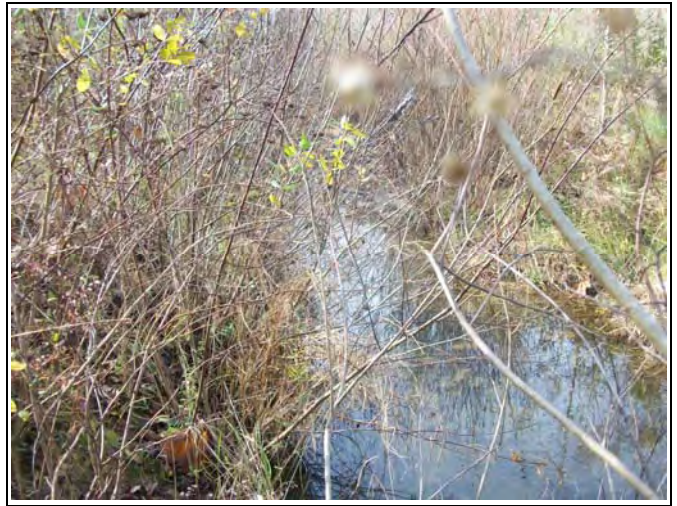
UT1 PID 21 – Constructed Riffle, UT1 Reach 3

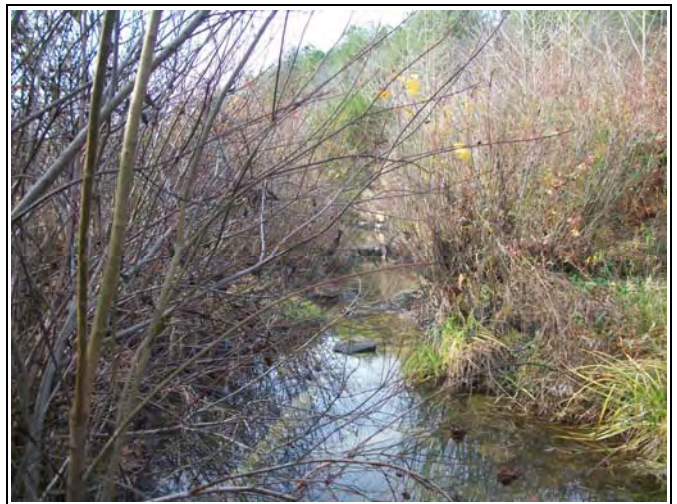
UT1 PID 23 – Constructed Riffle, UT1 Reach 3

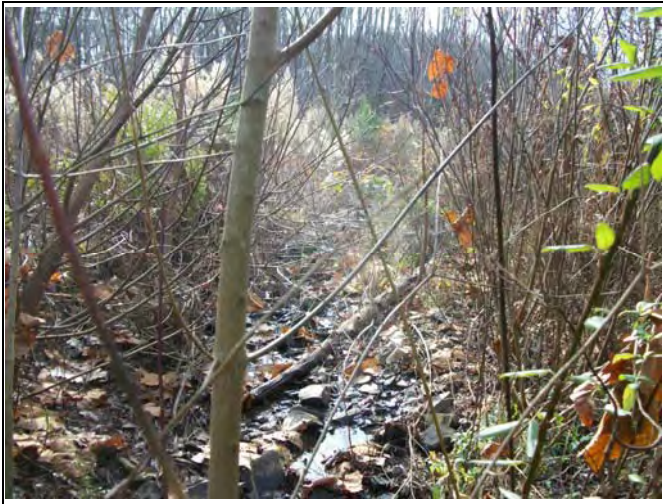
UT1 PID 24 – Constructed Riffle, UT1 Reach 3

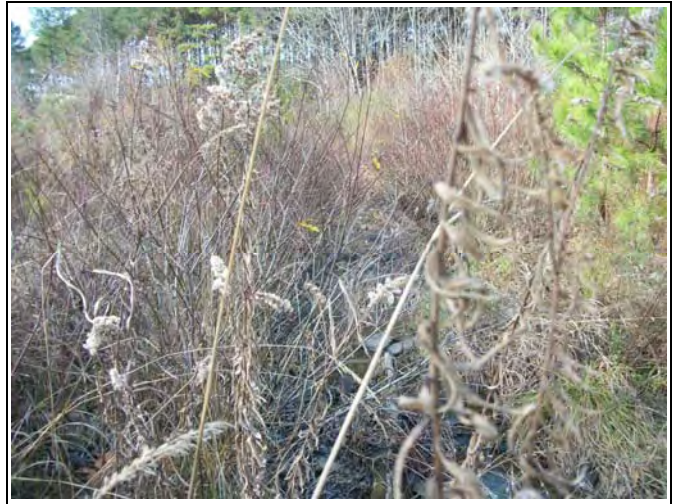
UT1 PID 25 – Constructed Riffle, UT1 Reach 3

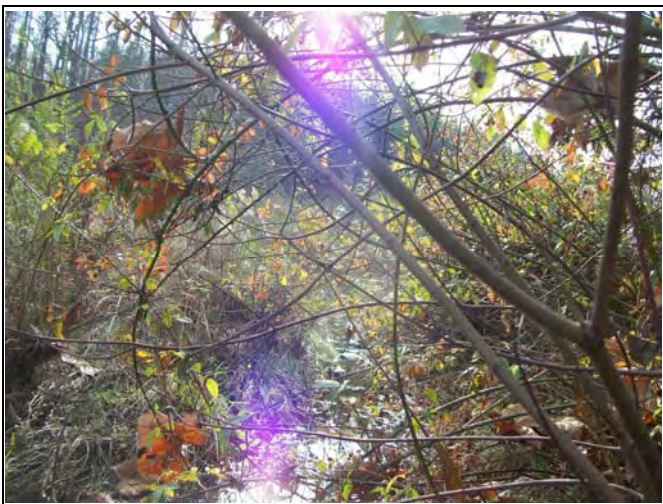
UT1 PID 29 – Constructed Riffle, UT1 Reach 3

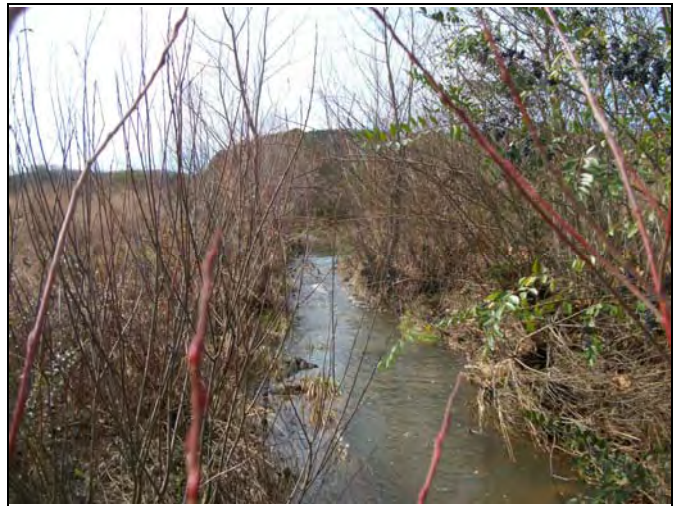
UT1 PID 34 – Constructed Riffle, UT1 Reach 2

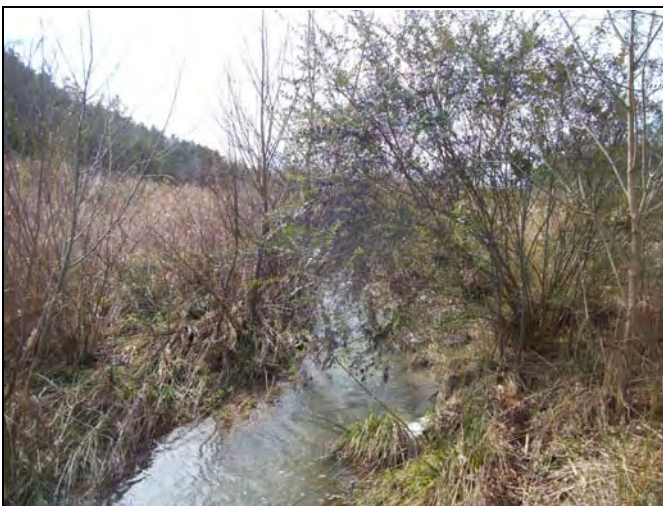
UT1 PID 35 – Constructed Riffle, UT1 Reach 2

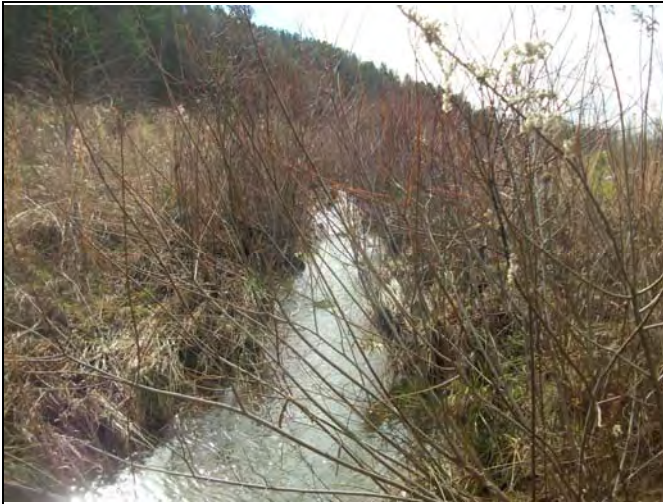
UT1 PID 37 – Constructed Riffle, UT1 Reach 2

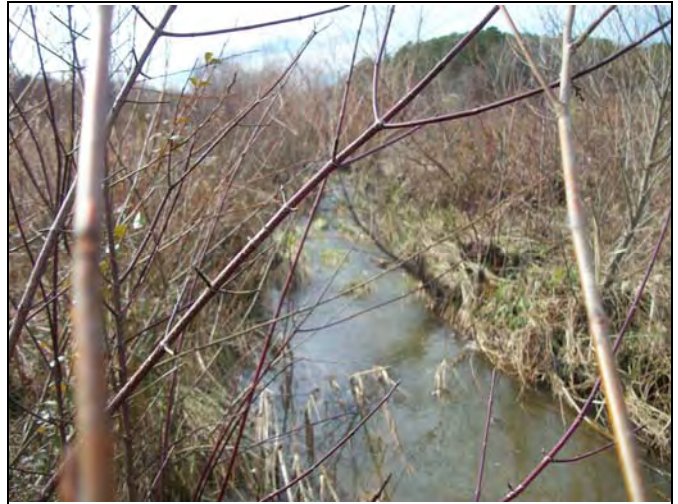
UT1 PID 38 – Constructed Riffle, UT1 Reach 2

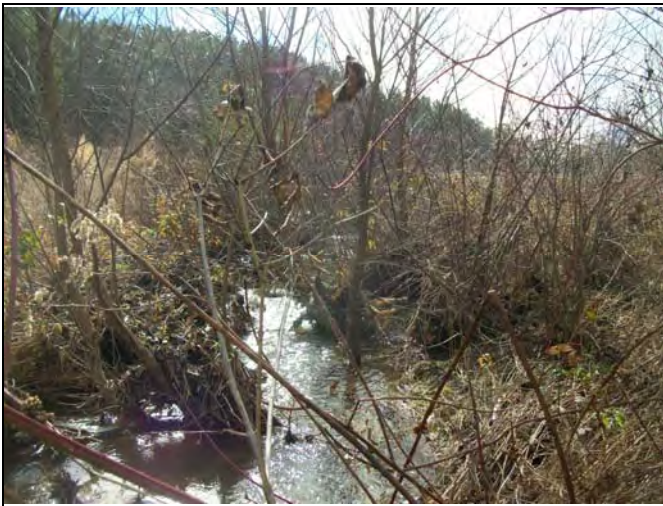
UT1 PID 39 – Rock and roll structures (3), UT1 Reach 3

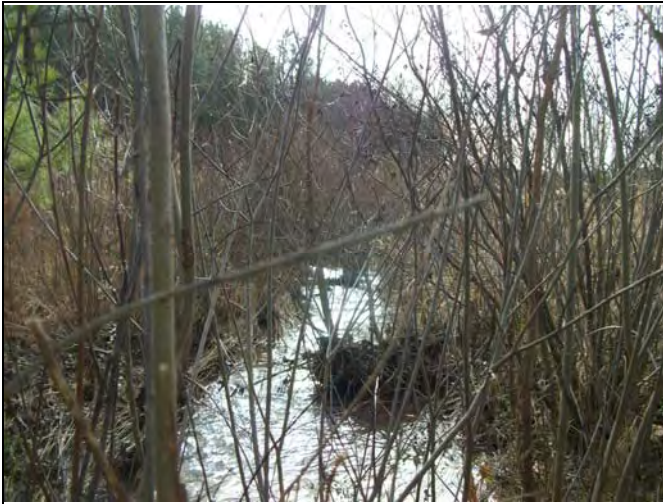
UT1 PID 43 – Constructed Riffle, UT1 Reach 1

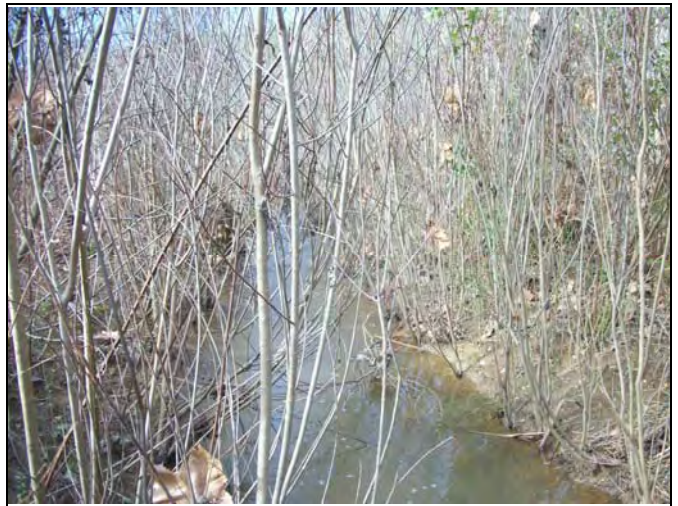
UT1 PID 46 – Constructed Riffle, UT1 Reach 1

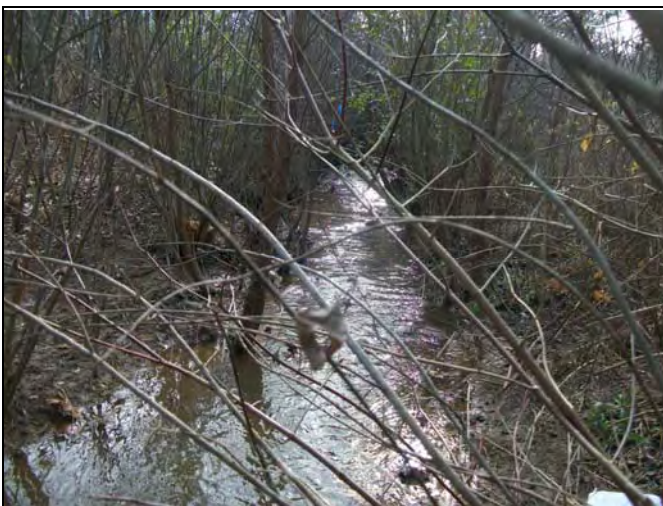
UT1 PID 47 – Constructed Riffle, UT1 Reach 1

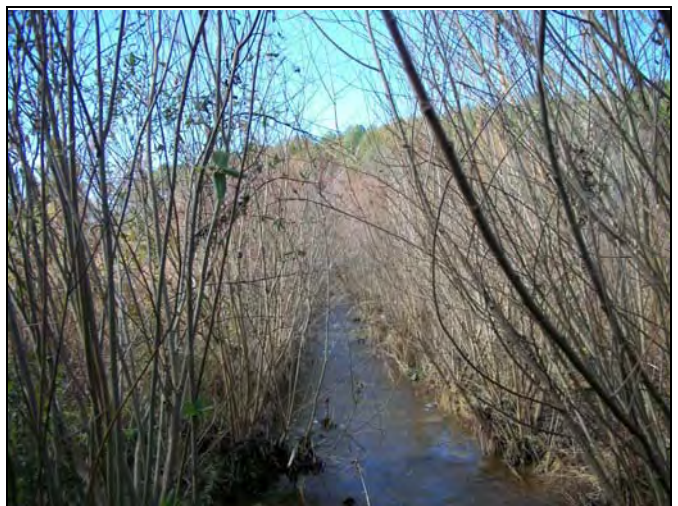
UT1 PID 48 – Constructed Riffle, UT1 Reach 1

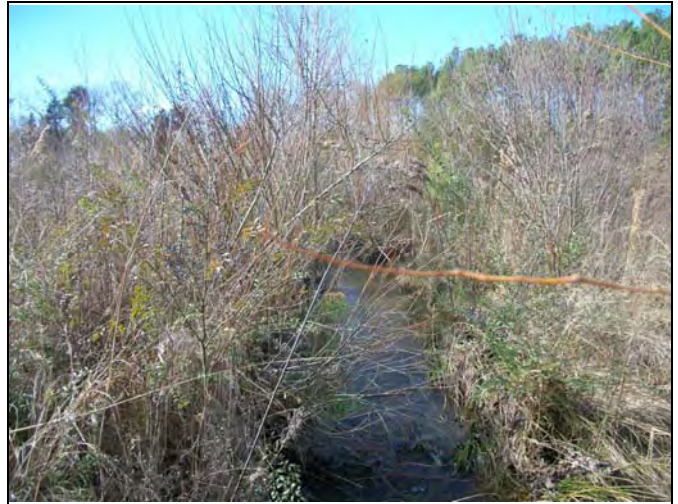
UT1 PID 50 – Constructed Riffle, UT1 Reach 1

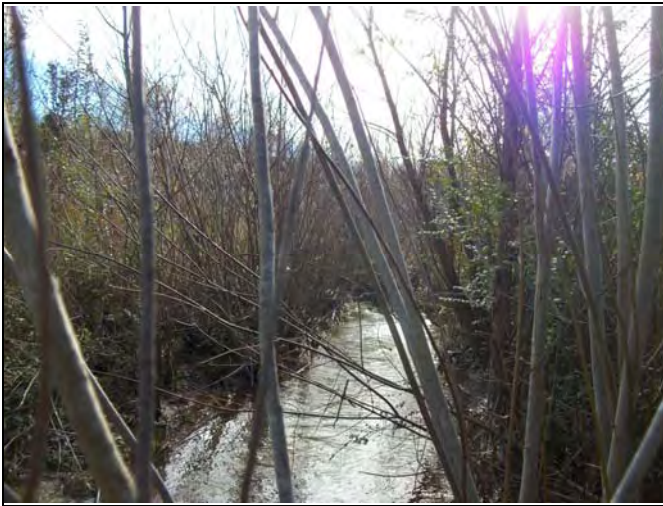
UT1 PID 51 – Constructed Riffle, UT1 Reach 1

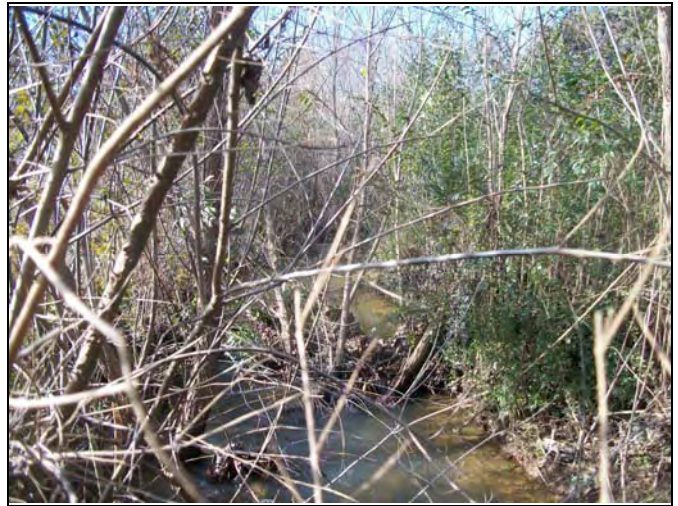
UT1 PID 52 – Constructed Riffle, UT1 Reach 1

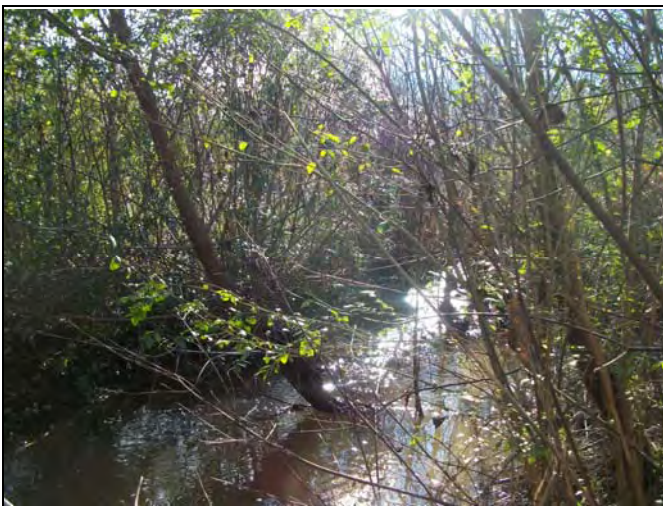
UT1 PID 53 – Constructed Riffle, UT1 Reach 1

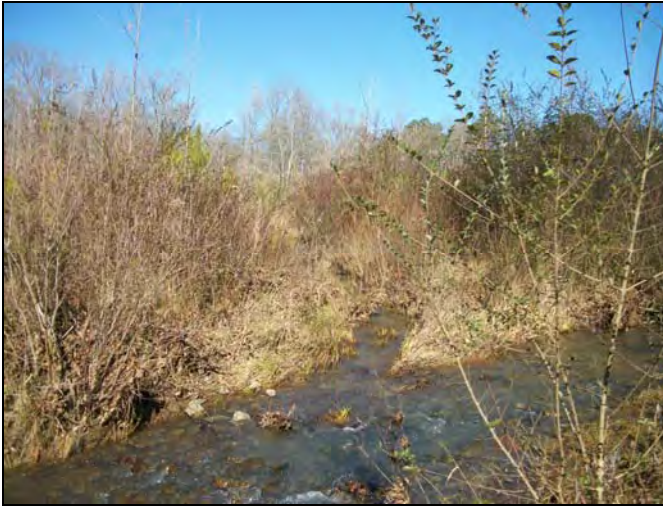
UT2 PID 1 – Constructed Riffle, UT2 End

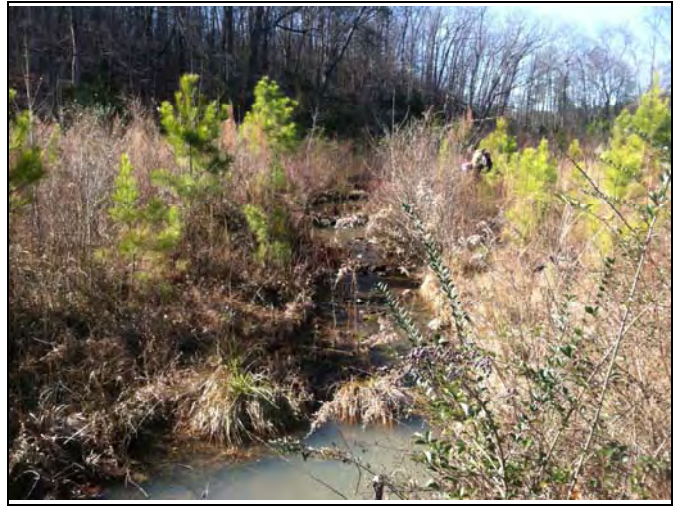
UT2 PID 2 – Constructed Riffle

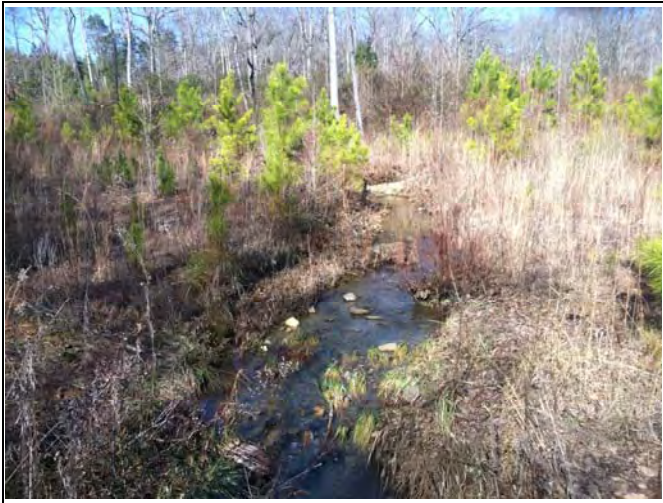
UT2 PID 3 – Constructed Riffle
