Big Cedar Creek Stream Restoration FINAL Year 5 Monitoring Report (2013) Stanly County, North Carolina

EEP Project ID #92532/EEP Contract #D06054-D

Data Collection Period: October - December 2013

Submission Date: May 2014

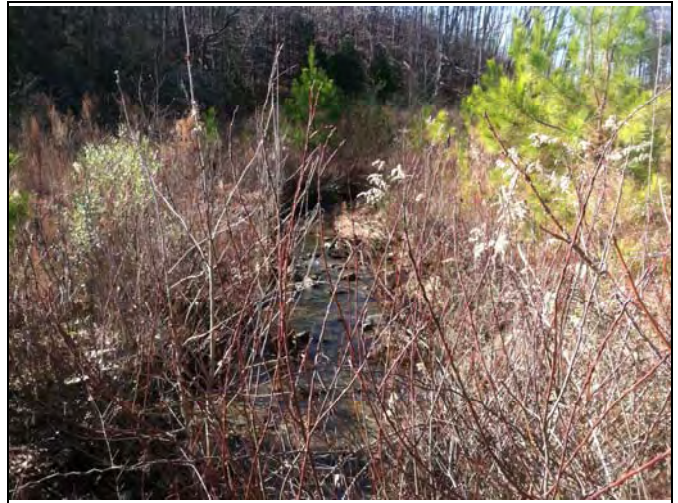
UT2 PID 4 – Constructed Riffle

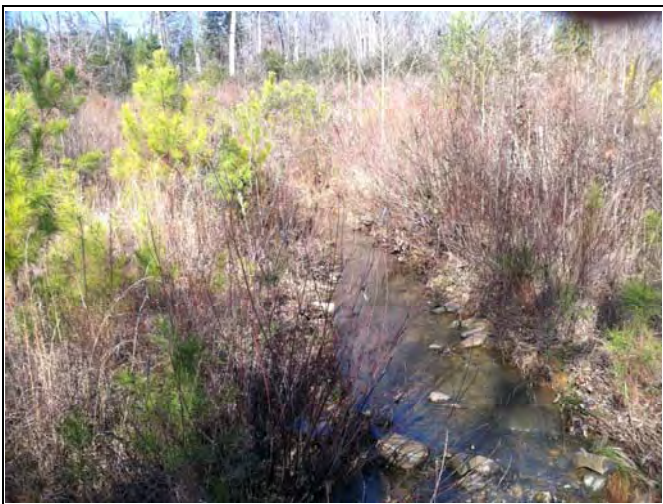
UT2 PID 5 – Constructed Riffle

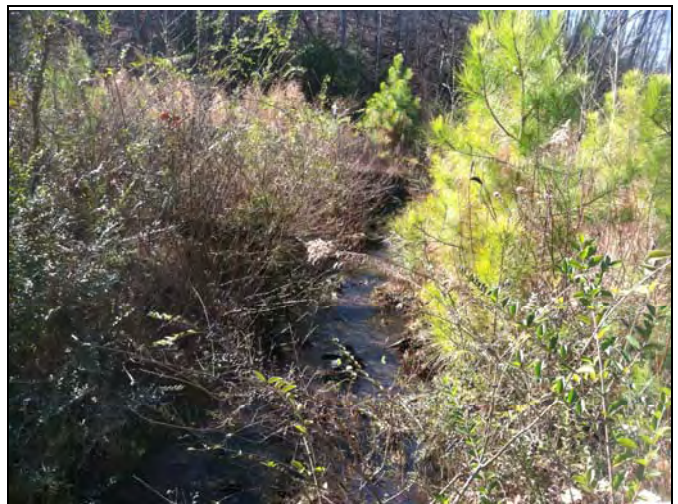
UT2 PID 6 – Constructed Riffle

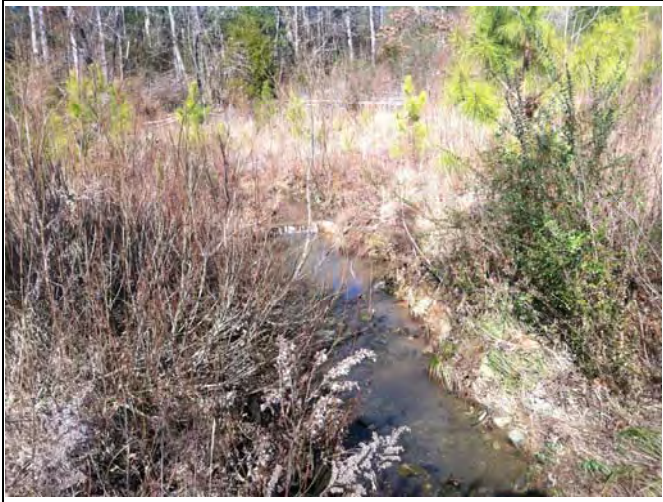
UT2 PID 7 – Constructed Riffle

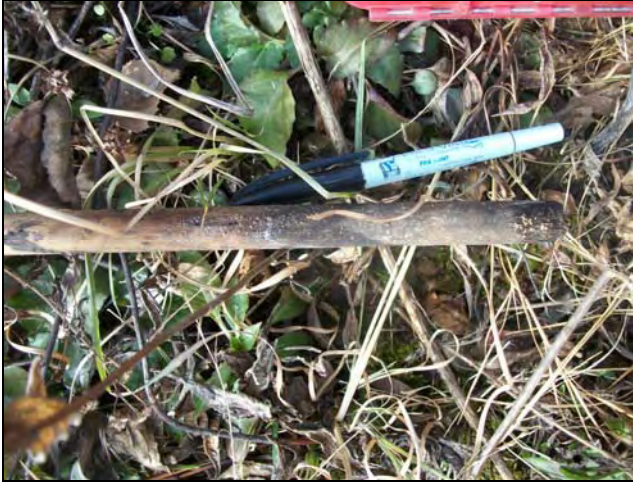
BCC Crest Gauge – 0.41-ft (12/3/2013)

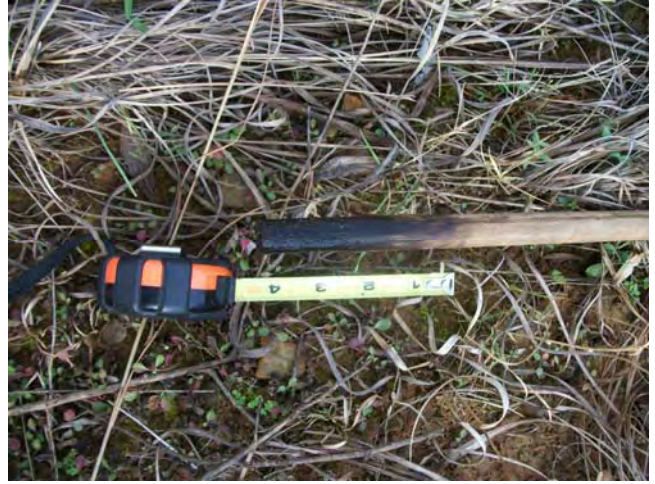
UT1 Crest Gauge – 0.33-ft (12/3/2013)
