MONITORING YEAR 2 ANNUAL REPORT

BIG HARRIS CREEK MITIGATION SITE

Cleveland County, NC
DMS Project No. 739
DEQ Contract 006256
DWR 401 Project No. 10-0811
USACE Action ID No. SAW-2009-0475
Broad River Basin
HUC 03050105

Data Collection Period: March – October 2019

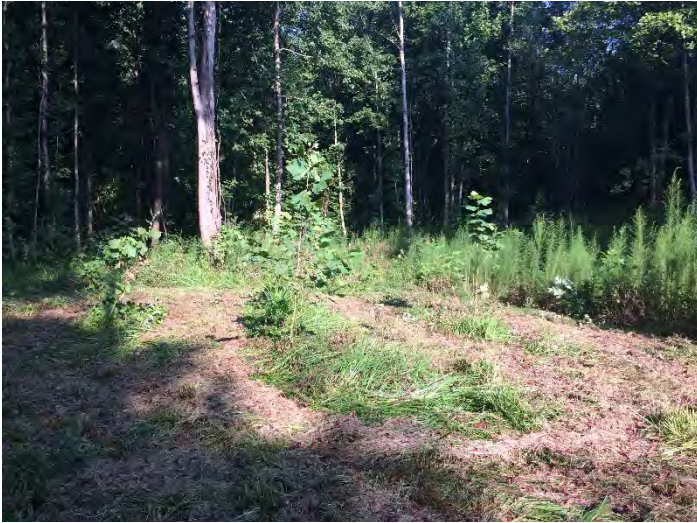
UBHC R1 Mowing Encroachment – view upstream (8/13/2019)
