MONITORING YEAR 3 ANNUAL REPORT

BIG HARRIS CREEK MITIGATION SITE

Cleveland County, NC
DMS Project No. 739
DEQ Contract 006256
DWR 401 Project No. 10-0811
USACE Action ID No. SAW-2009-0475
Broad River Basin
HUC 03050105

Data Collection Period: February – November 2020
Final Submission Date: February 15, 2021

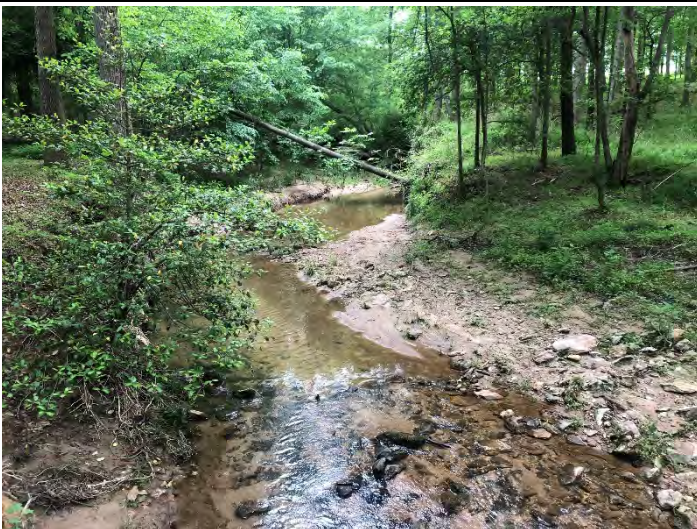
LSEC Photo Point 48 – view upstream (5/5/2020)

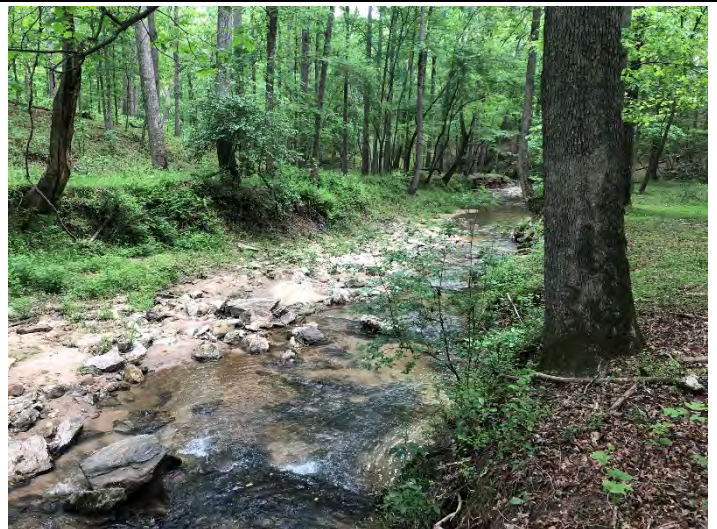
LSEC Photo Point 48 – view downstream (5/5/2020)

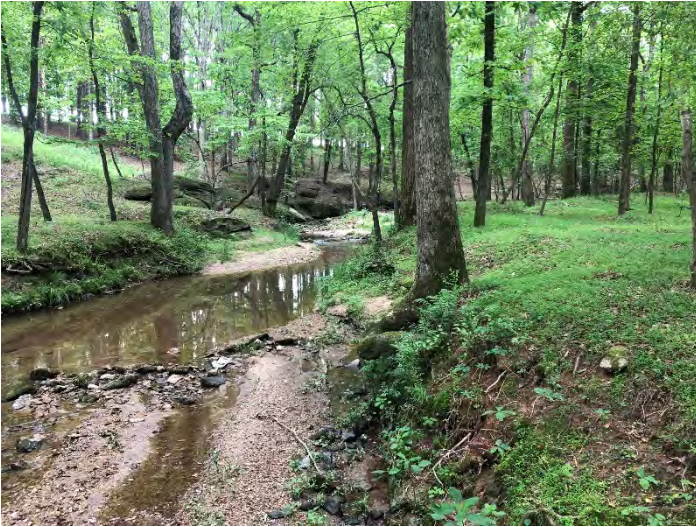
LSEC Photo Point 49 – view upstream (5/5/2020)

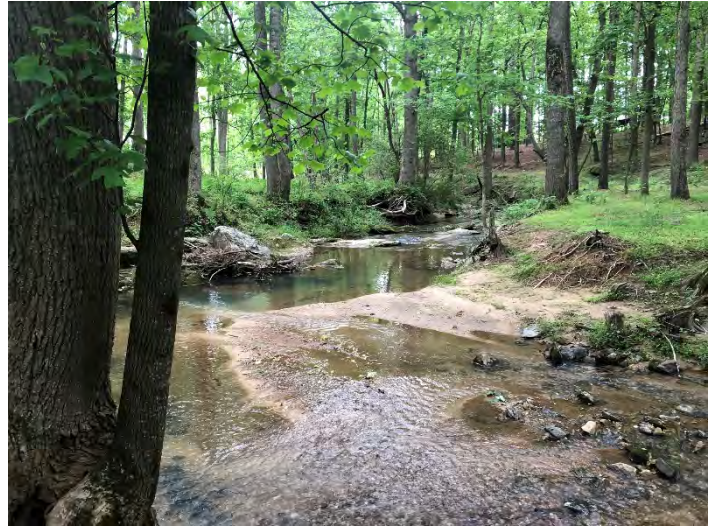
LSEC Photo Point 49 – view downstream (5/5/2020)

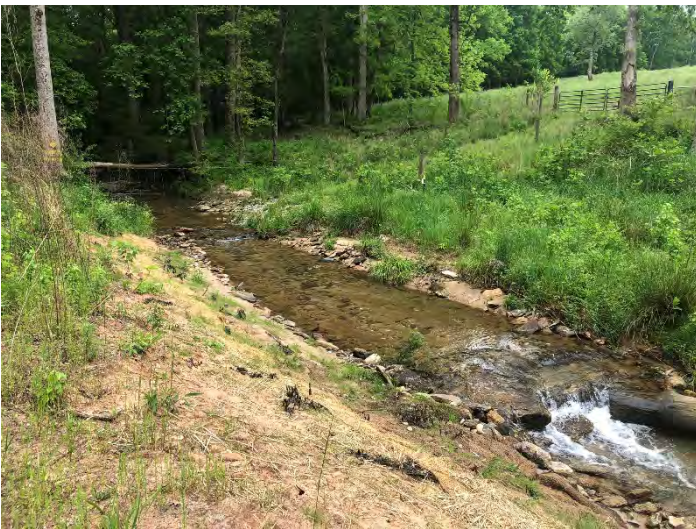
LSEC Photo Point 50 – view upstream (5/5/2020)

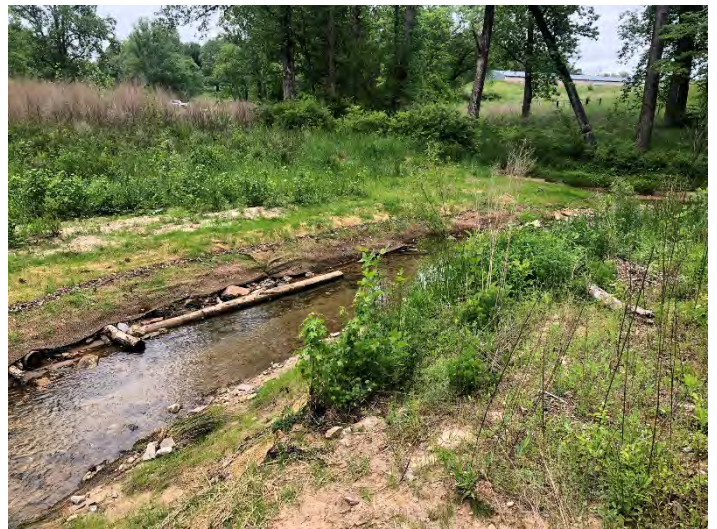
LSEC Photo Point 50 – view downstream (5/5/2020)

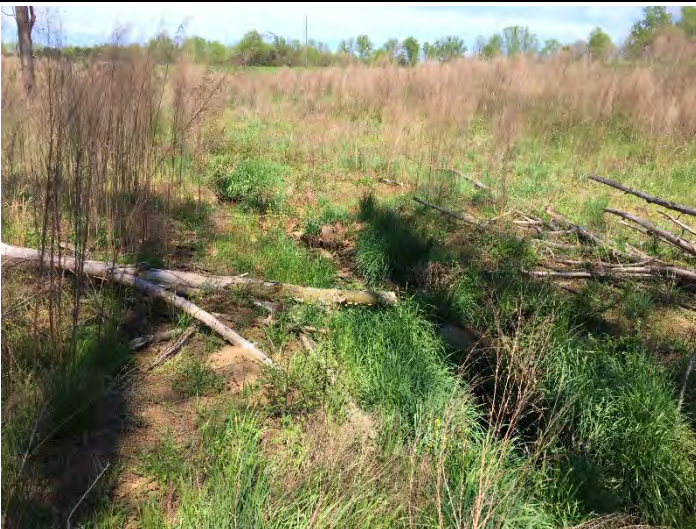
Scott Creek Photo Point 51 – view upstream (4/2/2020)

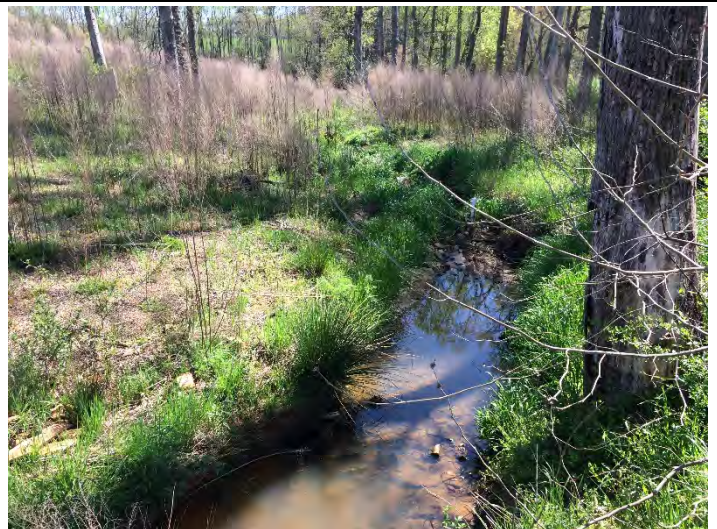
Scott Creek Photo Point 51 – view downstream (4/2/2020)

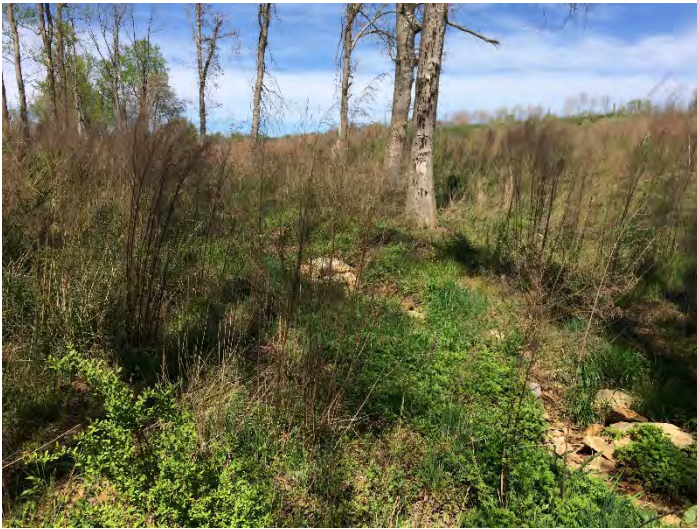
Scott Creek Photo Point 52 – view upstream (4/2/2020)

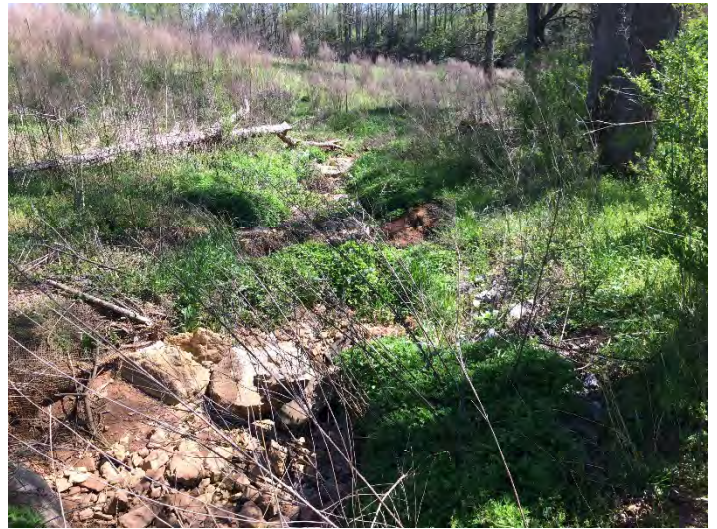
Scott Creek Photo Point 52 – view downstream (4/2/2020)

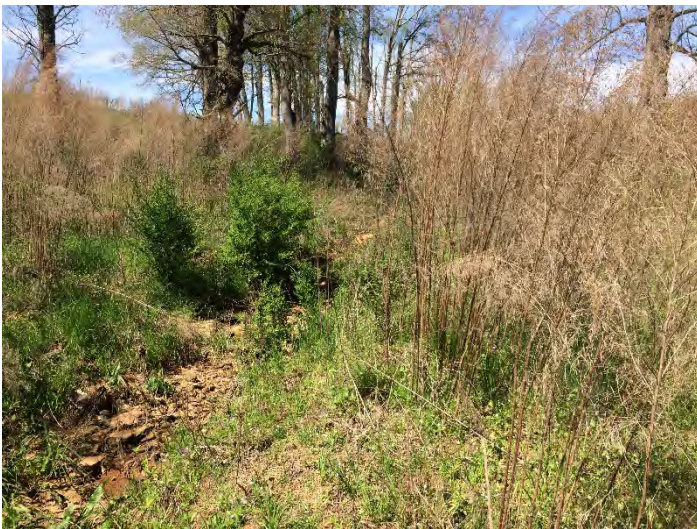
Scott Creek Photo Point 53 – view upstream (4/2/2020)

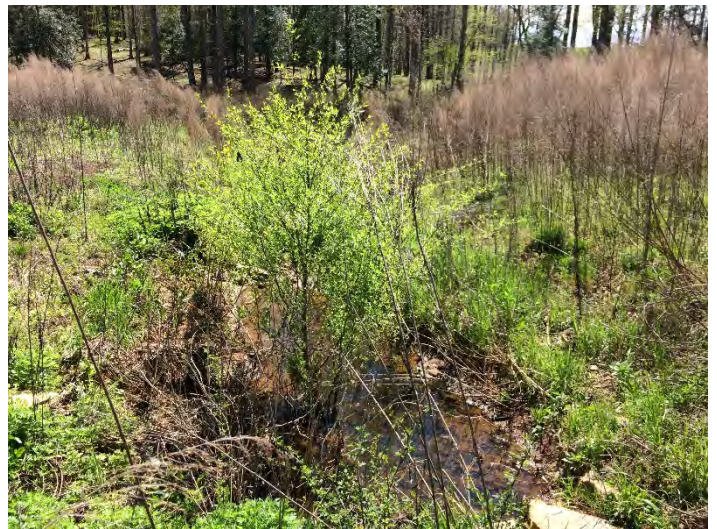
Scott Creek Photo Point 53 – view downstream (4/2/2020)

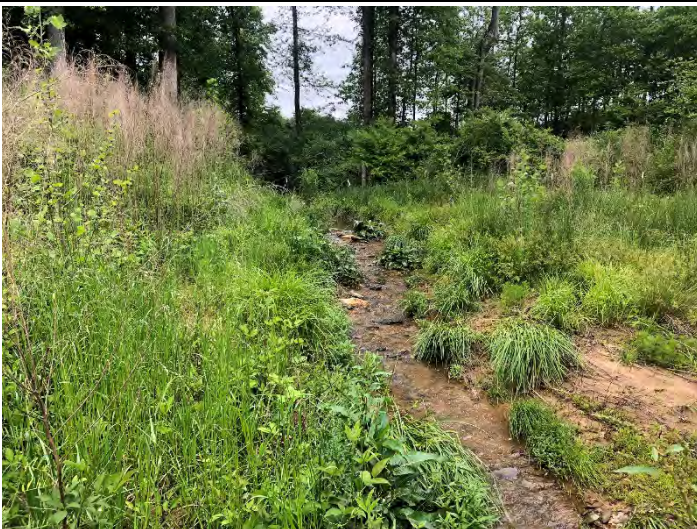
Carroll Creek Photo Point 54 – view upstream (5/5/2020)

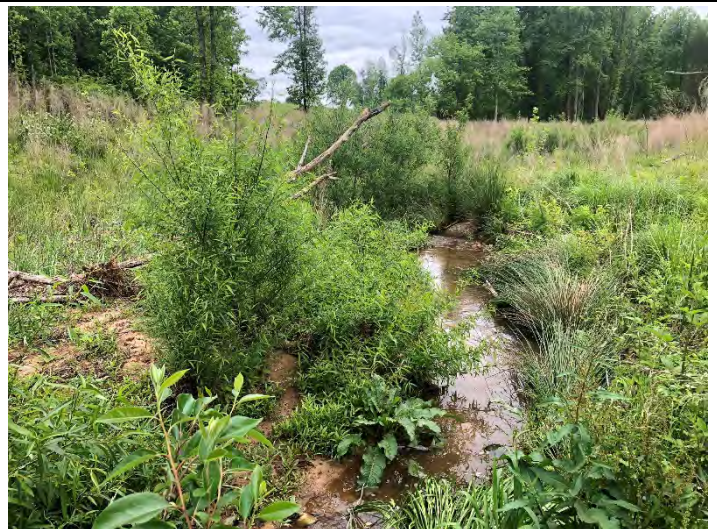
Carroll Creek Photo Point 54 – view downstream (5/5/2020)

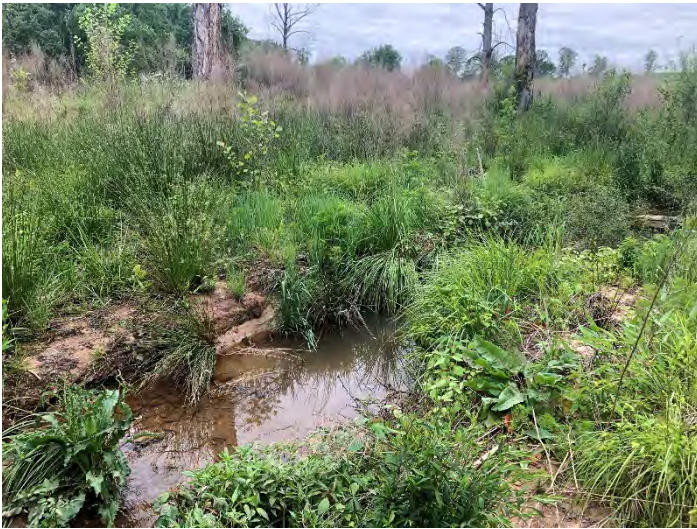
Carroll Creek Photo Point 55 – view upstream (5/5/2020)

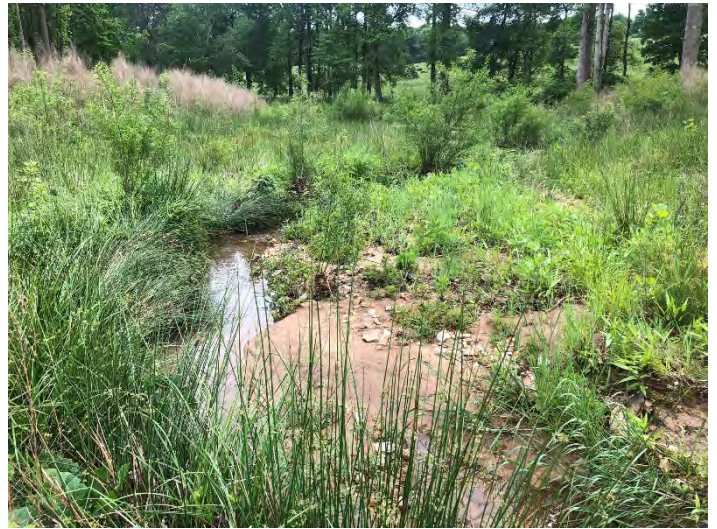
Carroll Creek Photo Point 55 – view downstream (5/5/2020)

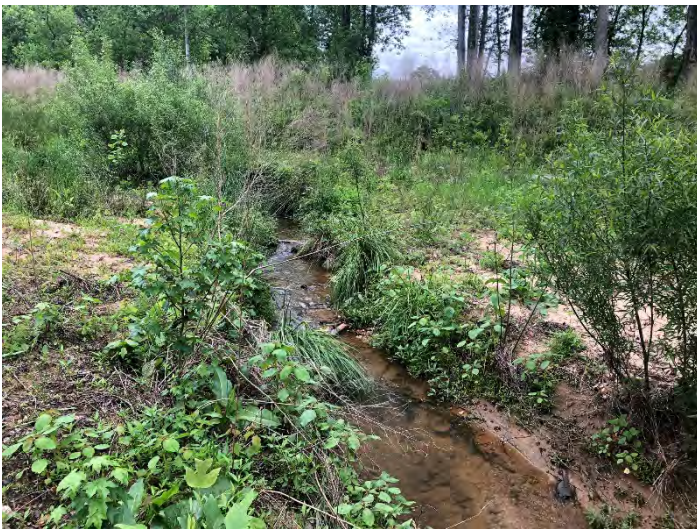
Carroll Creek Photo Point 56 – view upstream (5/5/2020)

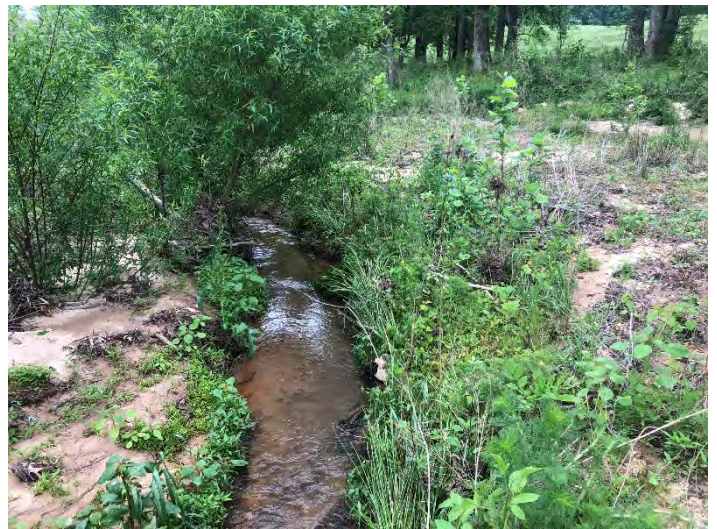
Carroll Creek Photo Point 56 – view downstream (5/5/2020)

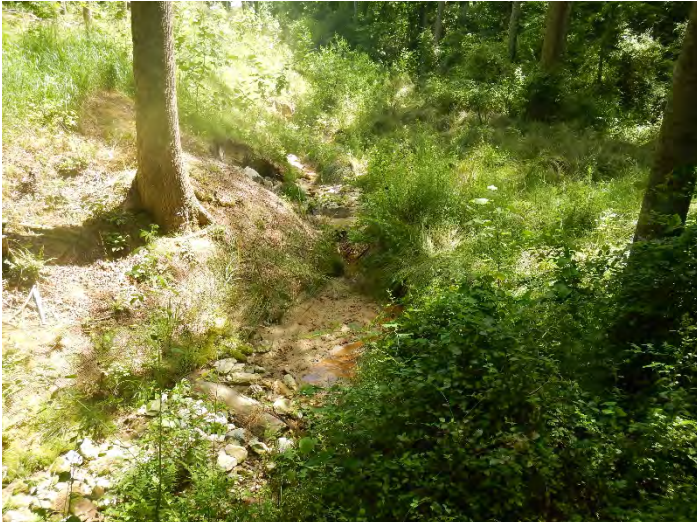
USEC R1 Photo Point 57 – view upstream (6/11/2020)

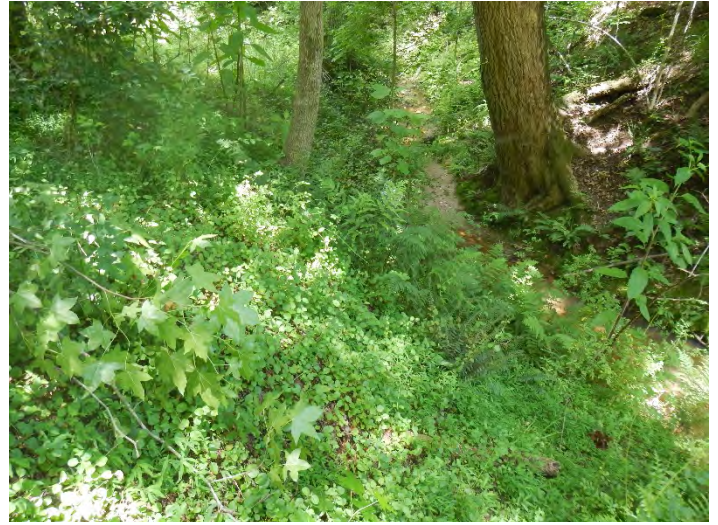
USEC R1 Photo Point 57 – view downstream (6/11/2020)

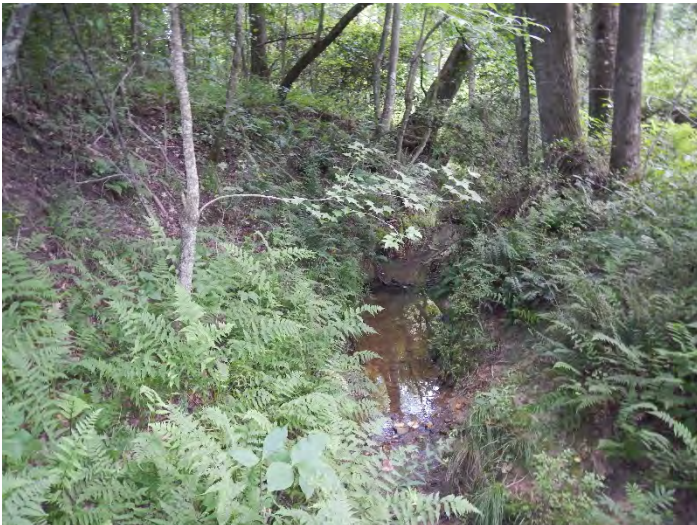
USEC R2 Photo Point 58 – view upstream (6/13/2020)

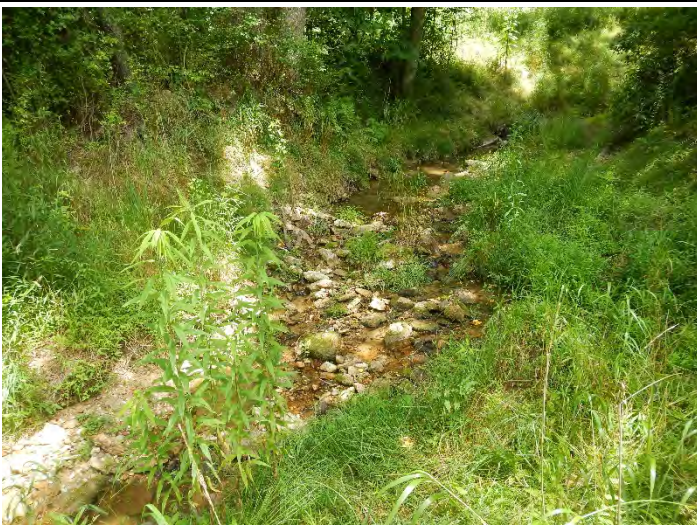
USEC R2 Photo Point 59 – view upstream (6/13/2020)

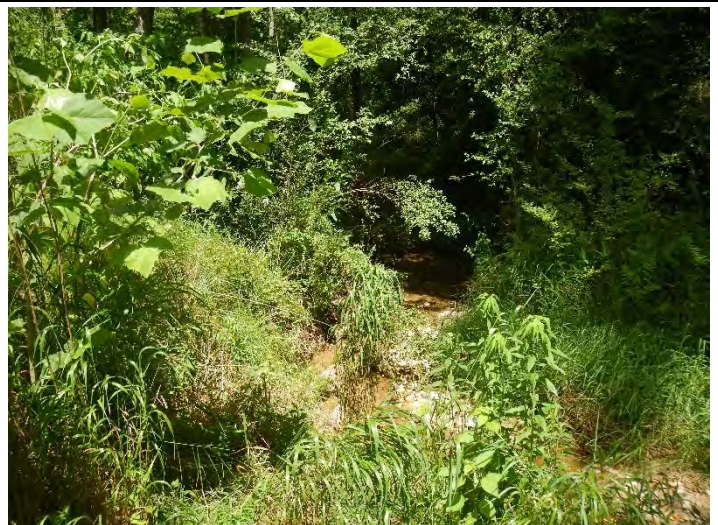
USEC R2 Photo Point 59 – view downstream (6/13/2020)

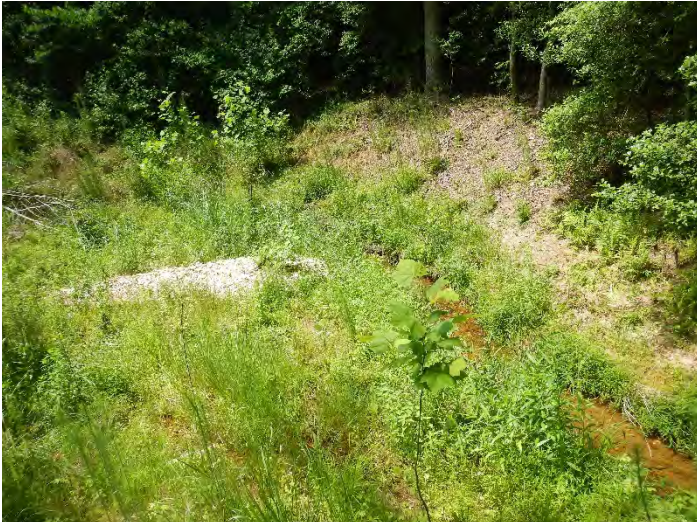
USEC R3 Photo Point 60 – view upstream (6/13/2020)

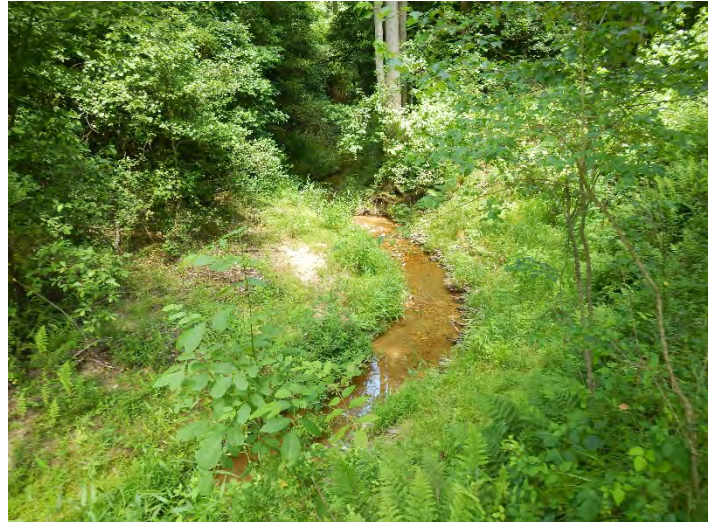
USEC R3 Photo Point 60 – view downstream (6/13/2020)

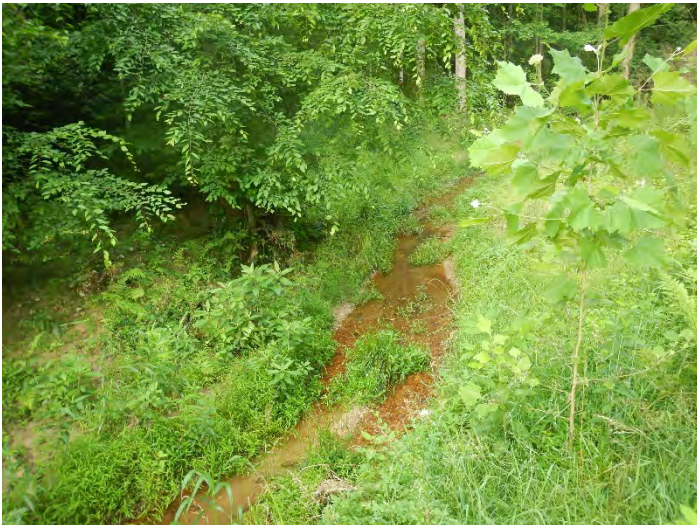
USEC R3 Photo Point 61 – view upstream (6/11/2020)

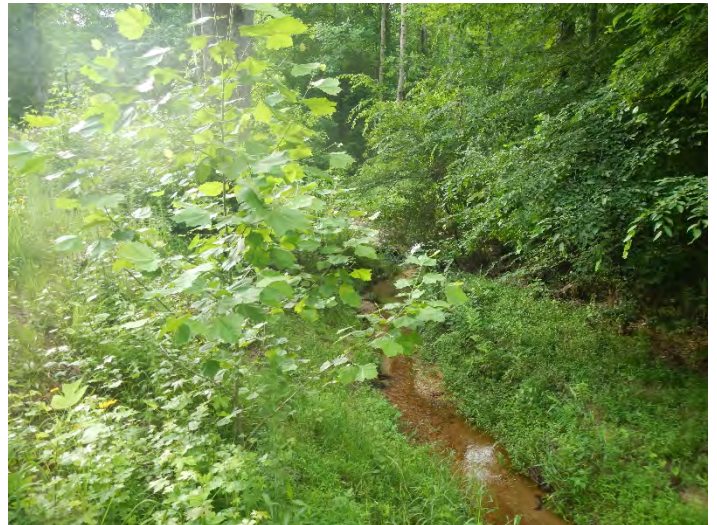
USEC R3 Photo Point 61 – view downstream (6/11/2020)

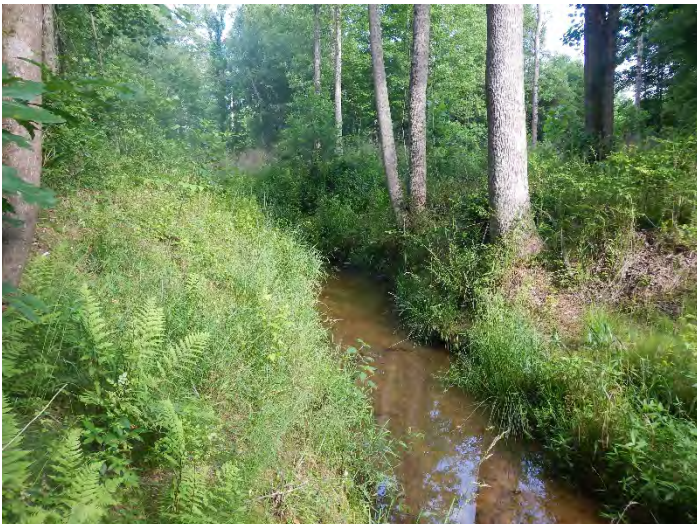
USEC R3 Photo Point 62 – view upstream (6/11/2020)

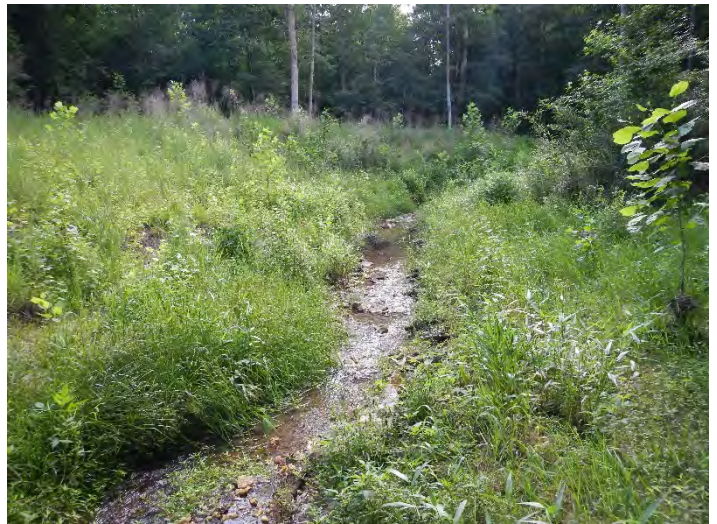
USEC R3 Photo Point 62 – view downstream (6/11/2020)

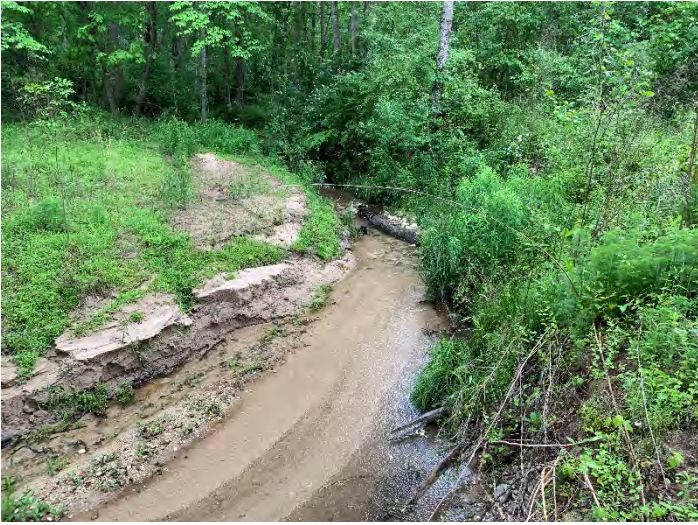
USEC R4A Photo Point 63 – view upstream (5/6/2020)

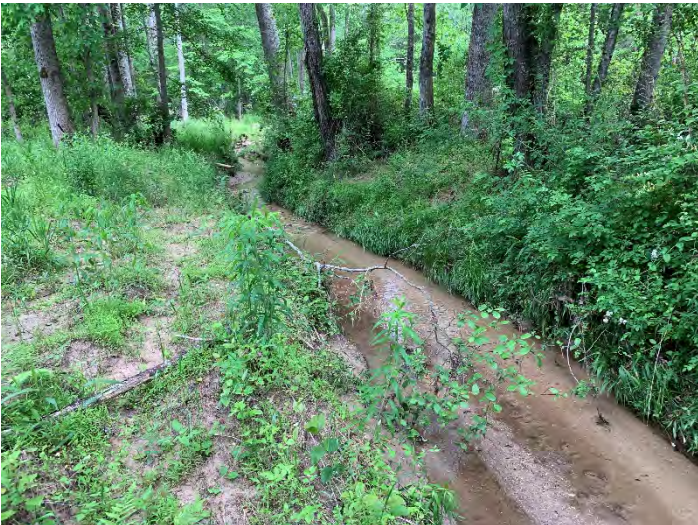
USEC R4B Photo Point 64 – view upstream (5/6/2020)

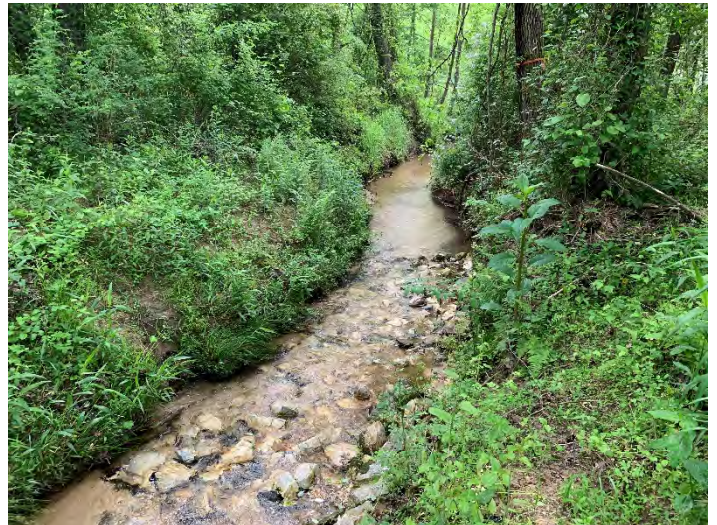
USEC R4B Photo Point 64 – view downstream (5/6/2020)

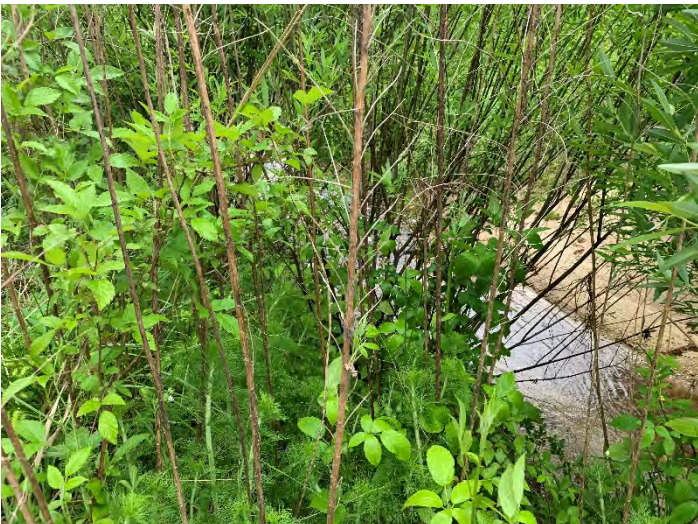
USEC R5 Photo Point 65 – view upstream (5/6/2020)

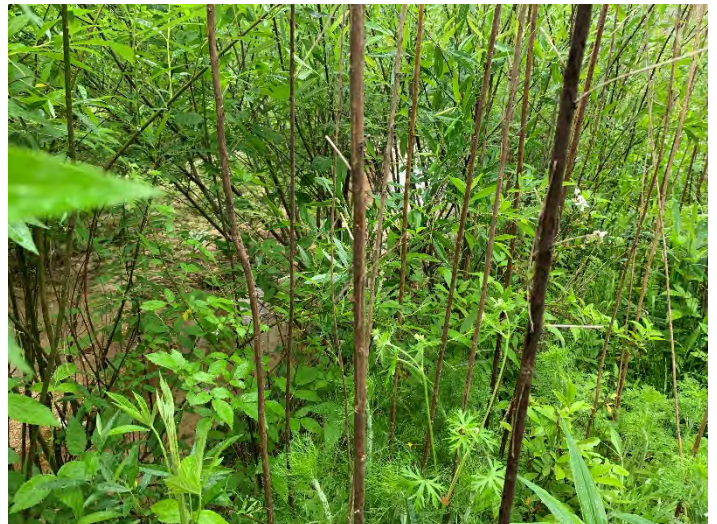
USEC R5 Photo Point 65 – view downstream (5/6/2020)

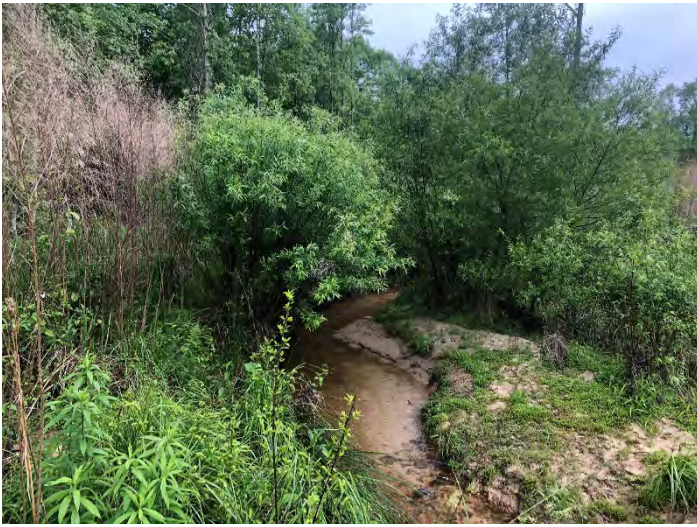
USEC R5 Photo Point 66 – view upstream (5/6/2020)

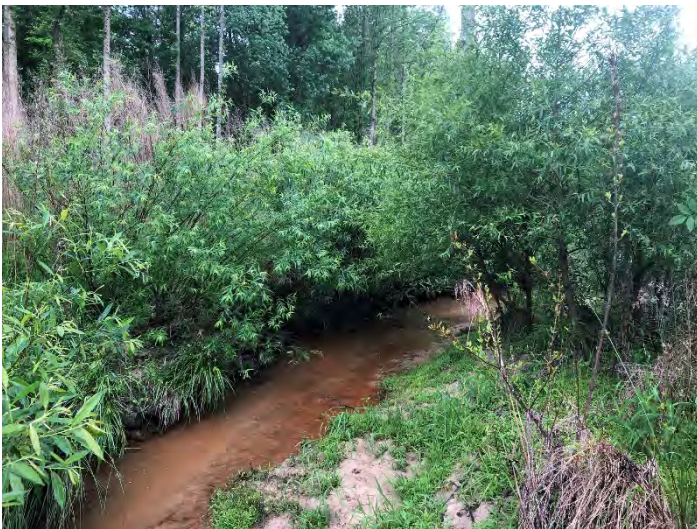
USEC R5 Photo Point 67 – view upstream (5/6/2020)

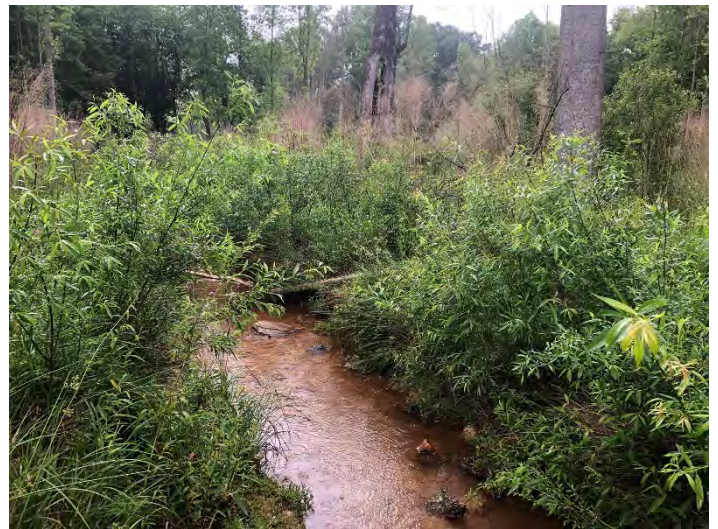
USEC R5 Photo Point 67 – view downstream (5/6/2020)

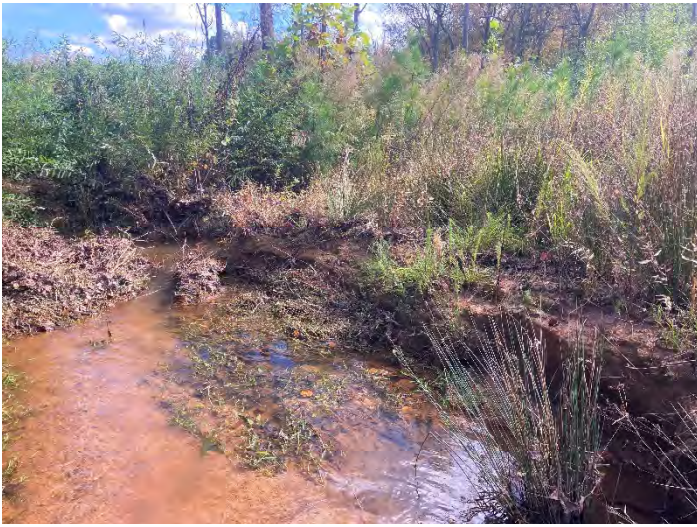
UBHC R2B Bank Scour (STA 137+33 – 137+67) – view downstream
(10/22/2020)

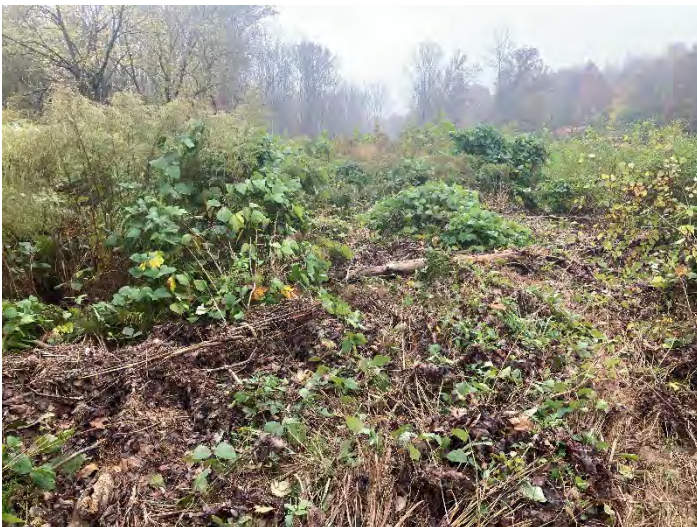
LBHC R1A Kudzu – view downstream *(10/27/2020)*

Wildlands' Response: Wildlands will continue invasive treatments across the site.

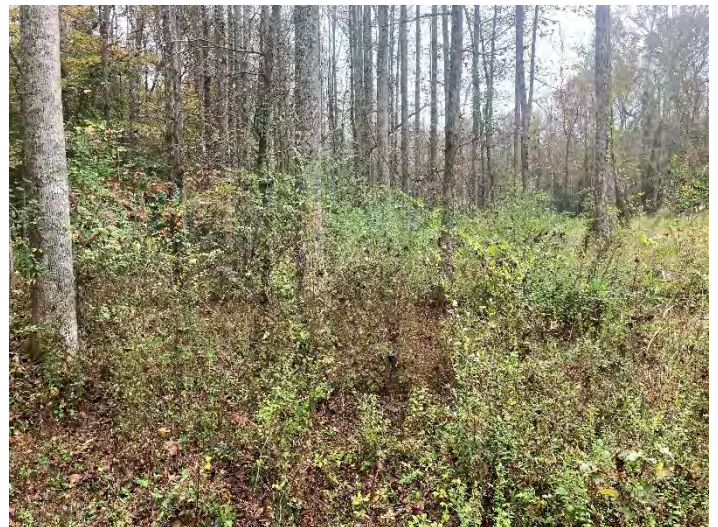
LBHC R2 Chinese Privet – view downstream *(10/27/2020)*
