As-built report for the AH&W Mitigation Site Big and Little Warrior Creeks Wilkes County

As-built report for the AH&W
Mitigation Site, Big and Little Warrior
Creeks, Wilkes County

North Carolina Wildlife Resources Commission

February 24, 2003

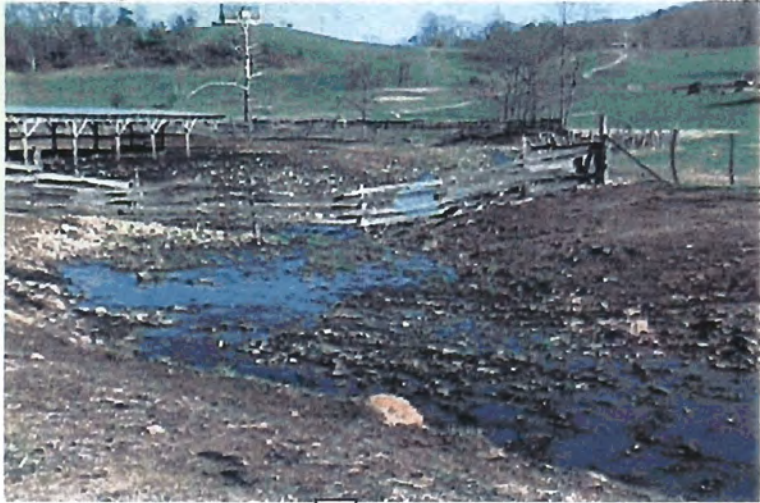
Big Warrior Creek before construction, 12/9/98

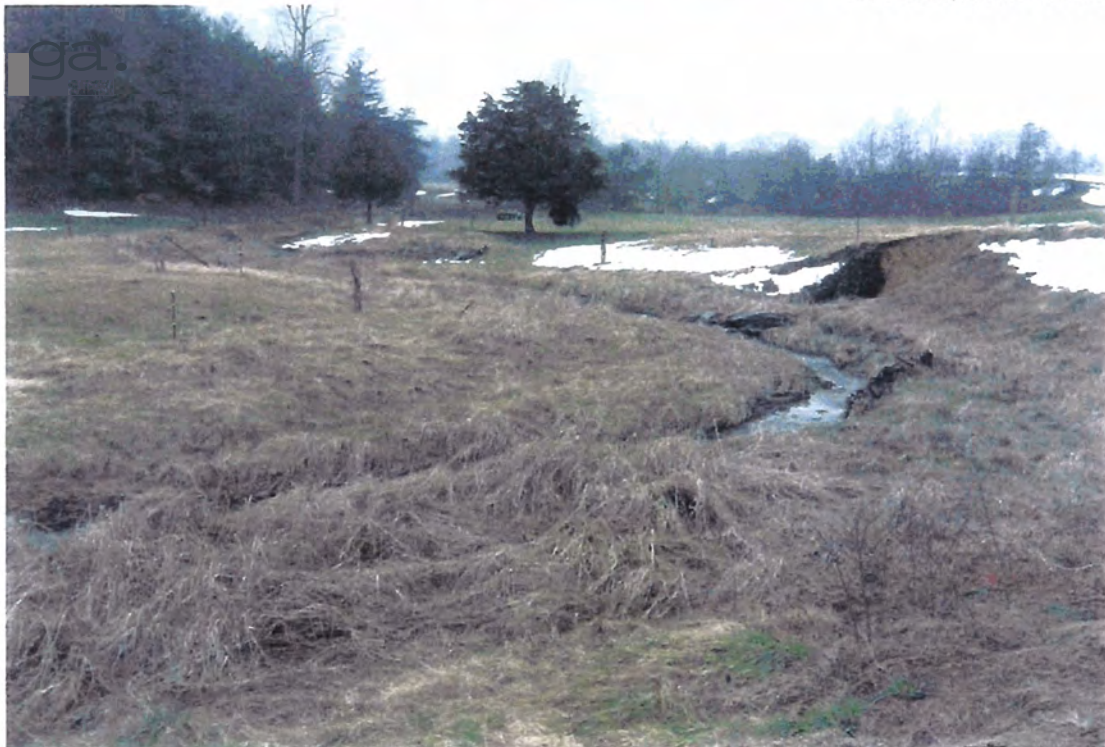
DSC00249, 3/1/30

Reach showing the high clay bank and above, in the lower pasture, on Big Warrior Creek. Photo is taken from the top of the bank looking upstream. This is series 8 from the BWC reference photos.

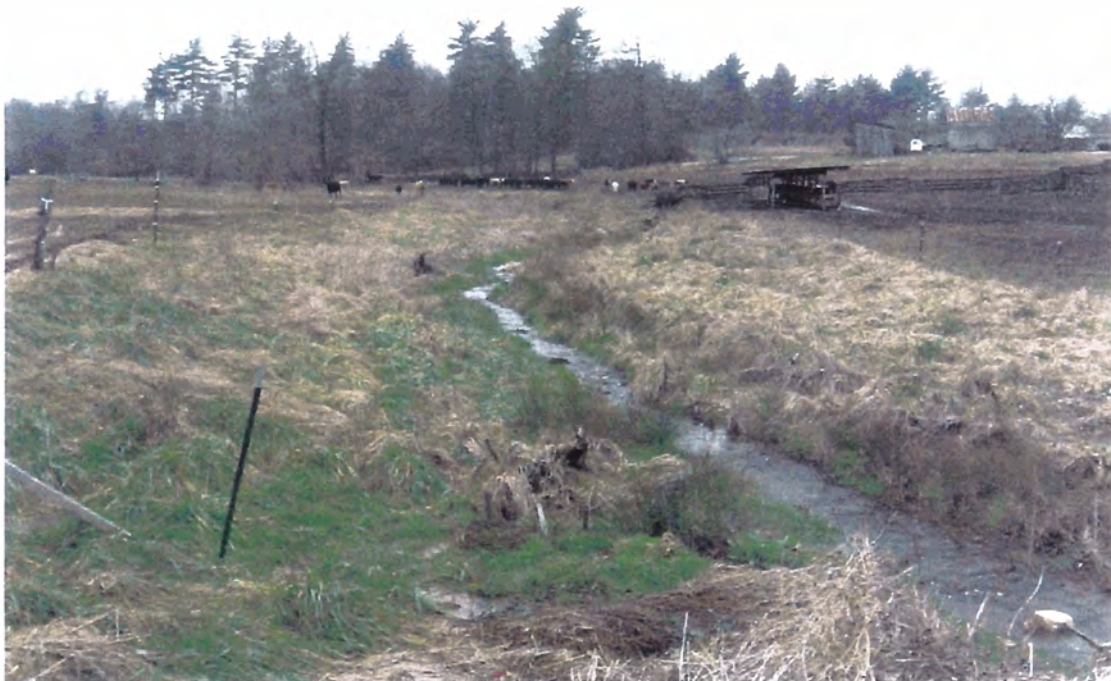
DSC00266, 3/1/30

Reach is in the middle of the feedlot, on Big Warrior Creek. Photo is taken from the right bank, just below survey point 1A44, looking upstream. This is series number 27 from the BWC reference photos.

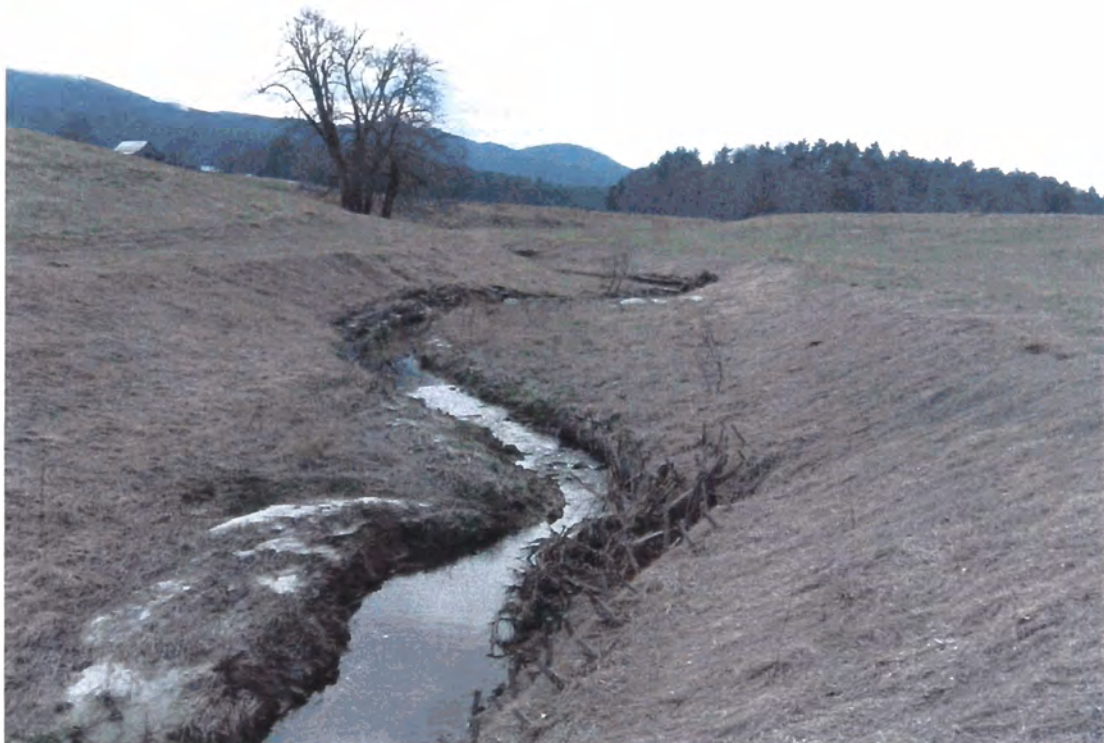
DSC00320, 03/1/31

Reach is **the** lower end of the lower pasture, on Little Warrior Creek. Photos are taken from just upstream of survey point 2A38 looking upstream. This is series number 4 from the LWC reference photos.
