**MONITORING YEAR 3, 4, AND 5 REPORT**  
**BOWLIN-PEAK CREEK MITIGATION SITE**

Ashe County, North Carolina

EEP Project Number: 92606  
Contract Number: D06082; Task Order: 06NW01-1

Period Covered: July 2009 - June 2012

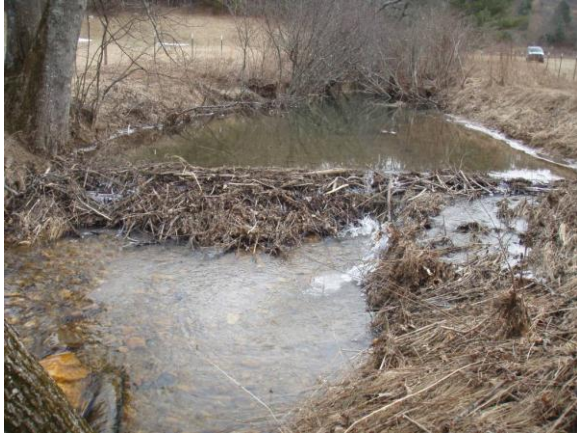
Two high priority stream problem areas were identified in MY4. On 3 Feb 2011, a beaver dam was identified at station 6+22 (Appendix B Section 1: photo SPA MY4-1). The dam caused sediment to fill in the pool behind the dam and backed water up to station 4+18. The dam was removed on 19 April 2011. The second high priority problem area in MY4 and subsequently identified in MY5, consisted of 30 lf of a left eroding stream bank at the meander bend at station 11+20 (Appendix B Section 1: photo SPA MY4-4). This was caused by at least one greater than bankfull storm event during the winter of 2010-2011. In addition to the bank erosion, the storm event caused the elevation of the head of the riffle at station 11+44 to increase 0.7 ft, submerging the log vane at station 11+11. The log vane no longer functions properly.

A beaver dam at station 6+22 was identified during the MY4. The stream channel elevation increased 1.7 ft at the beaver dam in MY4. The stream channel aggraded in the pool behind the beaver dam and at a pool located at station 3+02. In addition, the stream channel thalweg elevation decreased approximately 1.9 ft in MY4, a decrease of approximately 2.3 ft from the as-built condition in the pool downstream of the beaver dam at station 6+44. The deepening pool in itself is not a concern; however, the additional bank scouring may have contributed to the instability of the log cross-vane at the head of the pool (SPA MY4-2) by undermining the footer on the right bank. After the beaver dam was breached, the MY5 survey indicated the stream channel elevation at the beaver dam decreased 1.5 ft. However, the stream channel elevation for the pool at station 3+02 did not change. The stream channel at station 3+02, a pool aggraded in MY4 and remained shallow in MY5. The thalweg elevation increased approximately 0.4 ft in MY5 in the pool below the beaver dam.

SPA MY4-1, beaver dam, 3 Feb 11.

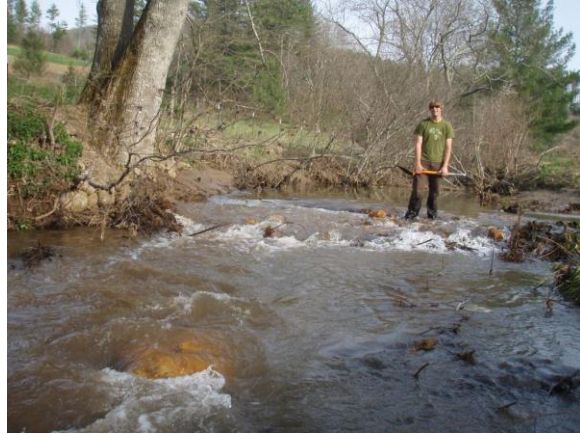
SPA MY4-1, after removal of beaver dam, 19 Apr 11.

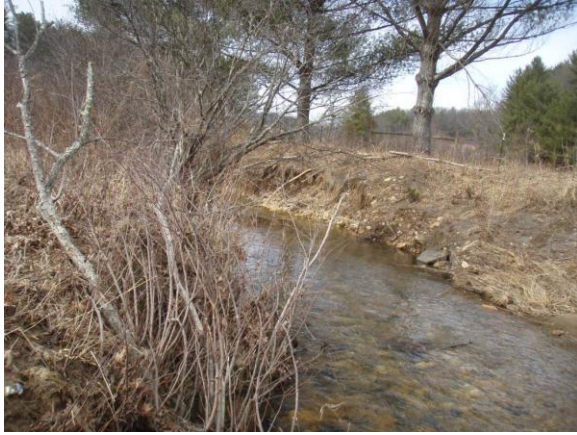
In MY4, approximately 30 lf of the stream channel migrated to the right starting at station 11+20. This was caused by at least one greater than bankfull storm event during the winter of 2010-2011. In addition to the bank erosion, the storm event caused the elevation of the head of the riffle at station 11+44 to increase 0.7 ft, submerging the log vane at station 11+11. The pool's thalweg elevation at station 11+20 increased by approximately 0.7 ft and a new pool was created downstream at station 11+52. The log vane was still submerged in MY5; however, the pool's thalweg elevation at station 11+20 decreased 0.5 ft, almost back to the MY3 elevation. The new pool at station 11+52 was still present in MY5 and appeared stable.

SPA MY4-4, right bank migration, 3 Feb 11.

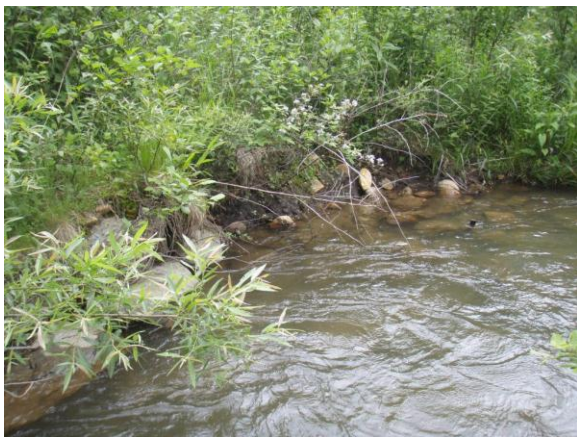
SPA MY5-4, eroding left bank, 21 May 12.

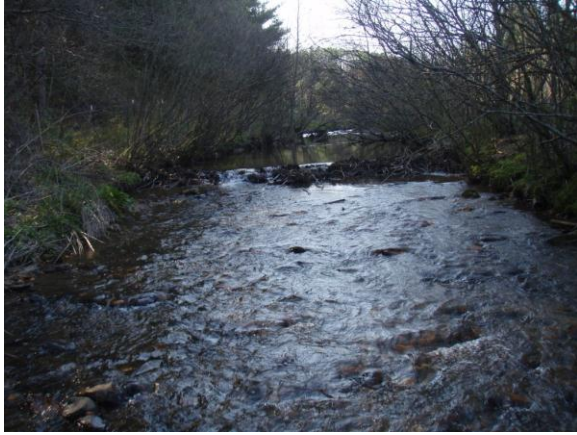
On 9 April 2012, a beaver dam was identified at station 18+11. The dam caused sediment to fill in the pool behind the dam and backed water up to station 16+75. The dam was removed on 29 May 2012 and the fine sediment appeared to be flushing out of the pool.

A beaver dam was identified at station 18+14 in MY5. The stream channel elevation increased 0.7 ft at the beaver dam and caused sediment to fill in the pool behind the dam. The beaver dam backed water up to station 16+75 submerging a pool and riffle. The dam was removed after the MY5 morphological survey.

SPA MY5-6, beaver dam, 10 Apr 12.

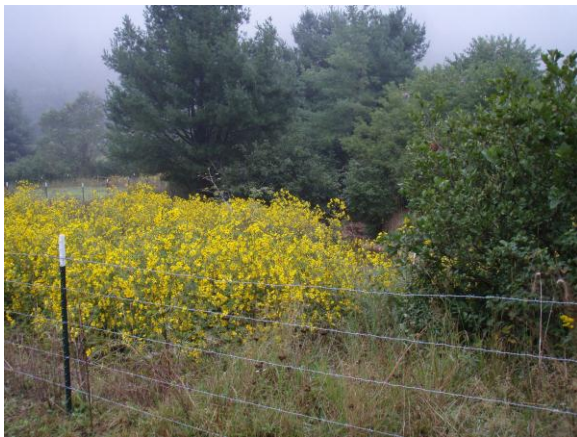
PS-5, bearing 45°: 26 Mar 08. Note: stream channel moved to the right.

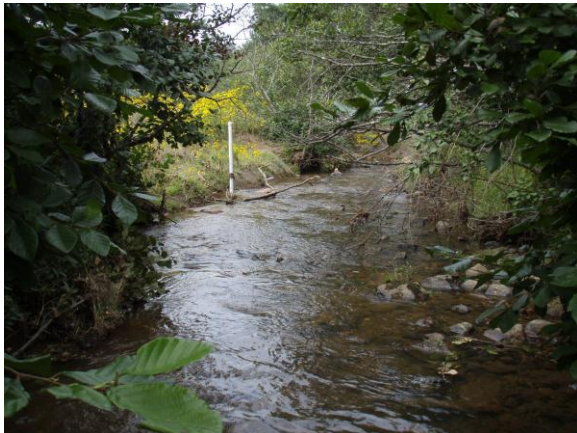
PS-7, bearing 320°: Post-construction view of cross-section 4 at station 10+43 looking down stream; 08 Jan 08.

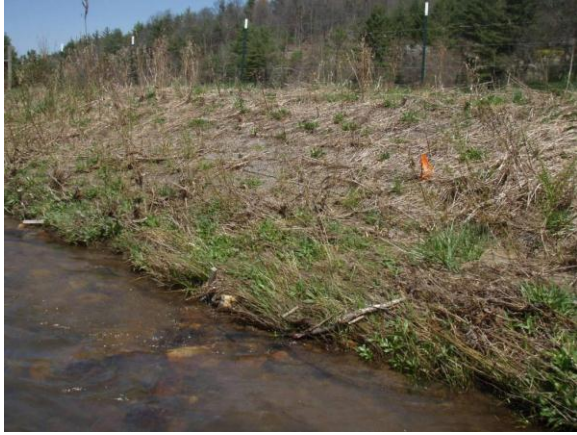
BF1, orange flag identifies top of rack line:  
12 Apr 10.

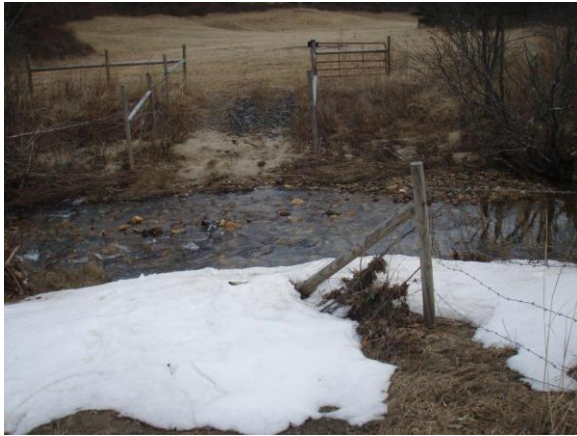
BF3, sediment and rack line on ford:  
03 Feb 11.

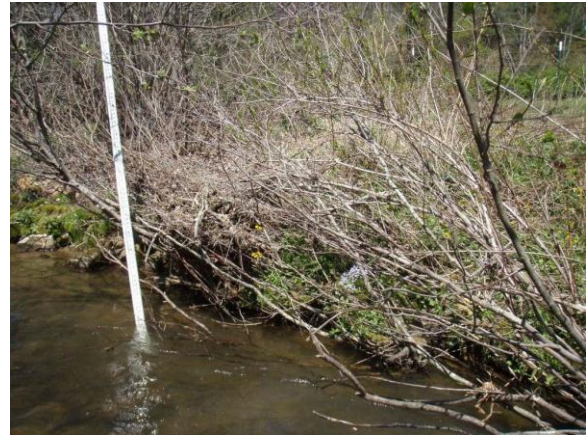
BF4, rack line on vegetation: 09 Apr 12.

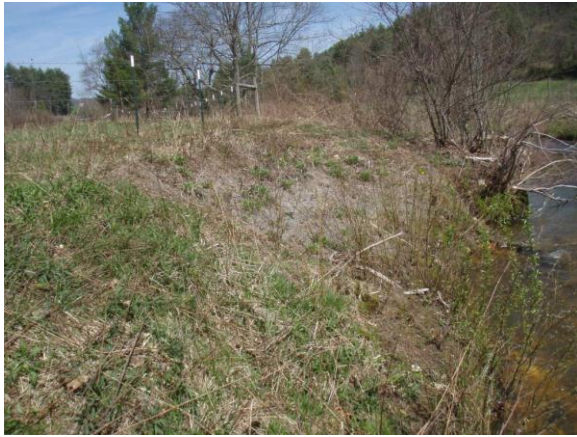
VPA MY4-1, 14 Apr 11.

Vegetation Problem Areas				
Identification	Feature/Issue	Station Number/Range	Suspected Cause	Photograph Number
MY4				
VPA MY4-1	Left stream bank	2+20 - 2+40	Beavers	VPA MY4-1
VPA MY4-2	Right stream bank	3+00 - 4+15	Beavers	VPA MY4-2
VPA MY4-3	Left stream bank	4+40 - 4+60	Beavers	VPA MY4-3
VPA MY4-4	Left stream bank	4+90 - 5+15	Beavers	VPA MY4-4
VPA MY4-5	Left stream bank	5+80 - 6+50	Beavers	VPA MY4-5
MY5				
VPA MY5-1	Left stream bank	2+20 - 2+40	Previous beaver activity	VPA MY5-1
VPA MY5-2	Right stream bank	3+75 - 4+15	Previous beaver activity	VPA MY5-2
VPA MY5-3	Left stream bank	4+40 - 4+60	Previous beaver activity	VPA MY5-3
VPA MY5-4	Right stream bank	16+75 - 17+60	Beaver activity	VPA MY5-4
