MY2 MONITORING REPORT

BRAHMA SITE

Alamance County, North Carolina

DMS Project No. 100092

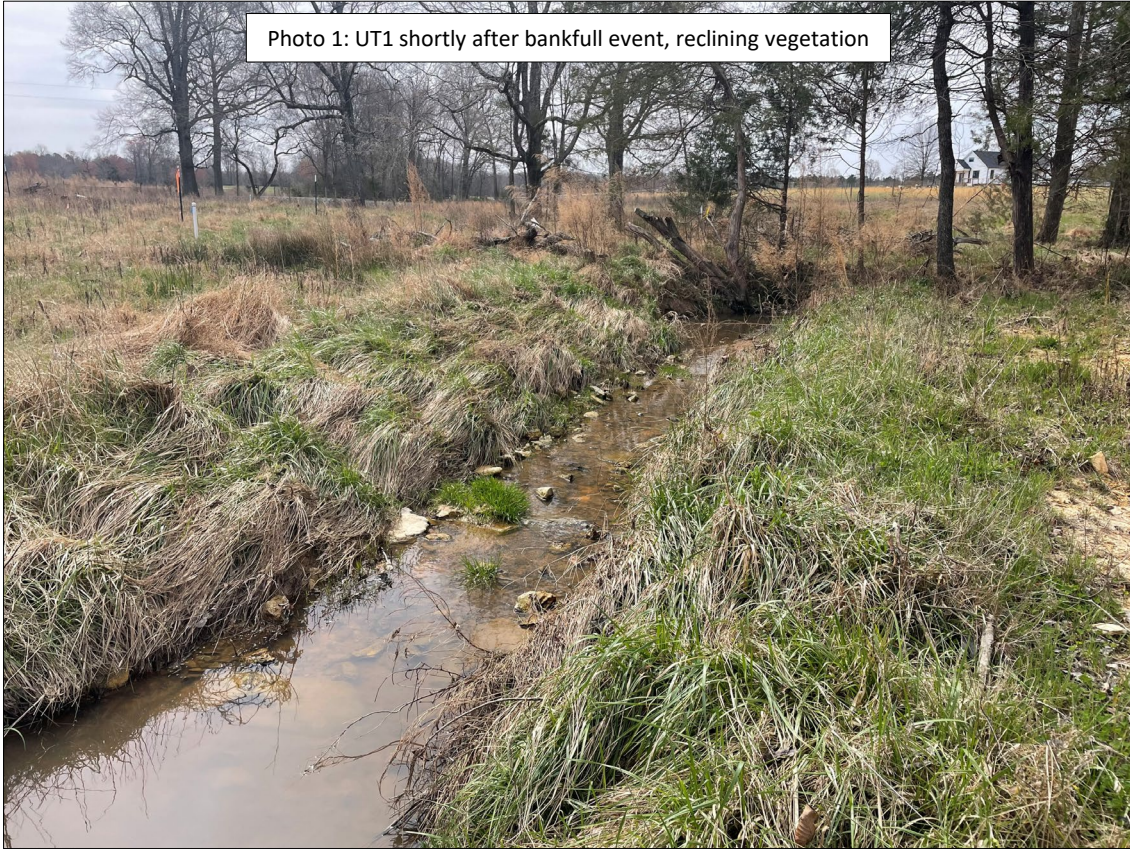
Photo 1: UT1 shortly after bankfull event, reclining vegetation

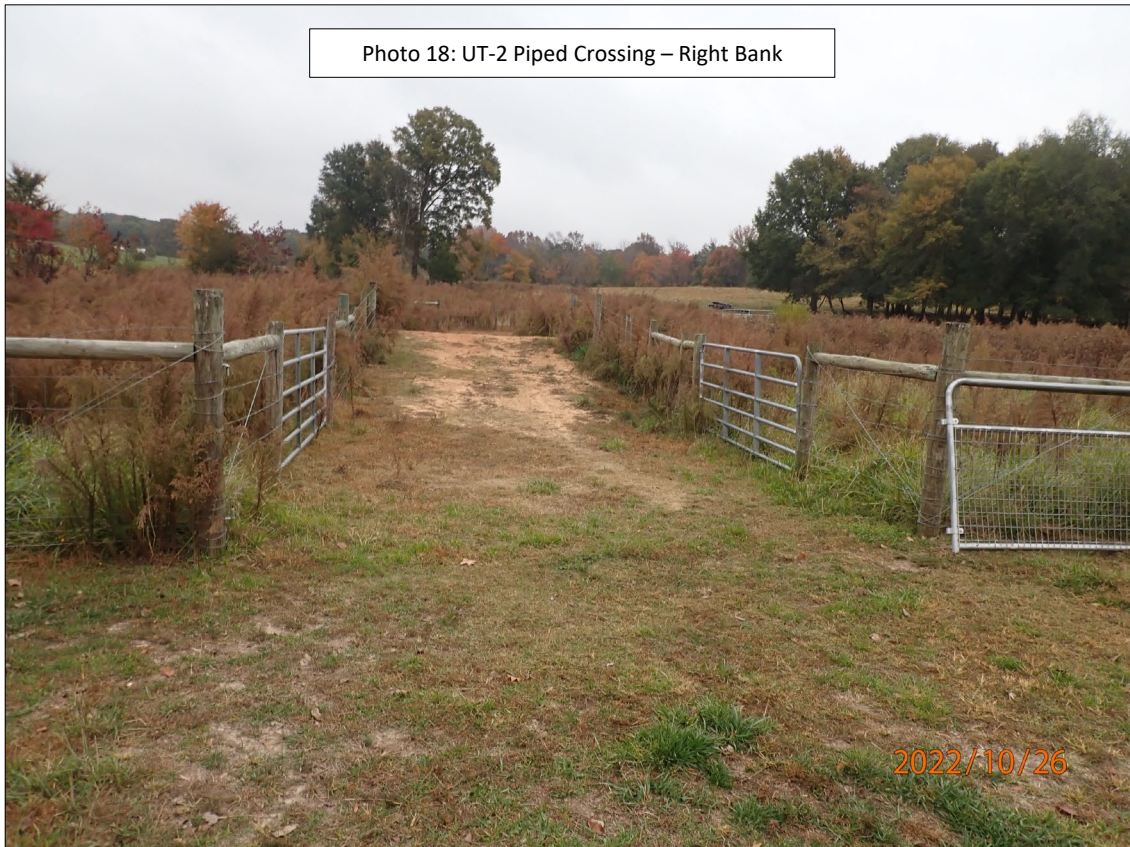
Photo 18: UT-2 Piped Crossing – Right Bank

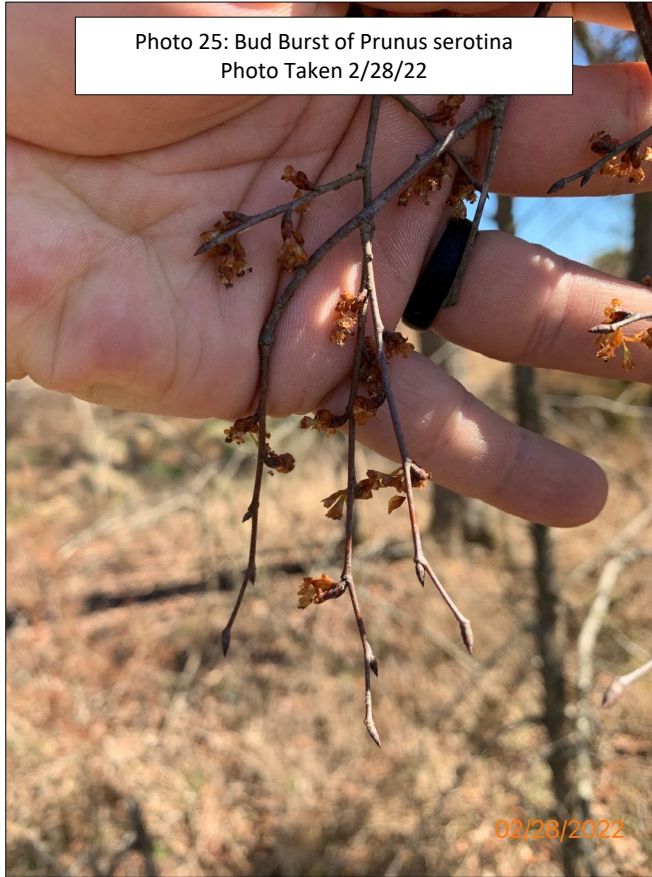
Photo 25: Bud Burst of *Prunus serotina*
Photo Taken 2/28/22

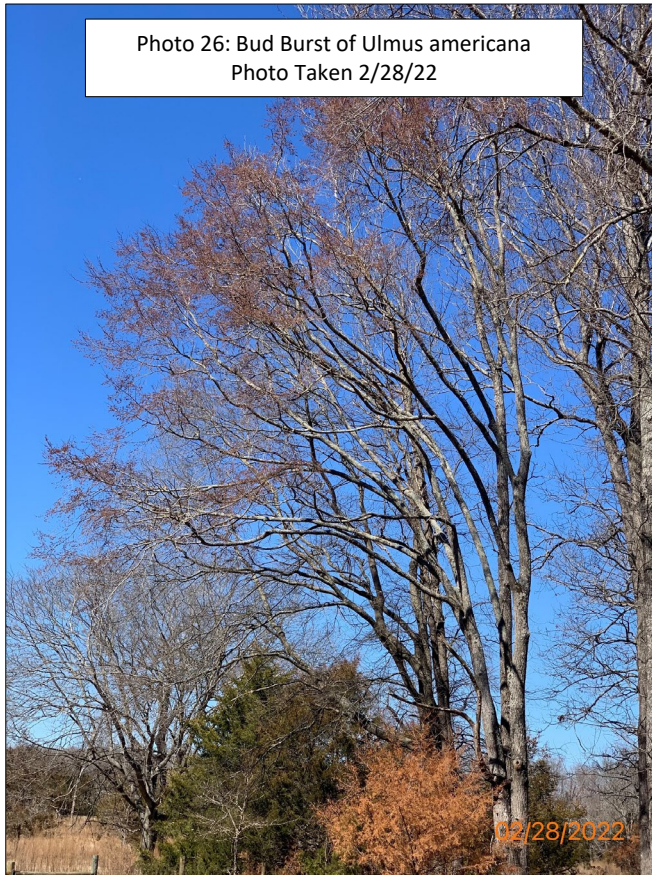
Photo 26: Bud Burst of *Ulmus americana*
Photo Taken 2/28/22
