# **MY3 FINAL MONITORING REPORT**

## **BRAHMA SITE**

Alamance County, North Carolina  
Cape Fear River Basin  
Cataloging Unit 03030002

DMS Project No. 100092  
Full Delivery Contract No. 7743  
DMS RFP No. 16-007571  
USACE Action ID No. SAW-2019-00126  
DWR Project No. 20190158

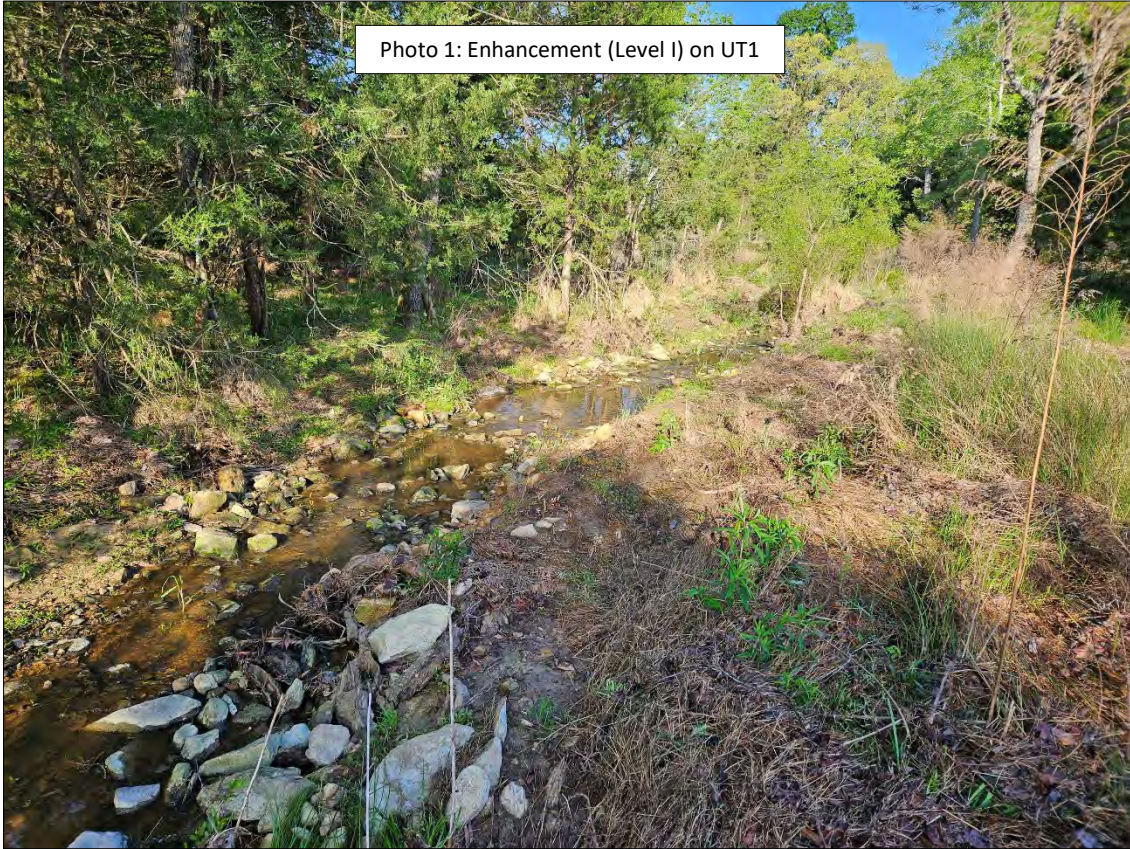
Photo 1: Enhancement (Level I) on UT1

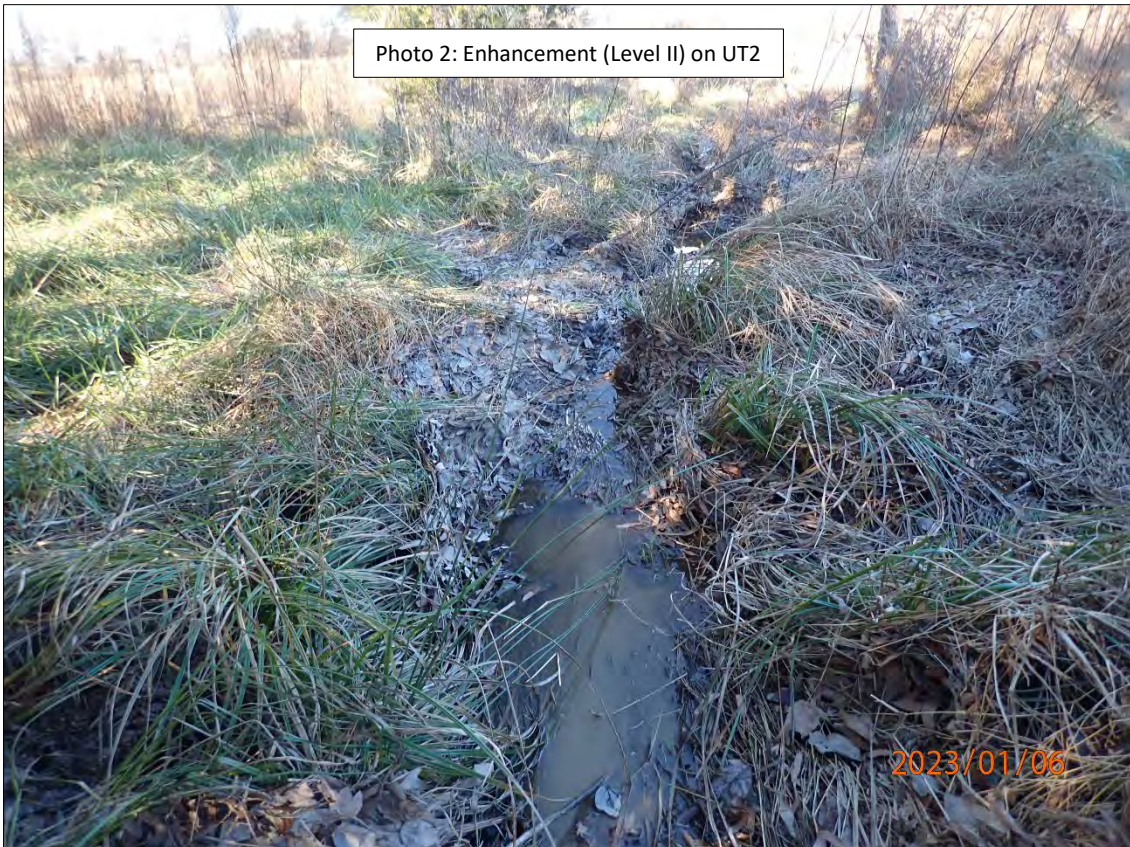
Photo 2: Enhancement (Level II) on UT2

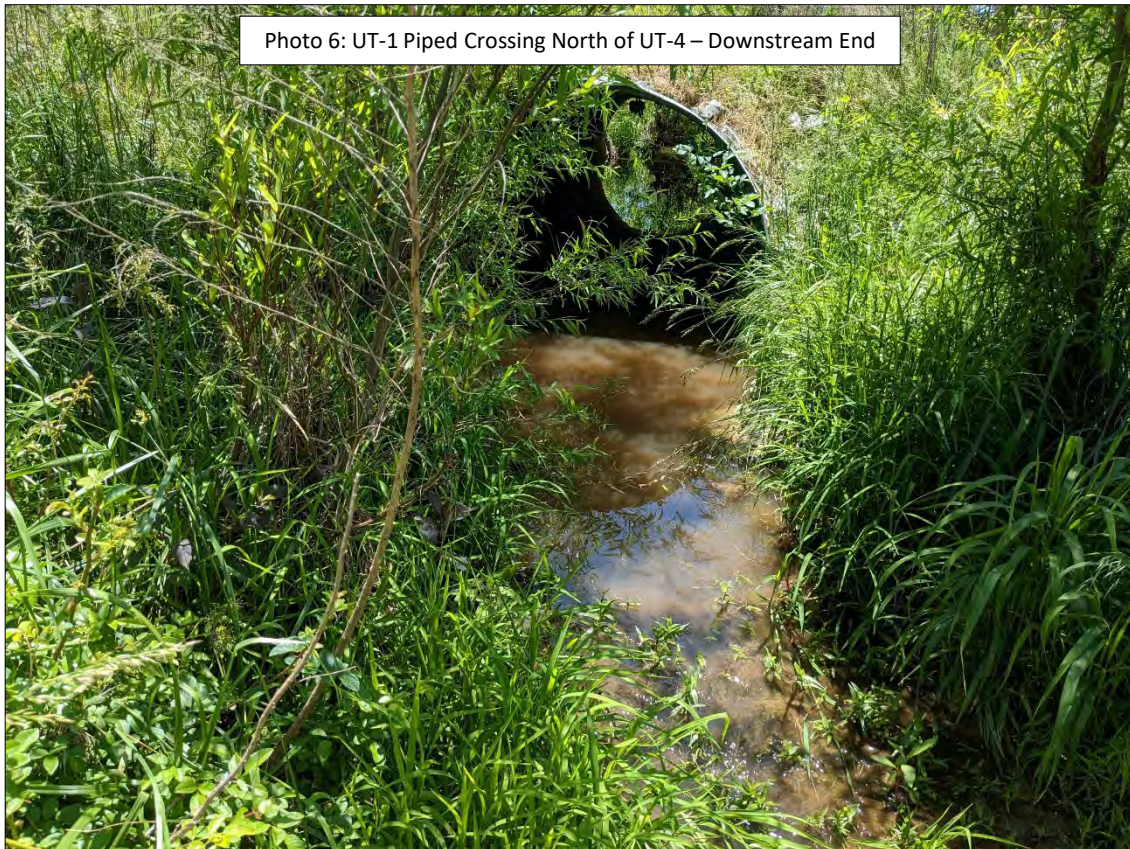
Photo 6: UT-1 Piped Crossing North of UT-4 – Downstream End

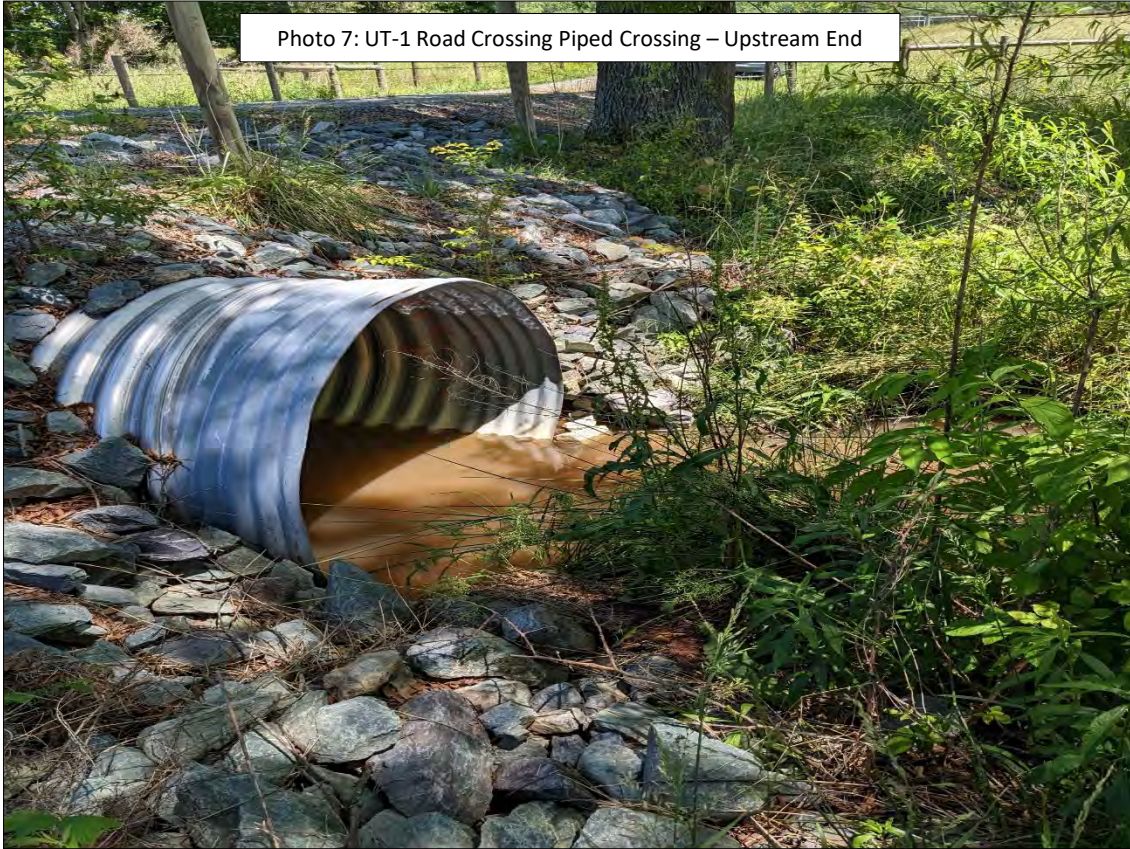
Photo 7: UT-1 Road Crossing Piped Crossing – Upstream End

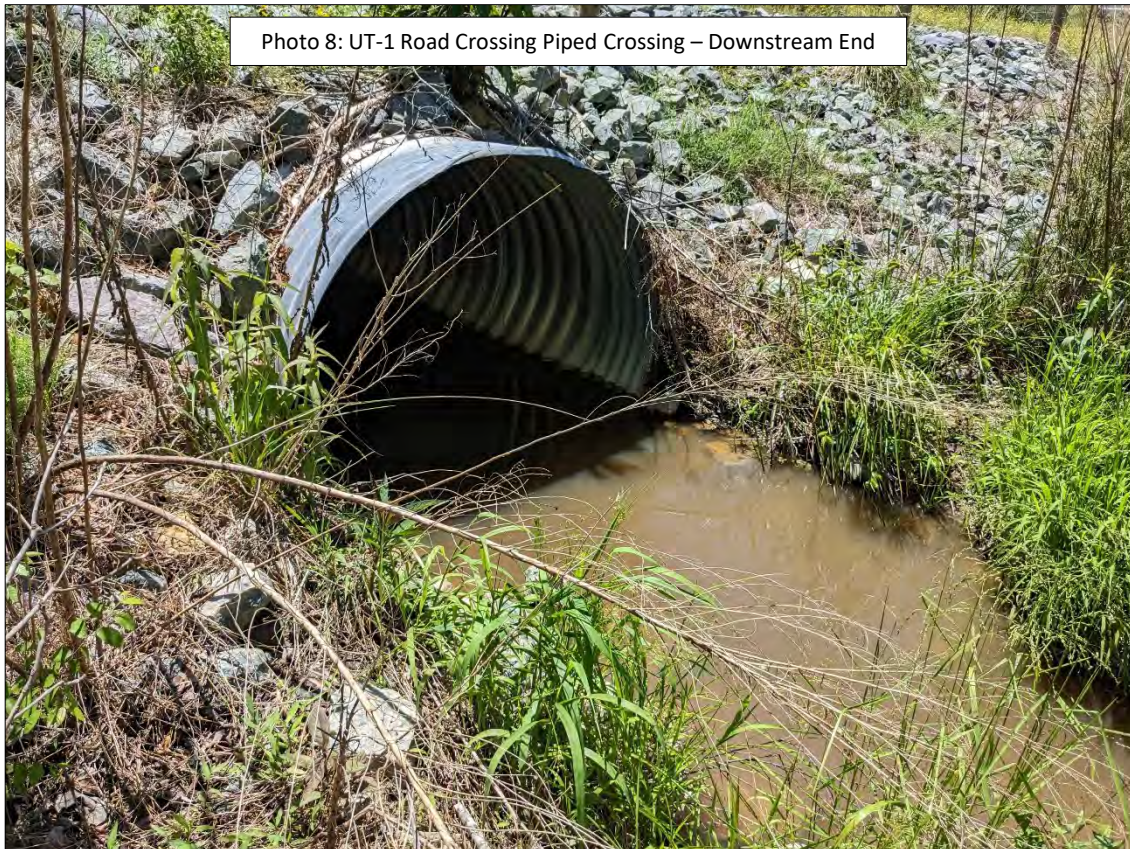
Photo 8: UT-1 Road Crossing Piped Crossing – Downstream End

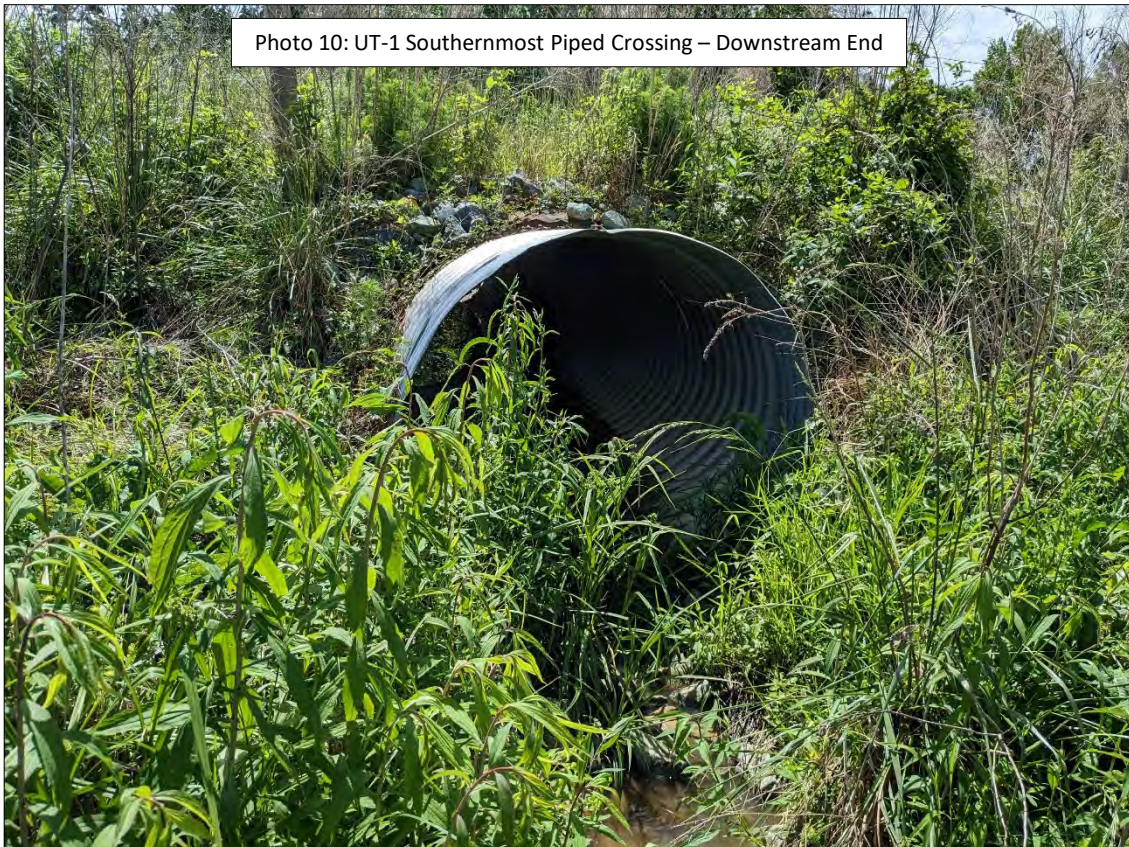
Photo 10: UT-1 Southernmost Piped Crossing – Downstream End

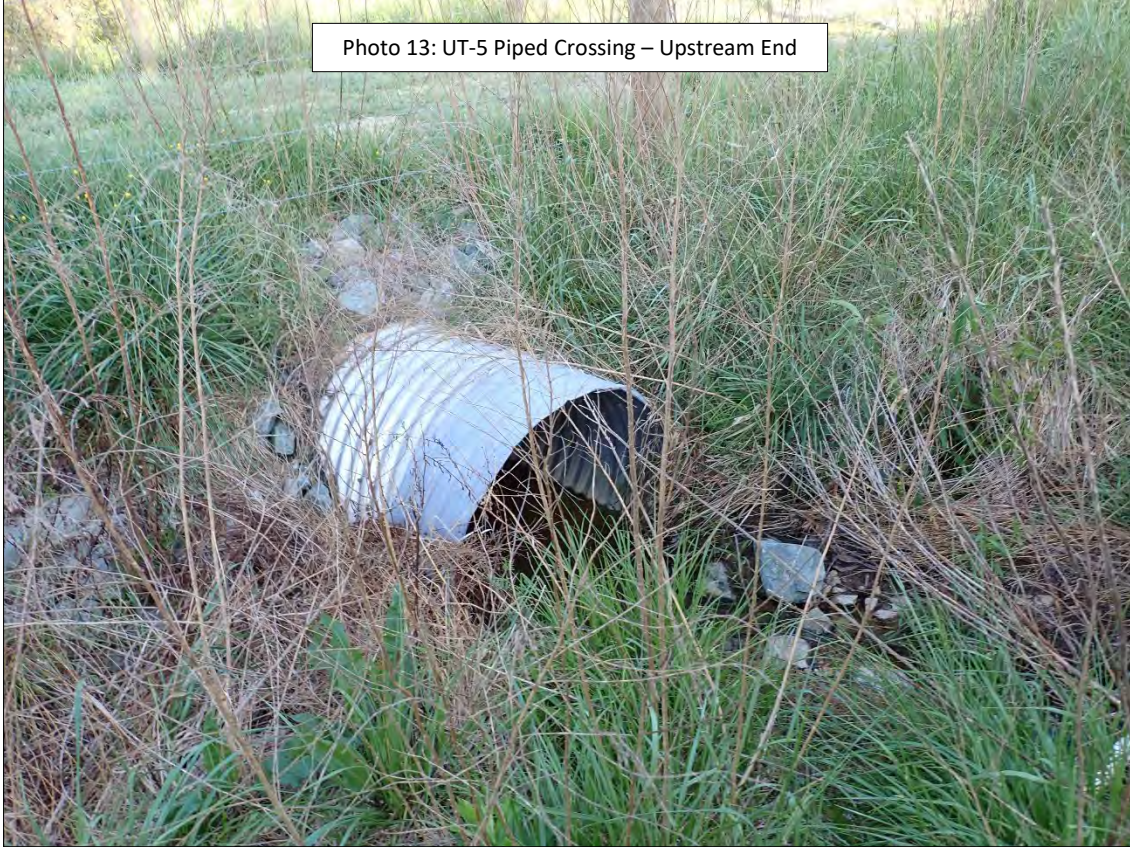
Photo 13: UT-5 Piped Crossing – Upstream End

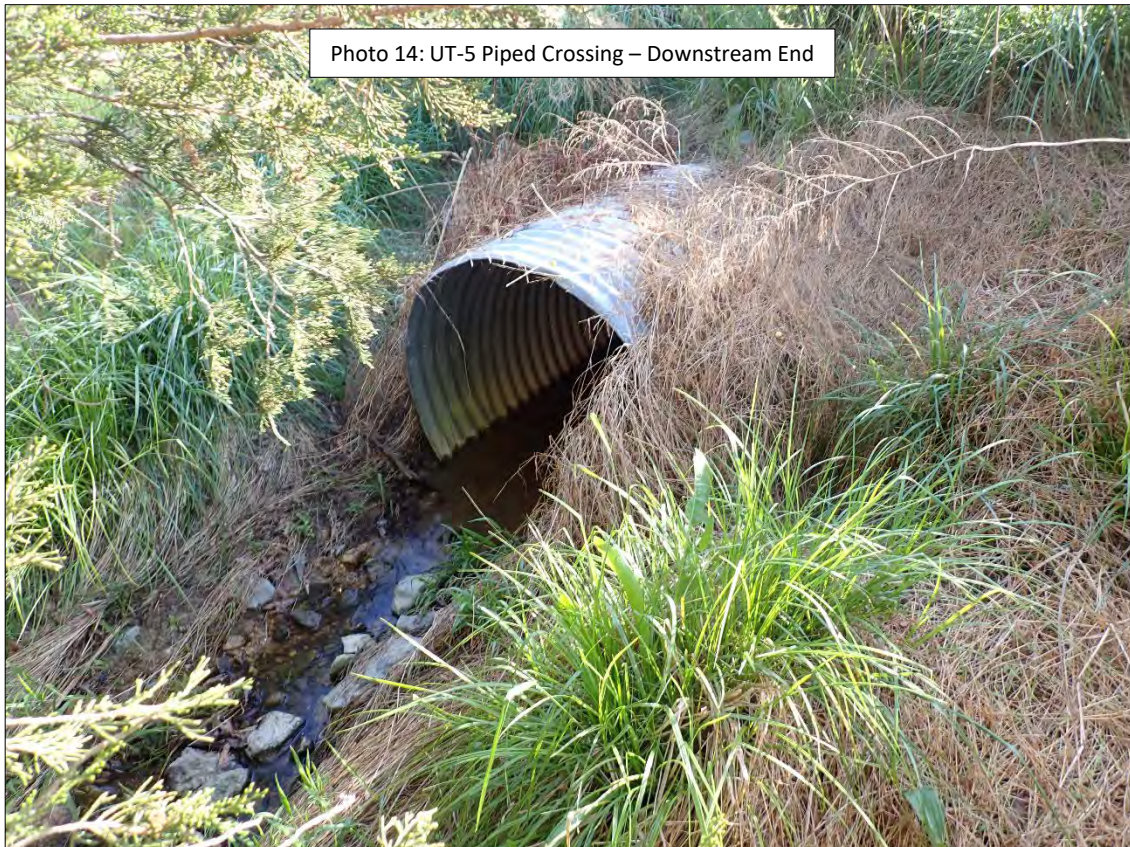
Photo 14: UT-5 Piped Crossing – Downstream End
