Briles Stream Restoration Monitoring Report Year 3 of 5 (2011) FINAL

Randolph County, North Carolina

Project ID No. 047

Submitted November 2011

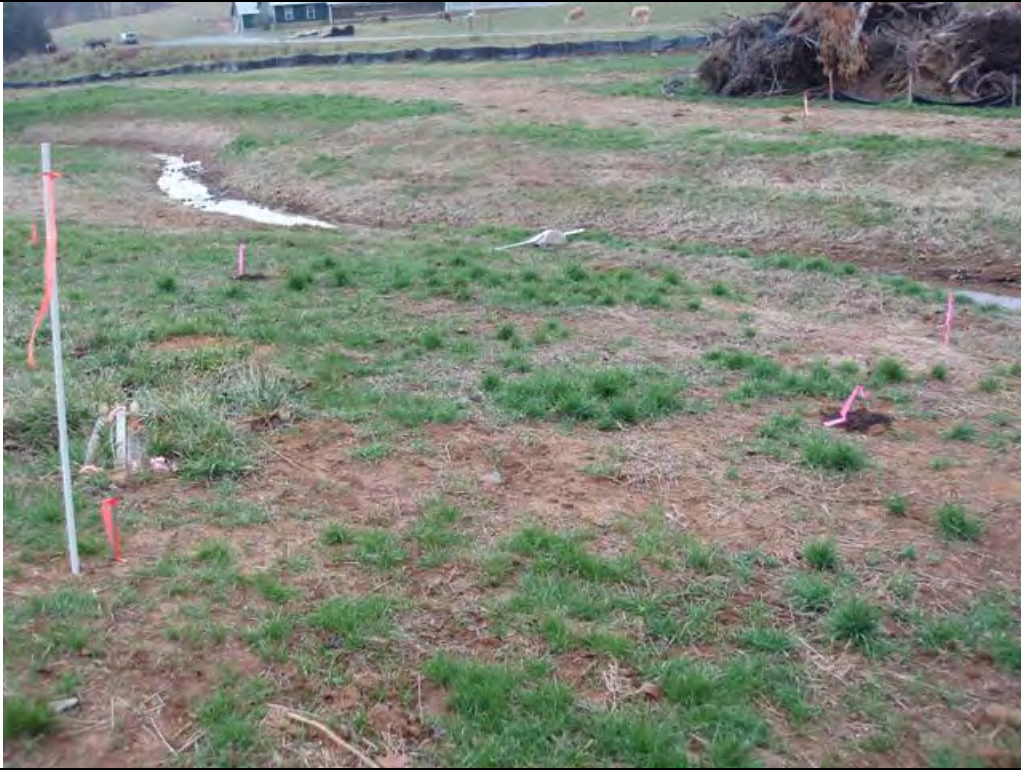
SP4: Bankfull indicator on Reach UTJC1
Taken: April 2011

Date of Data Collection	Date of Occurrence	Method	Photo # (if available)
7/6/2010	N/A	Rack lines observed along channel bank	
4/19/2011	N/A	Rack lines observed along channel bank	SP3/SP4

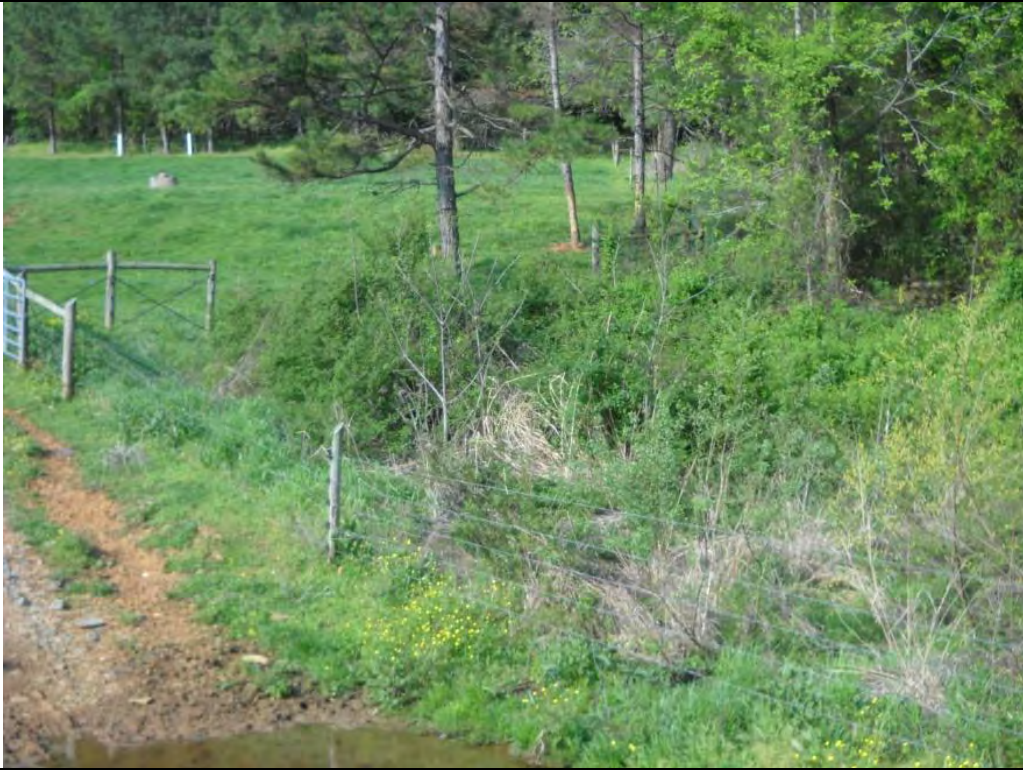
VP4: Multiflora Rose on Reach UTJC1
Taken: April 2011

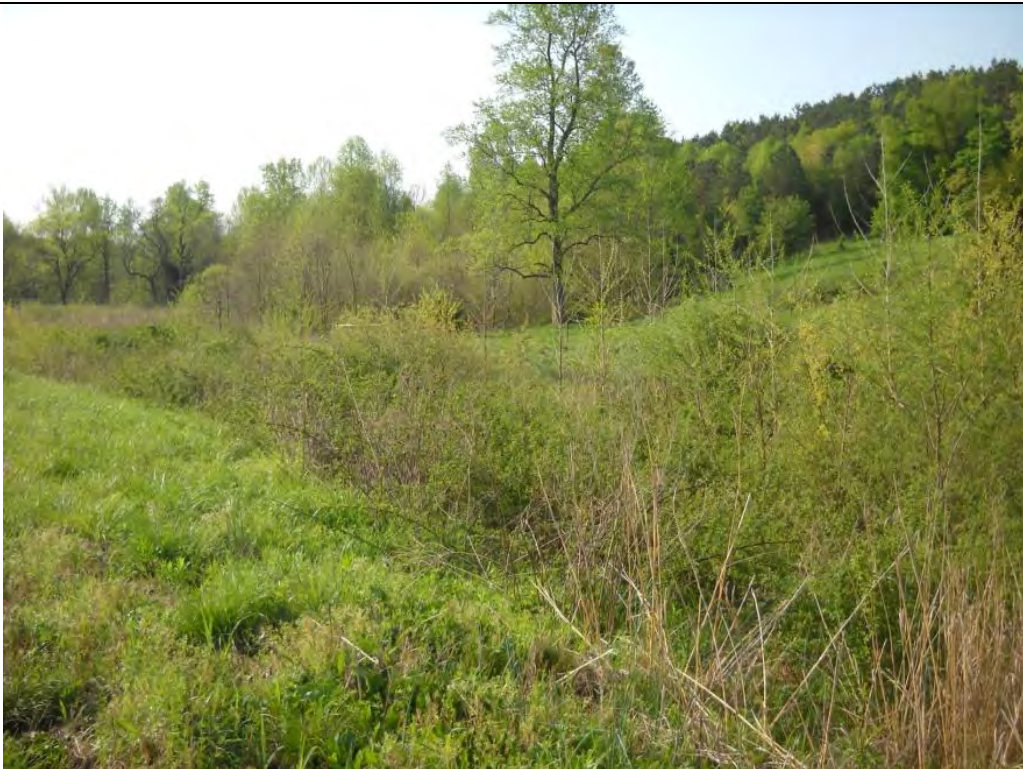
VP5: Multiflora Rose on Reach UTJC3
Taken: April 2011
