# **BROCK STREAM RESTORATION SITE Monitoring Year 2 (2010)**

**Jones County, North Carolina  
EEP Project No. 92333**

**Final Monitoring Report**

**March 2011**

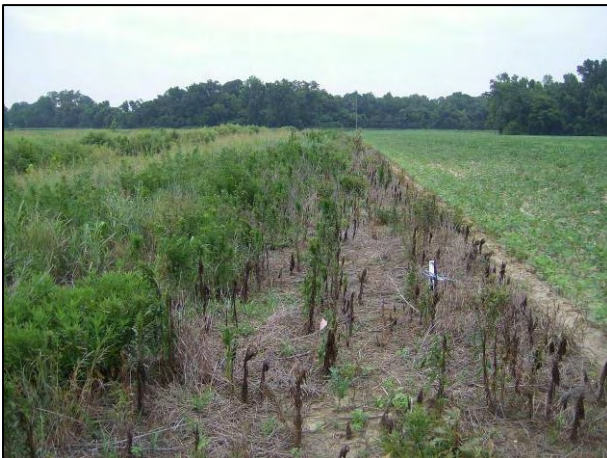
**Photostation 5.**  
Facing north across Vegetation Plot #2.  
Taken July 2010

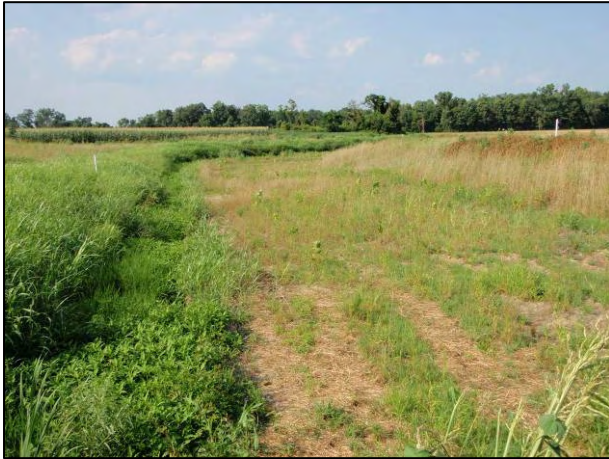
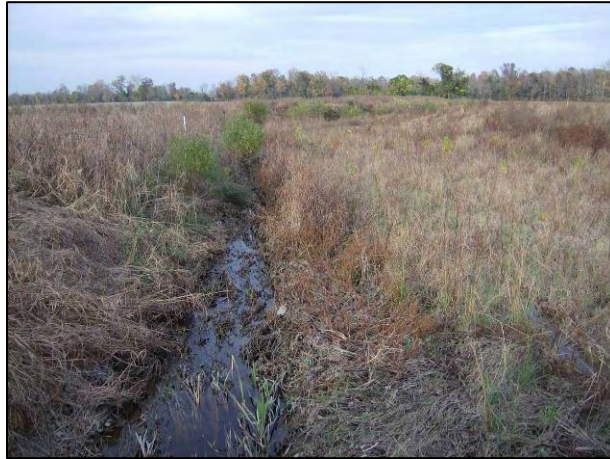
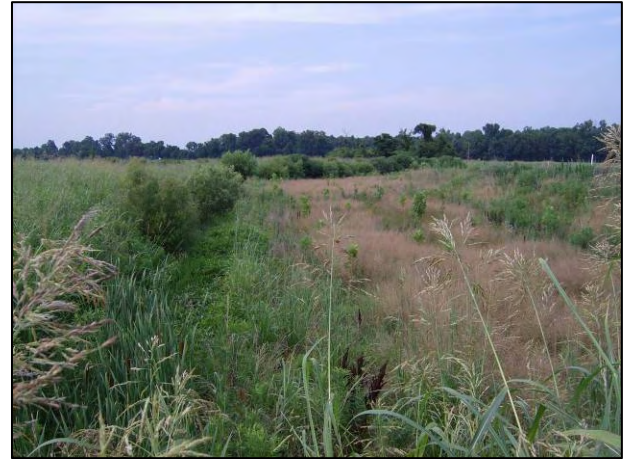
**Photostation #1:** Facing north from beginning of project at Station 10+00

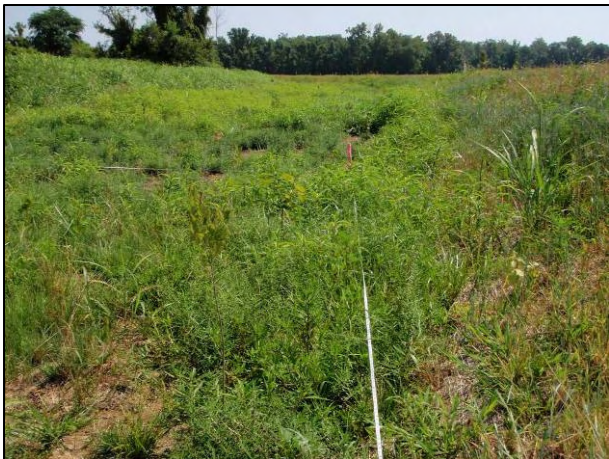
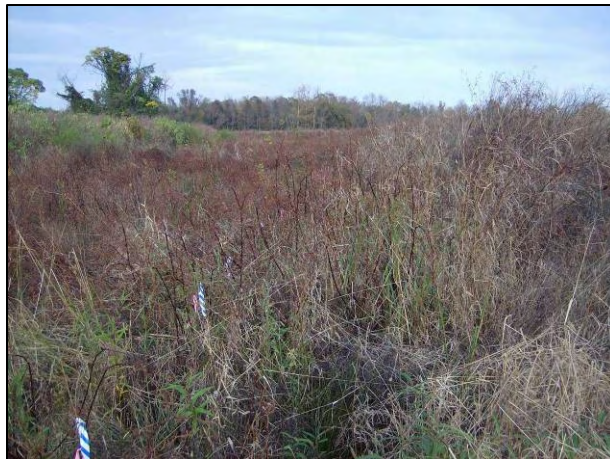
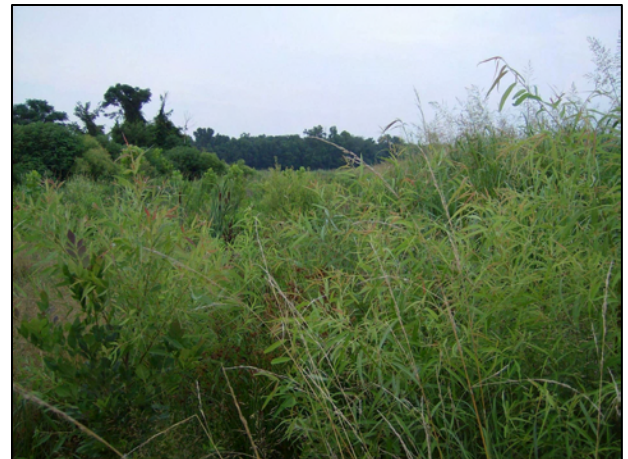
**Photostation #2:** Facing northeast along the eastern side of Vegetation Plot #1

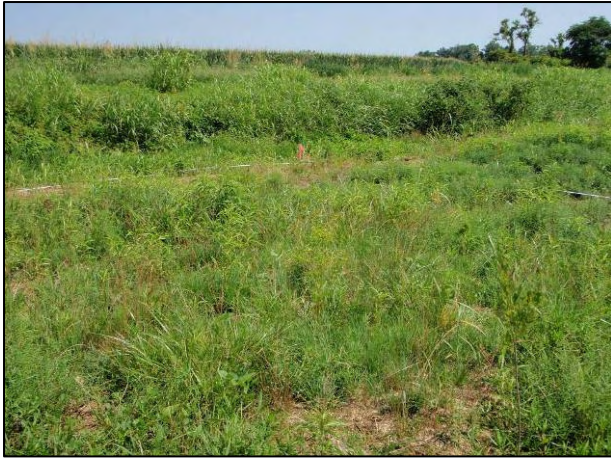
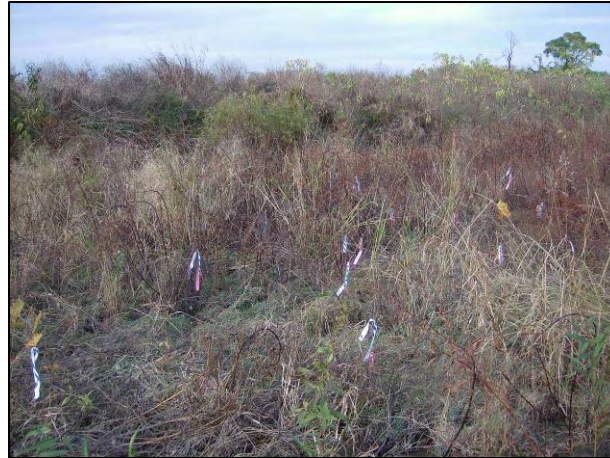
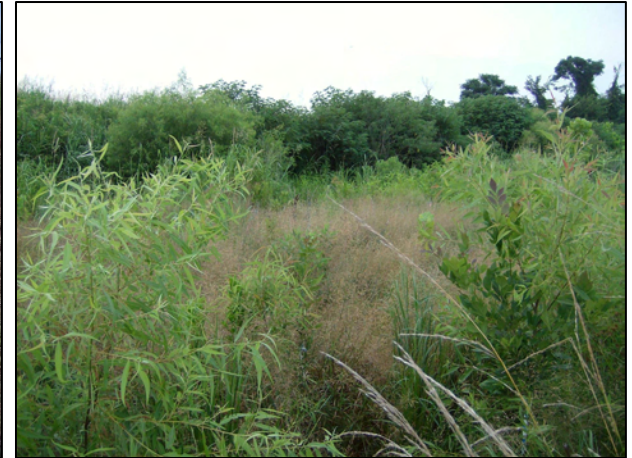
**Photostation #3: Facing north across Vegetation Plot #1**

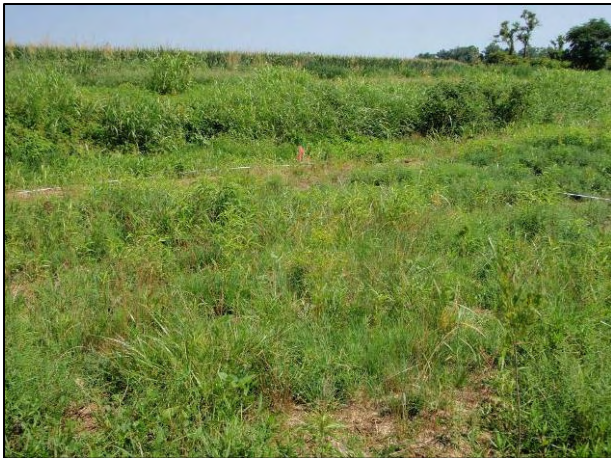
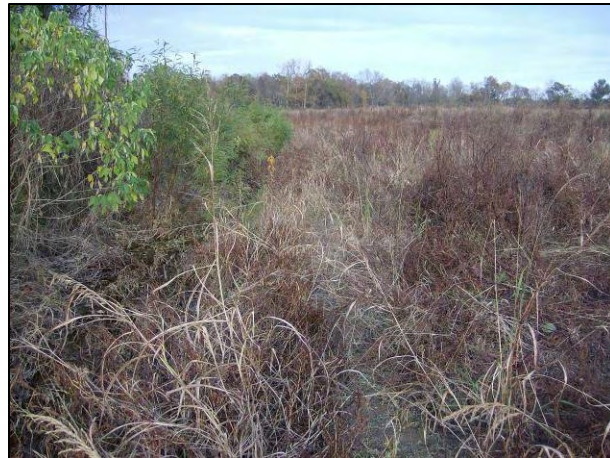
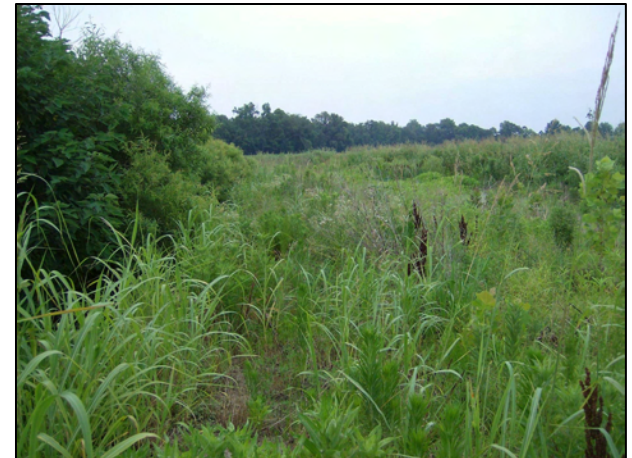
**Photostation #4: Facing downstream at Cross Section #1**

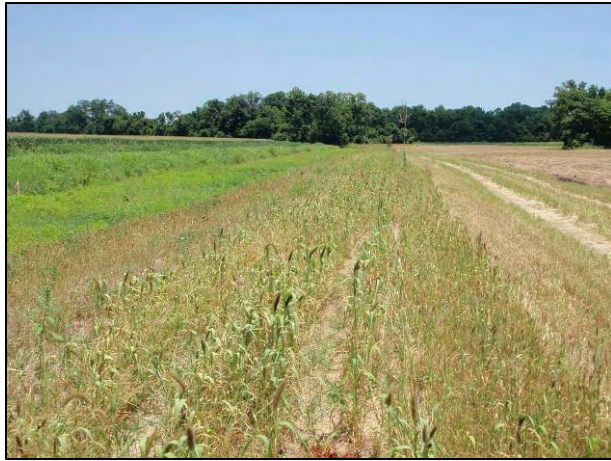
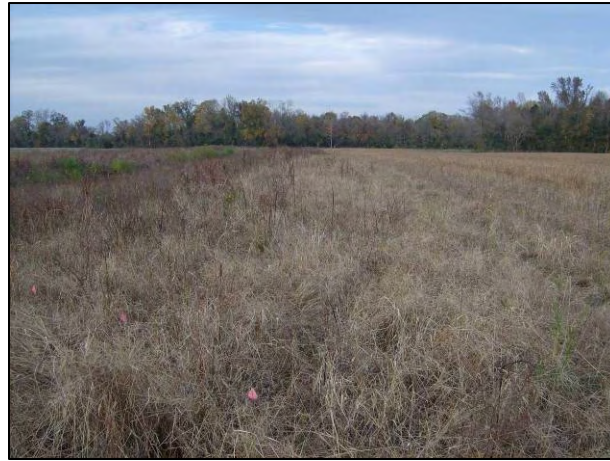
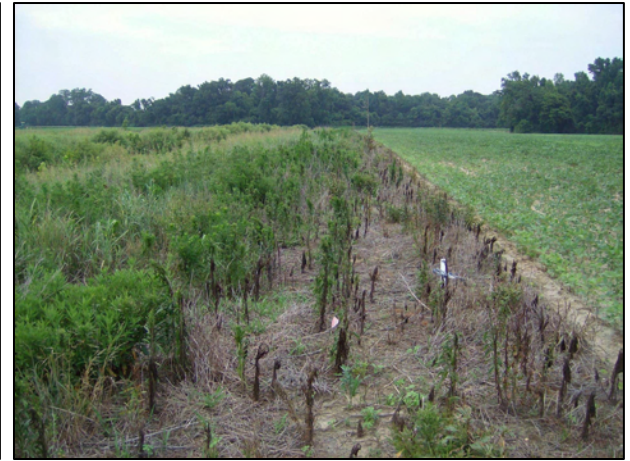
**Photostation #5: Facing northeast along the east side of Vegetation Plot #2**

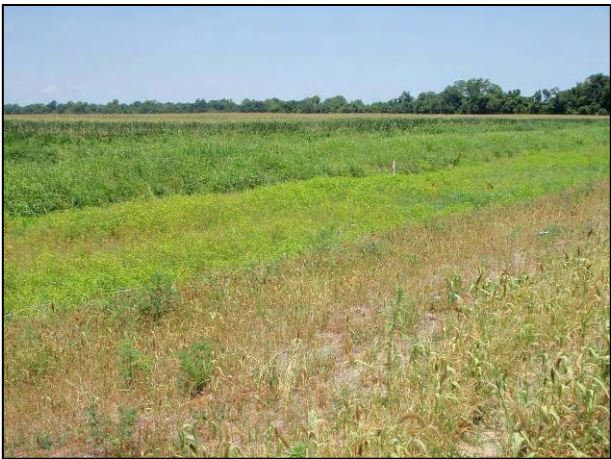
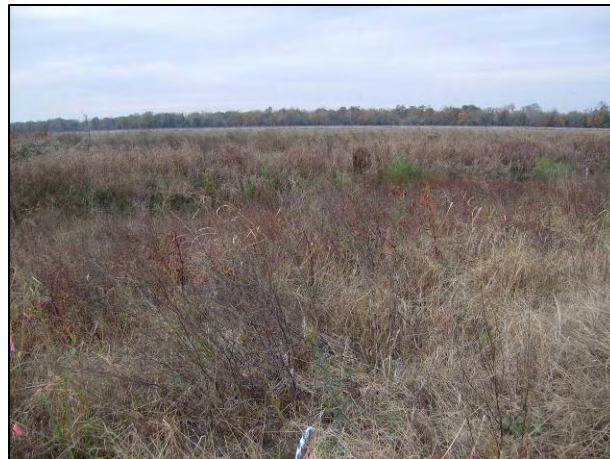
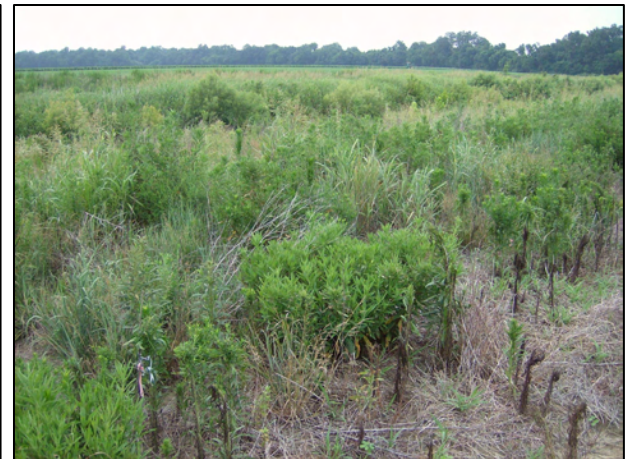
**Photostation #6: Facing northwest across Vegetation Plot #2**

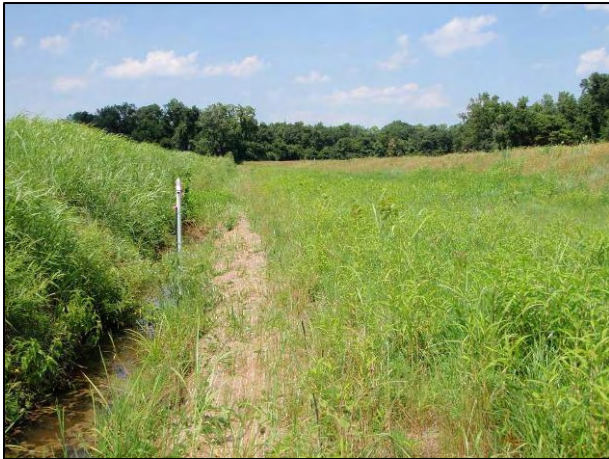
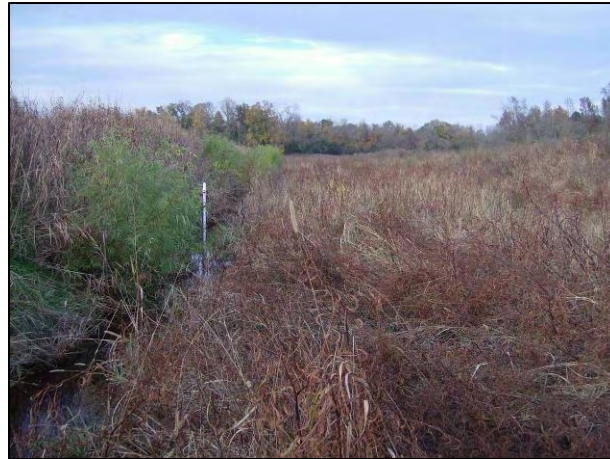
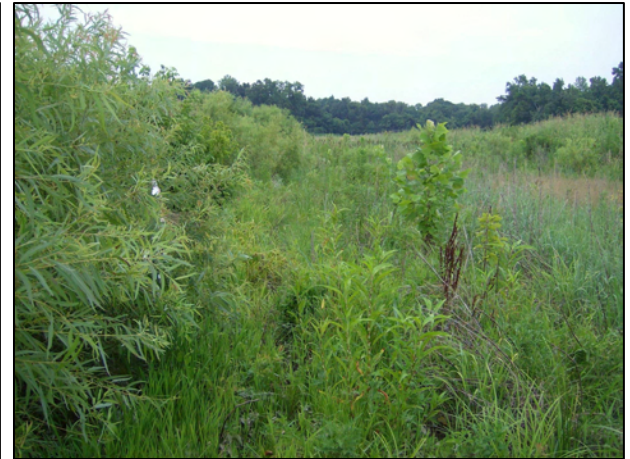
**Photostation #7:** Facing north-northeast at Crest Gage situated near Station 18+65

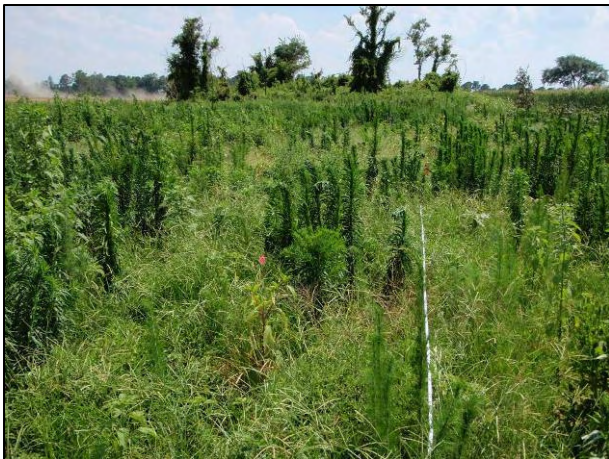
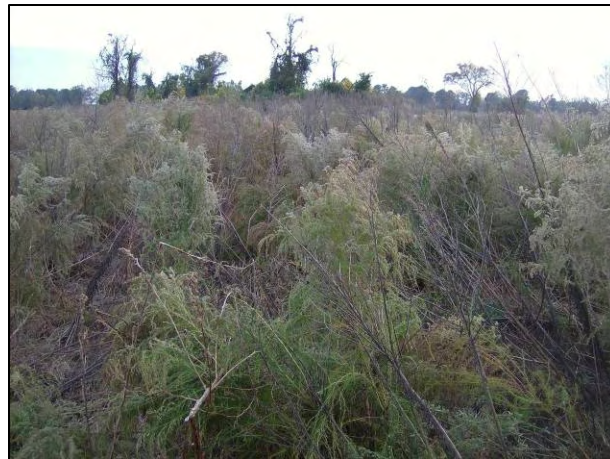
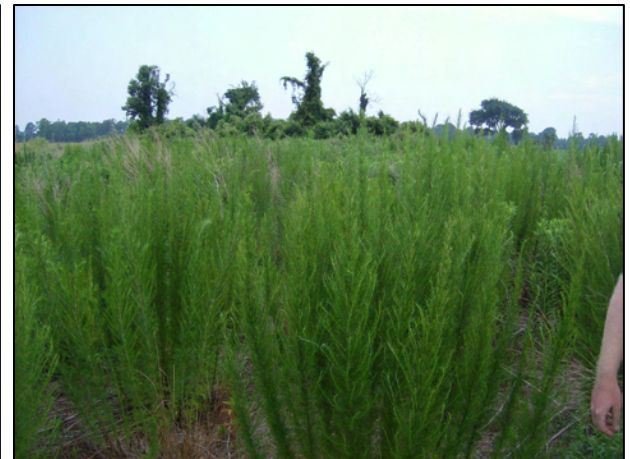
**Photostation #8:** Facing southwest along western axis of Vegetation Plot #3

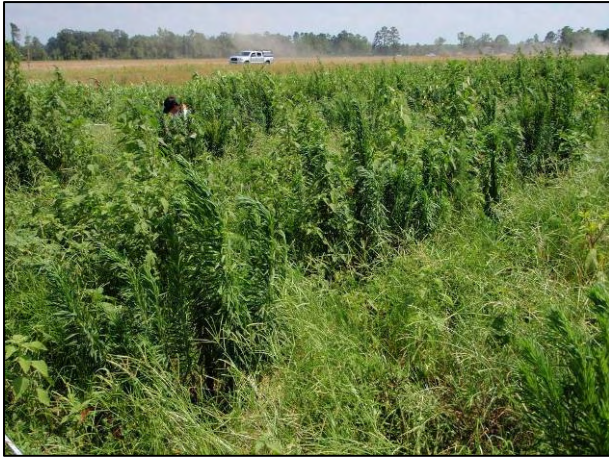
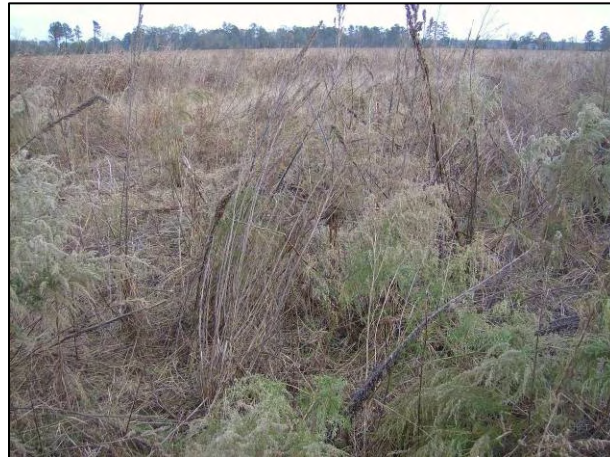
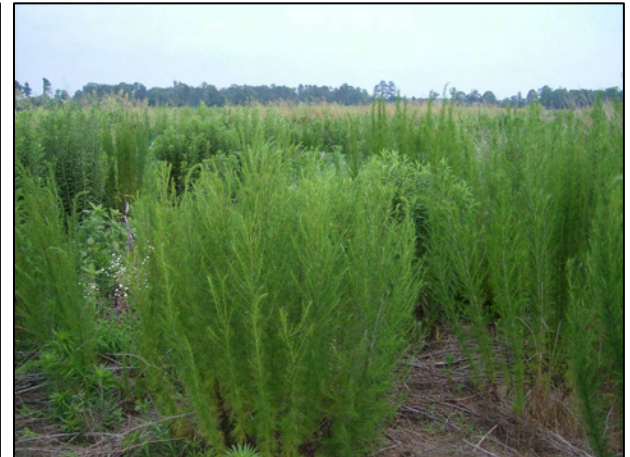
**Photostation #9: Facing southeast across Vegetation Plot #3**

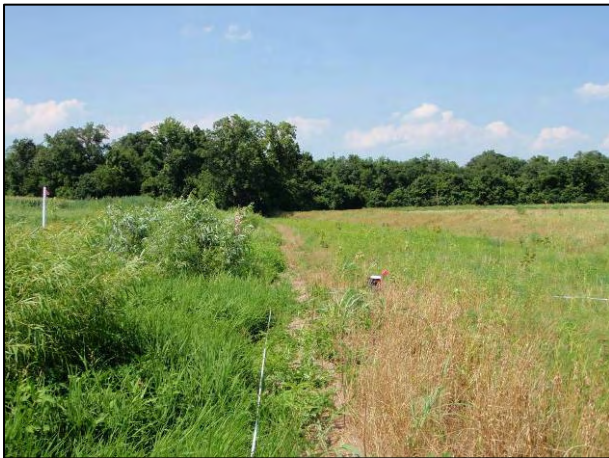
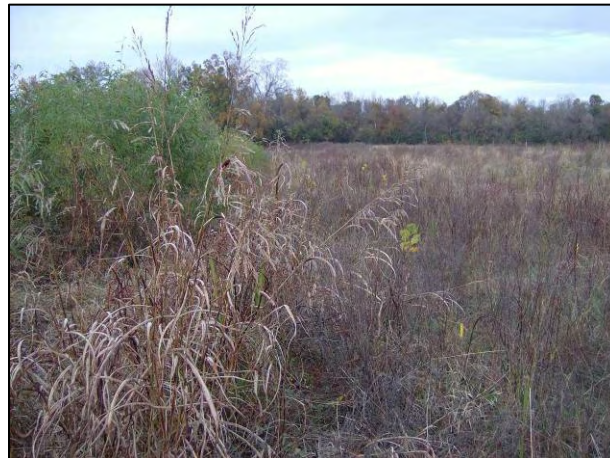
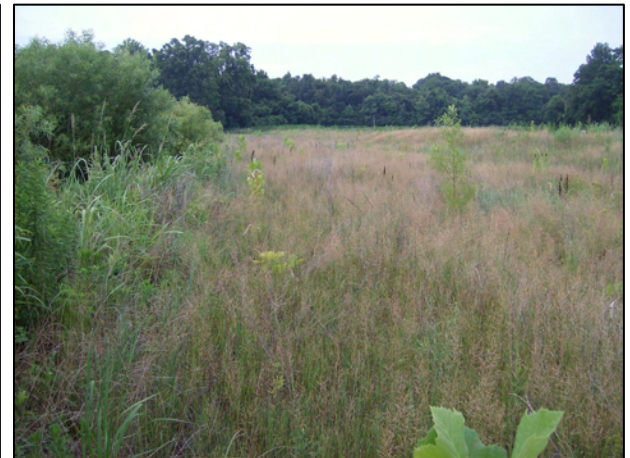
**Photostation #10: Facing northeast along tributary in the vicinity of Station 22+50**

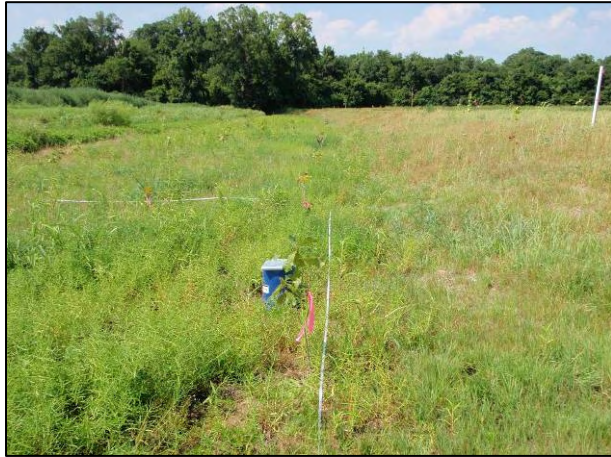
**Photostation #11:** Facing northeast along the eastern axis of Vegetation Plot #4
