BROCK STREAM RESTORATION SITE Monitoring Year 4 (2012)

**Jones County, North Carolina
EEP Project No. 92333**

Final Monitoring Report

December 2012

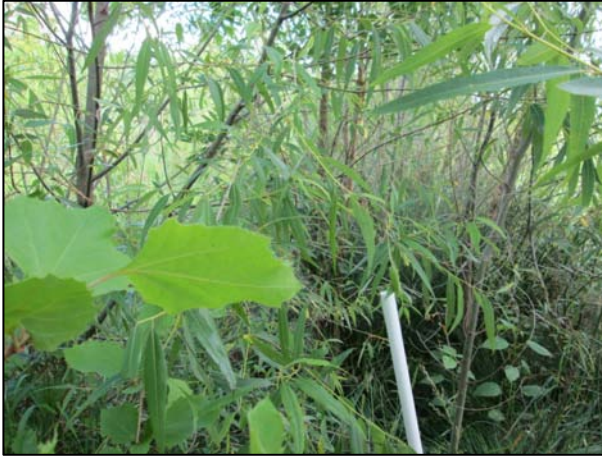
Photostation 2.
Facing northeast across Vegetation Plot #1.
Taken August 2012.

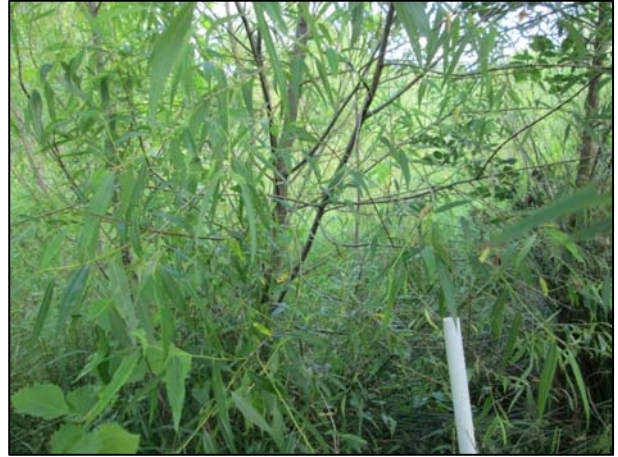
Photostation 3.
Facing north across Vegetation Plot #1.
Taken August 2012.

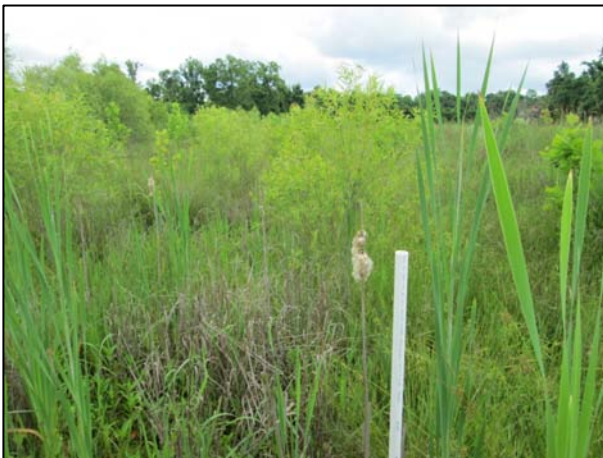
Photostation 11.
Facing northeast across Vegetation Plot #4.
Taken August 2012.

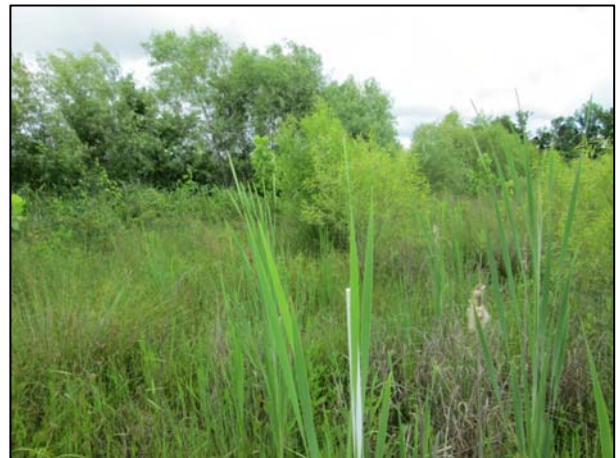
Photostation 12.
Facing north across Vegetation Plot #4.
Taken August 2012.

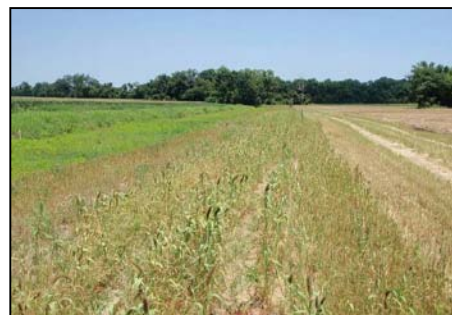
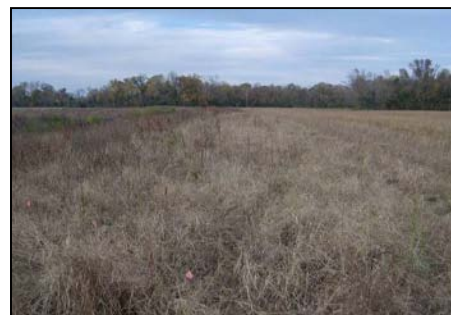
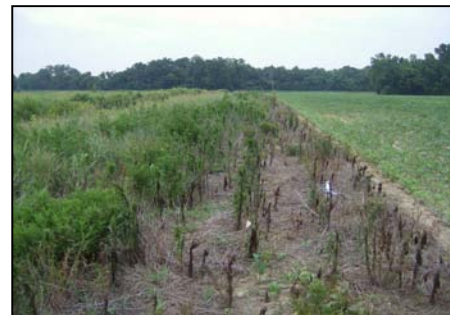
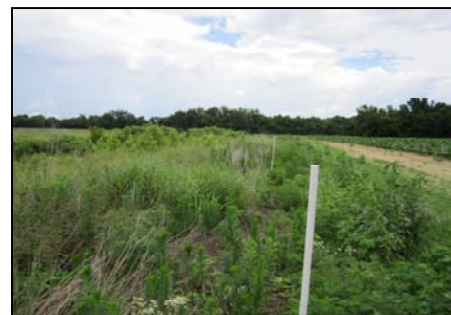
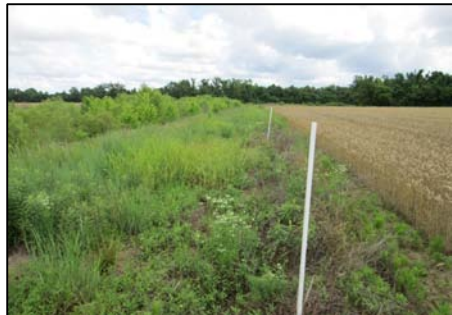
#5 Facing
northeast along
the east side of
Vegetation Plot
#2

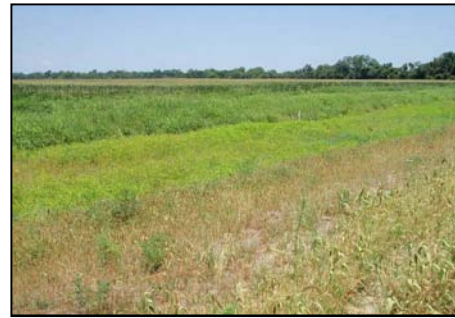
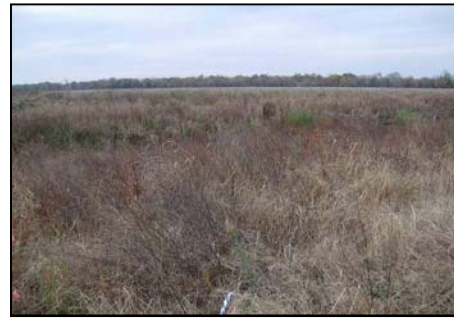
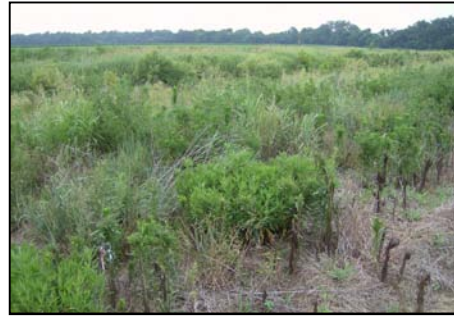
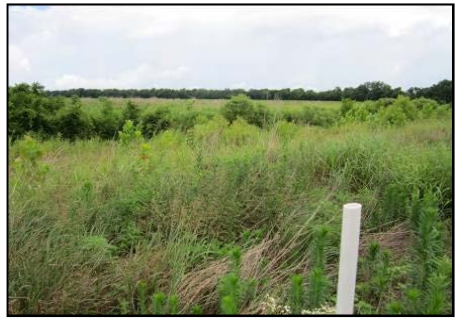
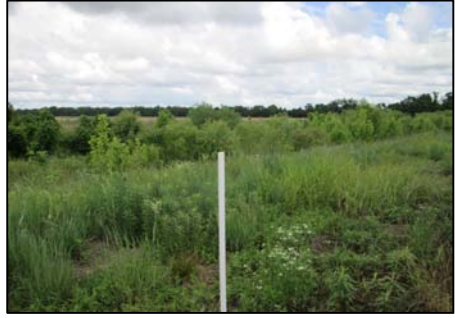
#6 Facing northwest across Vegetation Plot #2

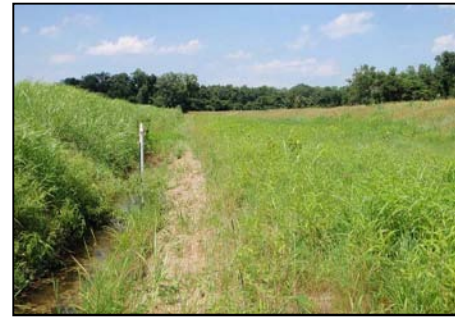
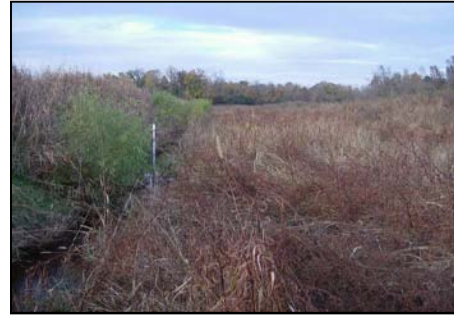
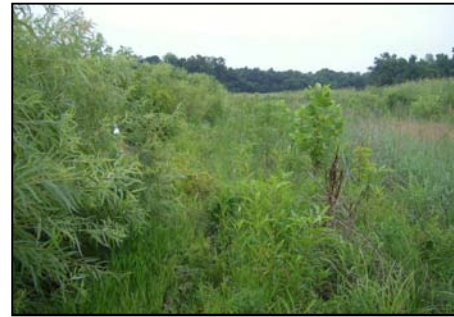
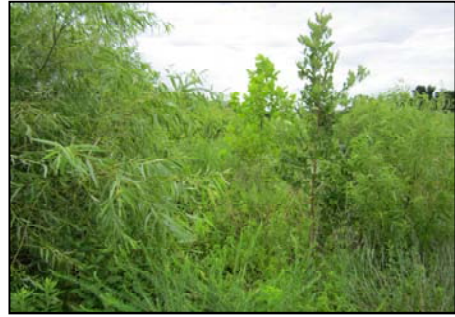
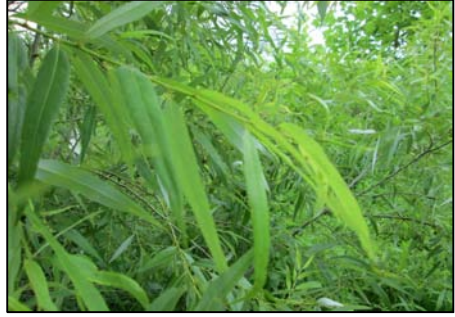
#7 Facing north-northeast at Crest Gage situated near Station 18+65

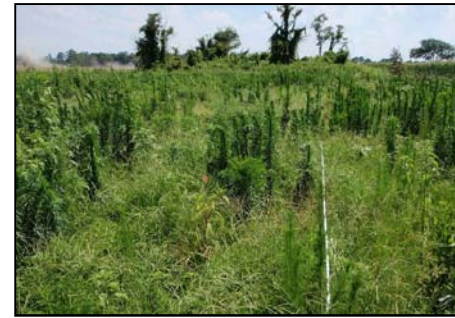
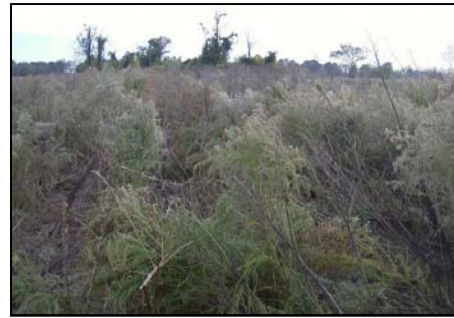
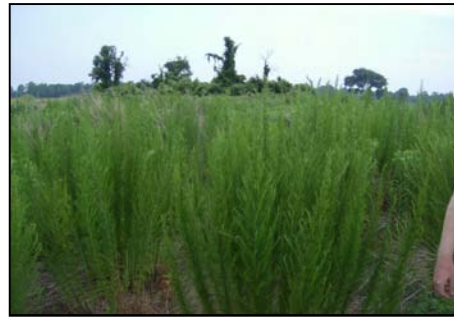
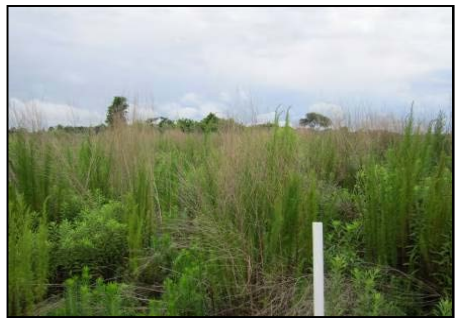
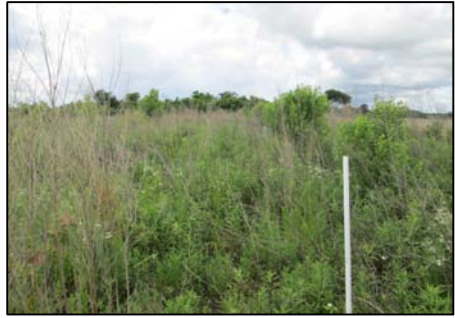
#8 Facing southwest along western axis of Vegetation Plot #3

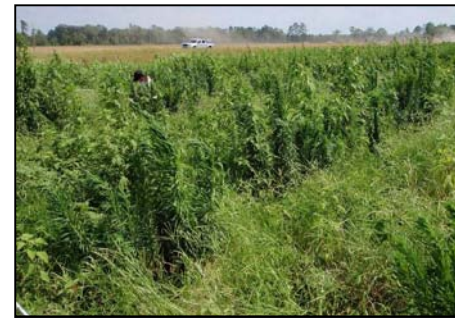
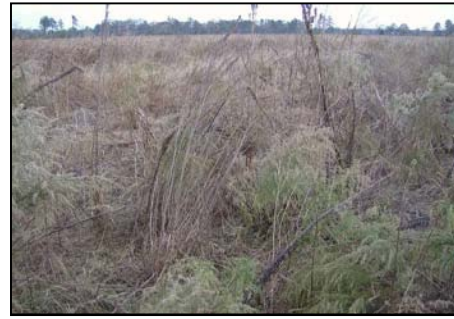
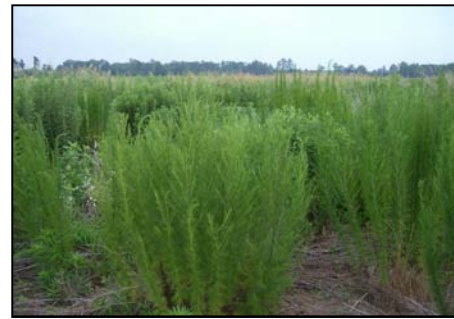
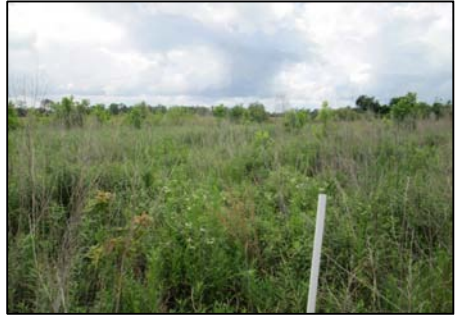
#9 Facing southeast across Vegetation Plot #3

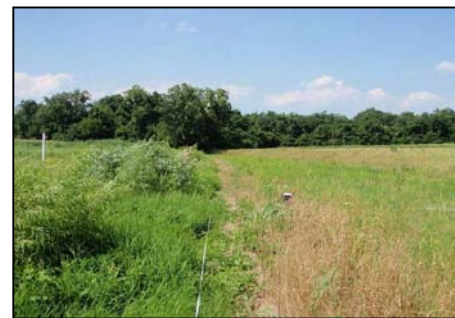
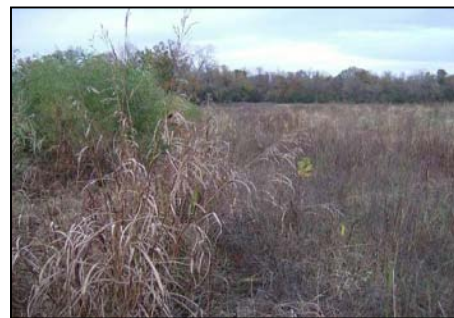
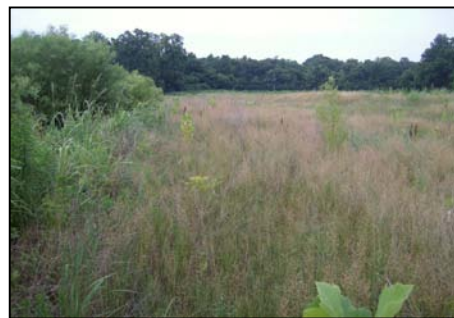
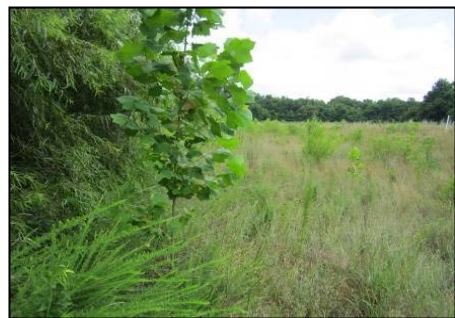
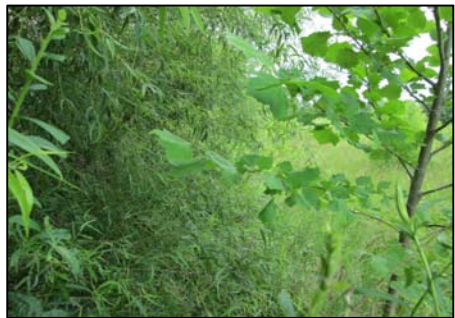
#10 Facing northeast along tributary in the vicinity of Station 22+50

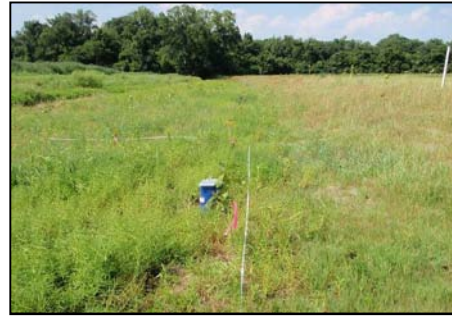
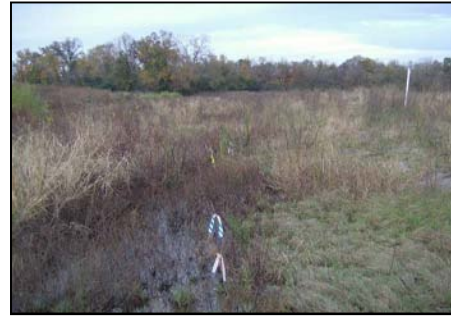
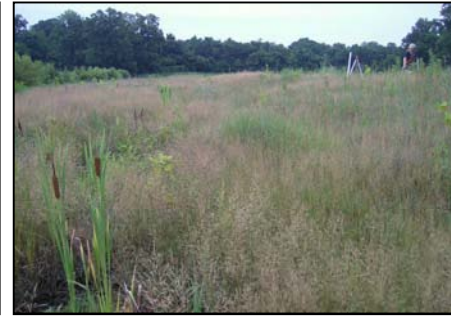
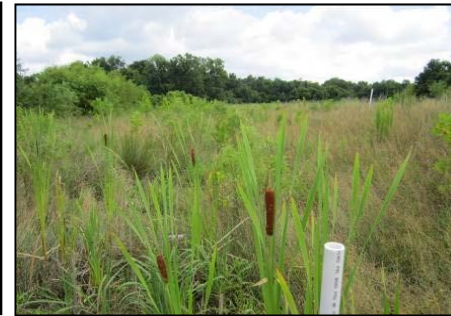
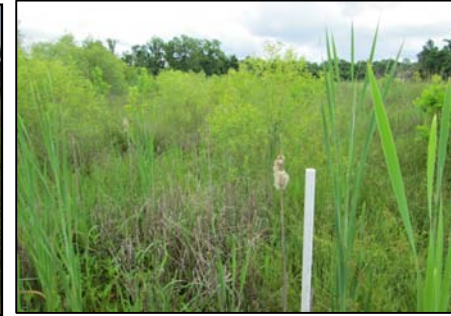
#11 Facing
northeast along
the eastern axis
of Vegetation
Plot #4

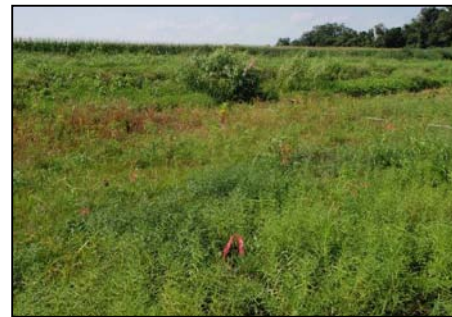
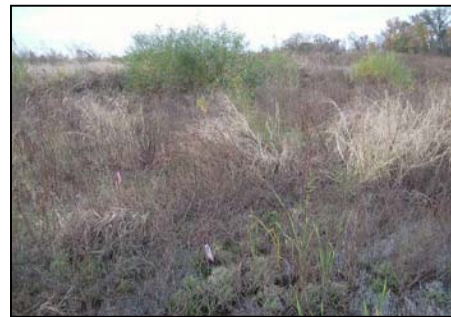
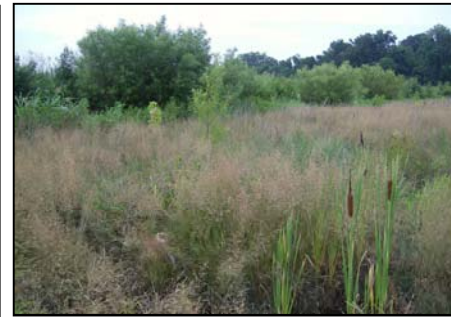
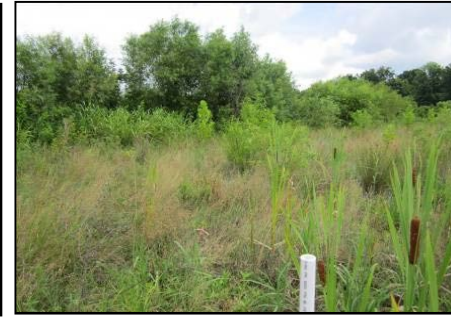
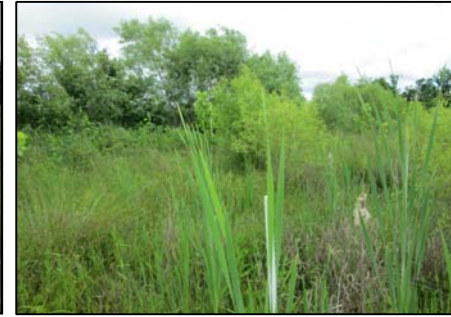
#12 Facing
northwest
across
Vegetation Plot
#4

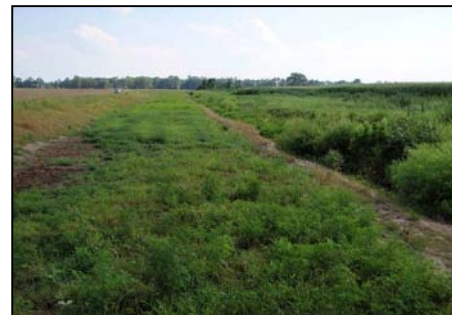
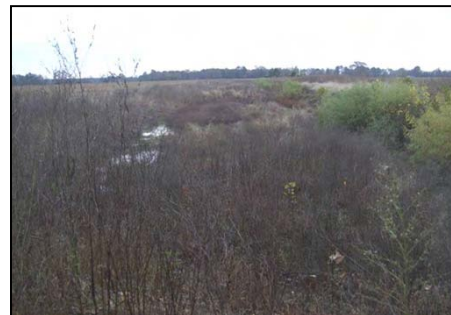
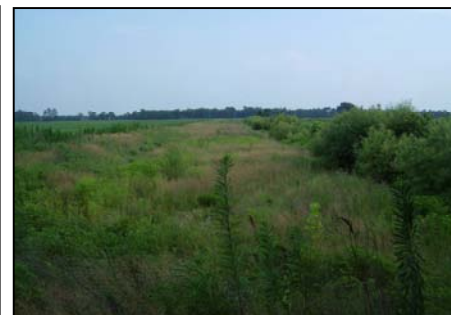
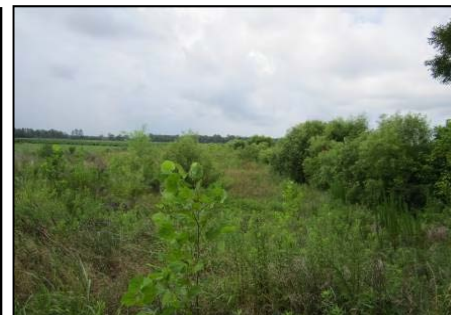
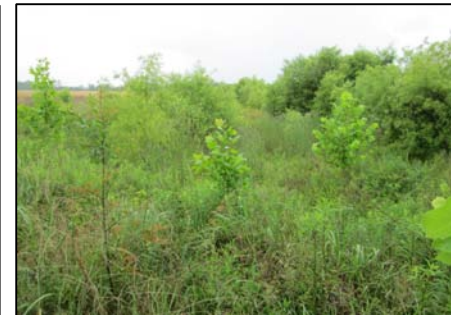
#13 Facing
southwest
(upstream)
along the
tributary from
Station 28+25

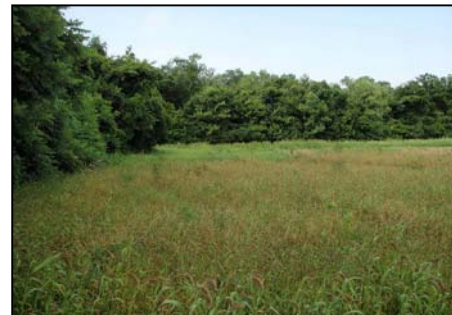
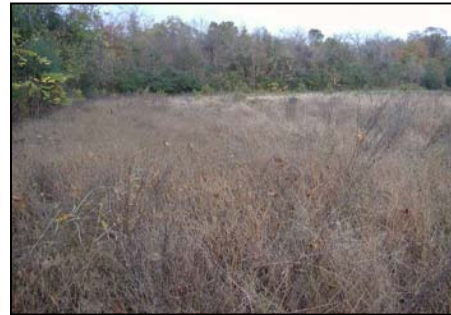
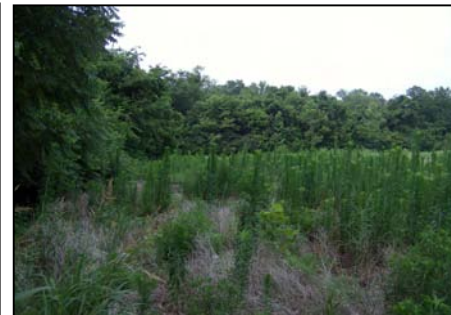
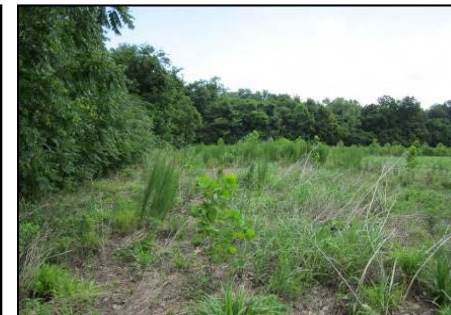
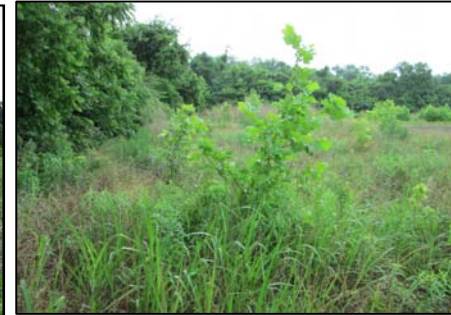
#14 Facing
northeast along
buffer area
associated with
tributary from
Station 28+25
