BROCK STREAM RESTORATION SITE Monitoring Year 5 (2013)

**Jones County, North Carolina
EEP Project No. 92333**

Final Monitoring Report

December 2013

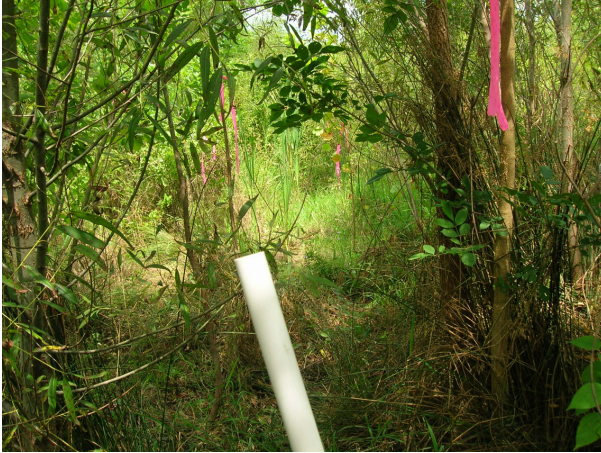
Photostation 2.
Facing northeast across Vegetation Plot #1.
Taken August 2013.

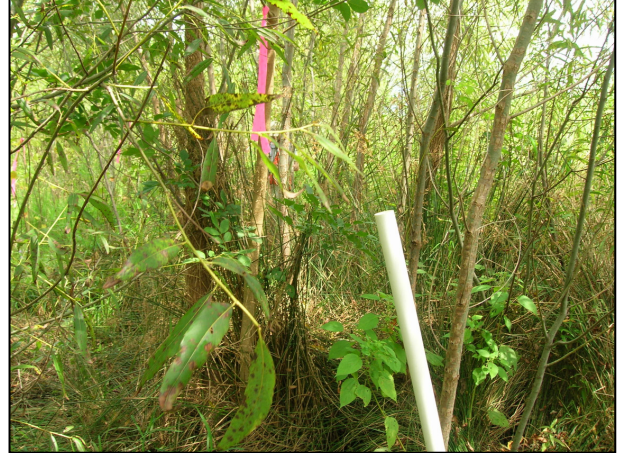
Photostation 3.
Facing north across Vegetation Plot #1.
Taken August 2013.

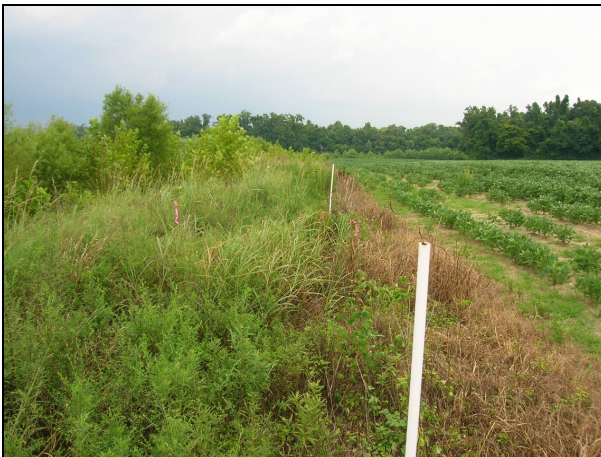
Photostation 5.
Facing north across Vegetation Plot #2.
Taken August 2013.

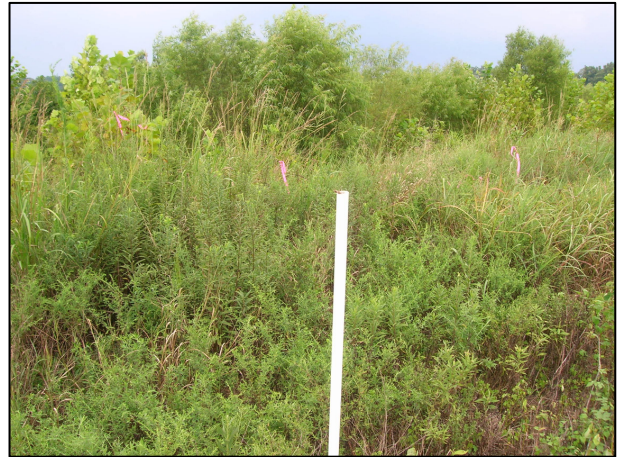
Photostation 6.
Facing northwest across Vegetation Plot #2.
Taken August 2013.

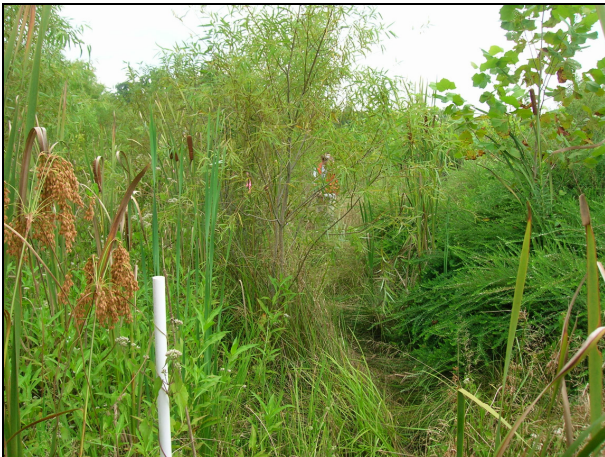
Photostation 11.
Facing northeast across Vegetation Plot #4.
Taken August 2013.

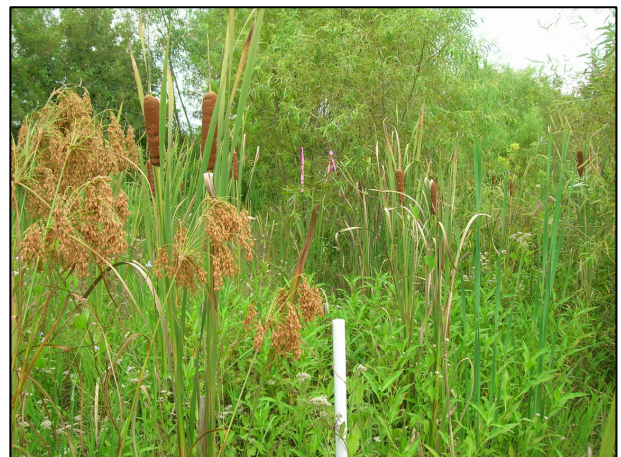
Photostation 12.
Facing north across Vegetation Plot #4.
Taken August 2013.
