BROWN BRANCH STREAM RESTORATION

FIRST YEAR MONITORING REPORT

May 2004

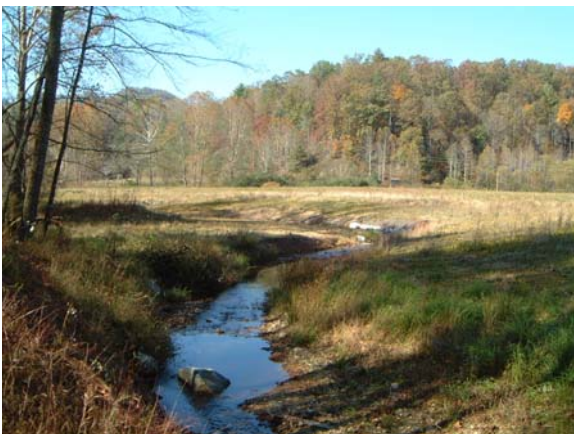
Photo Station #17. Looking downstream from as-built Station ~12+50. Tributary confluence to left. Rock has rolled from bank into channel from left.

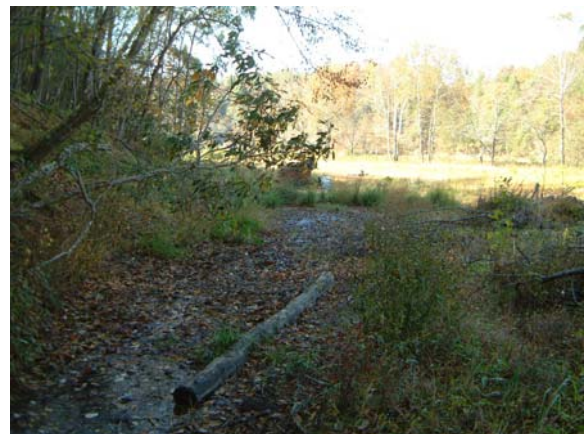
Photograph NM-54. Looking west across wetland near as-built Station ~8+00.

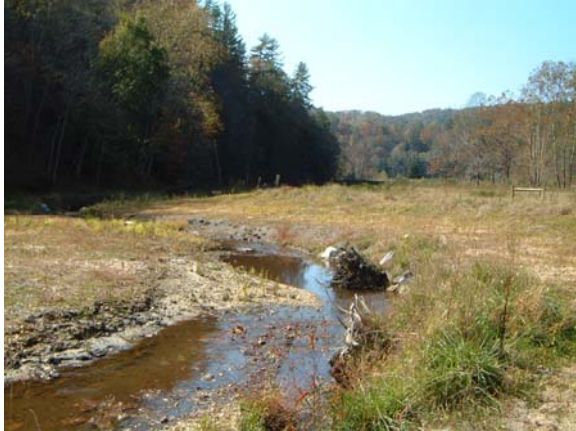
Photograph NM-55. Looking downstream at rootwads from as-built Station ~8+50.

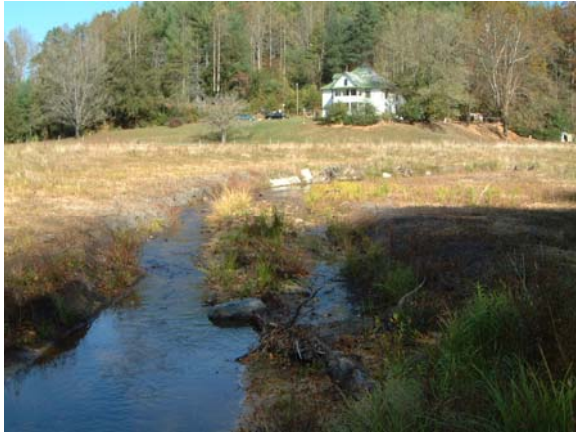
Photograph NM-57. Looking upstream at log vane from as-built Station ~7+00.

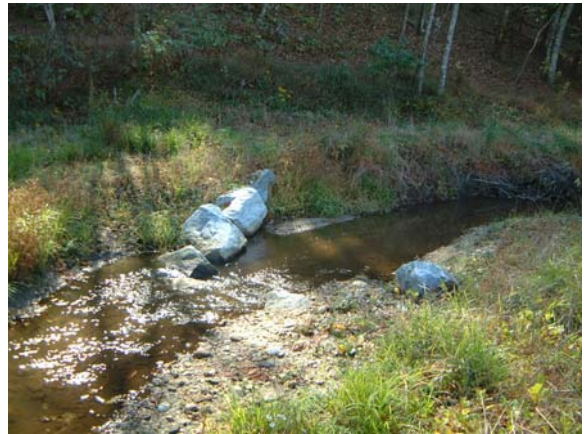
Photograph NM-58. Looking downstream at rock "J" vane from as-built Station ~6+80.

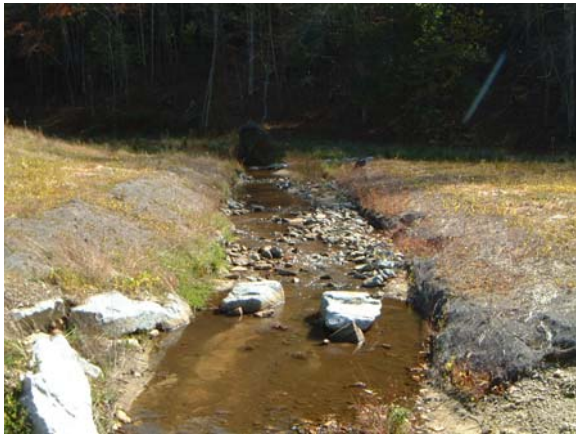
Photograph NM-63. Looking upstream at rock "J" vane from as-built Station ~5+25.

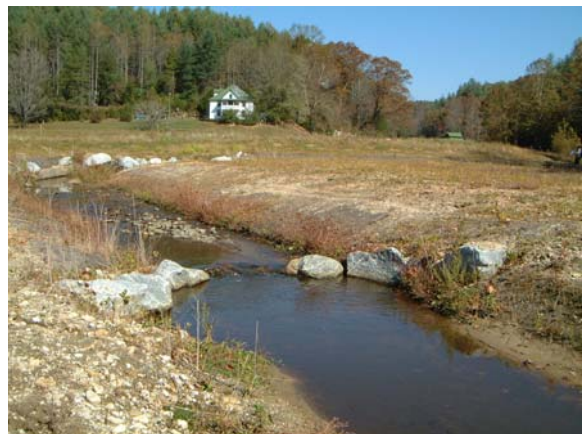
Photograph NM-66. Looking upstream at cross vane from as-built Station ~4+00.

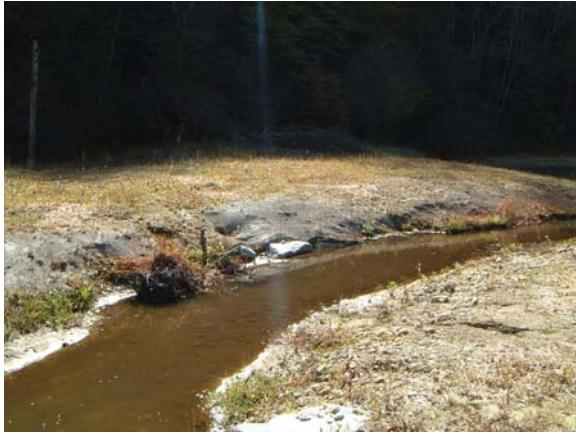
Photograph NM-67. Looking downstream at rootwad from as-built Station ~4+00.

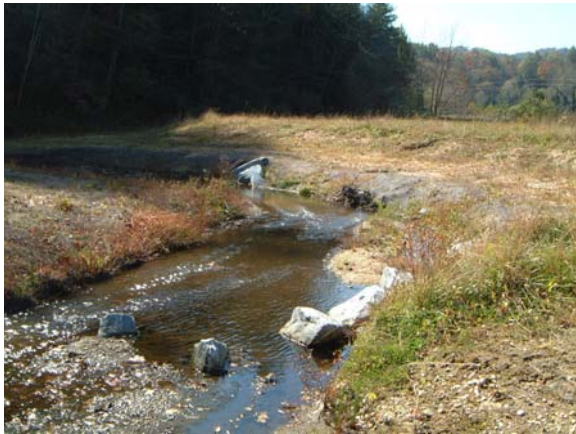
Photograph NM-69. Looking downstream at rock "J" vane from as-built Station ~3+25.

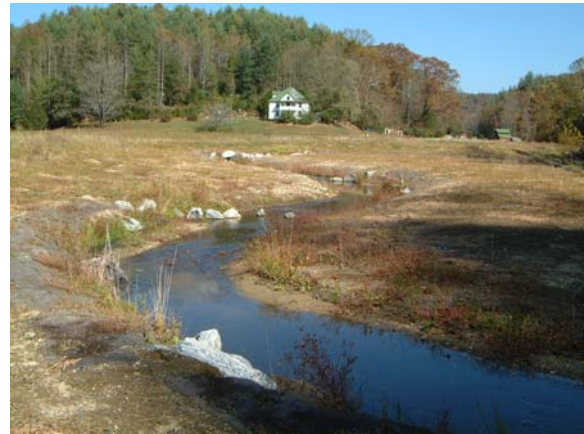
Photograph NM-70. Looking upstream from as-built Station ~2+75.

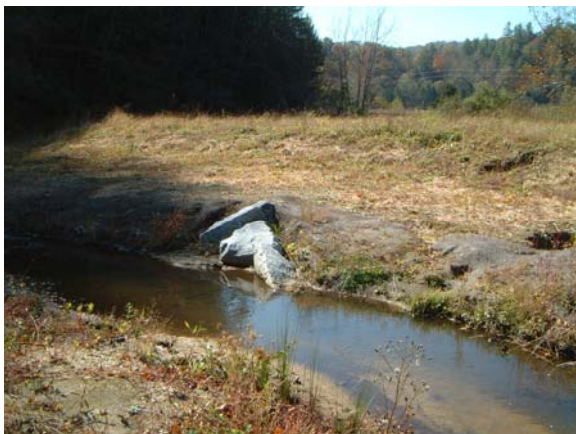
Photograph NM-71. Looking downstream at rock vane from as-built Station ~2+75.

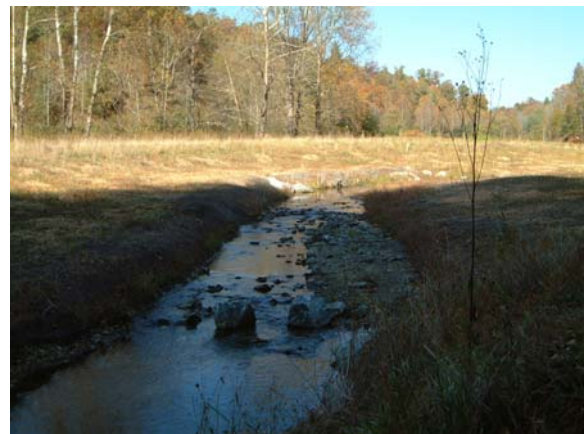
Photograph NM-72. Looking upstream at rock "J" vane from as-built Station ~2+00.

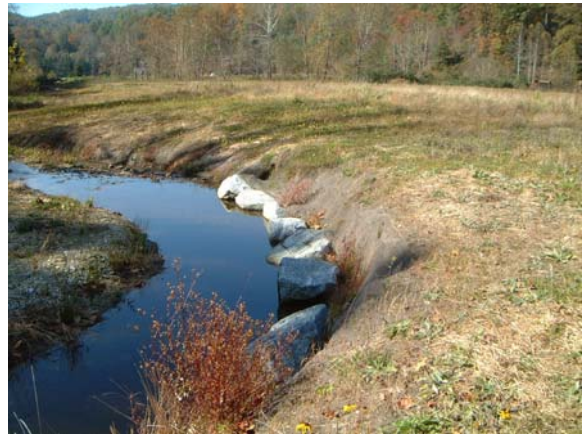
Looking downstream at rolled rocks at as-built Station ~11+00.

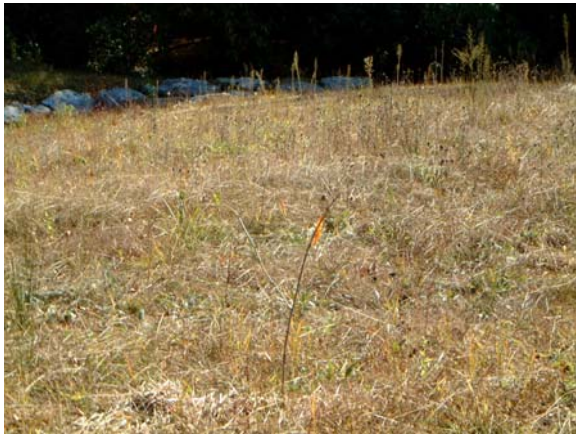
Poor quality bare root plant.
