Brown Branch Stream Restoration (Anita Alta 4-H Camp) 2004 Annual Monitoring Report

February, 2005

2004 Brown Branch Monitoring Abstract

This is the 2nd year of the 5-year monitoring plan for Brown Branch.

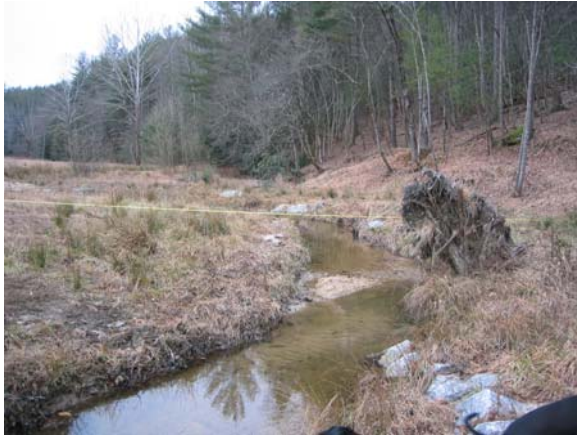
Typical Pool

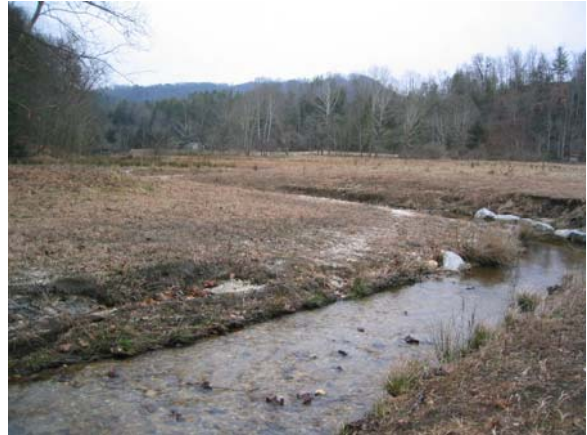
Typical Riffle

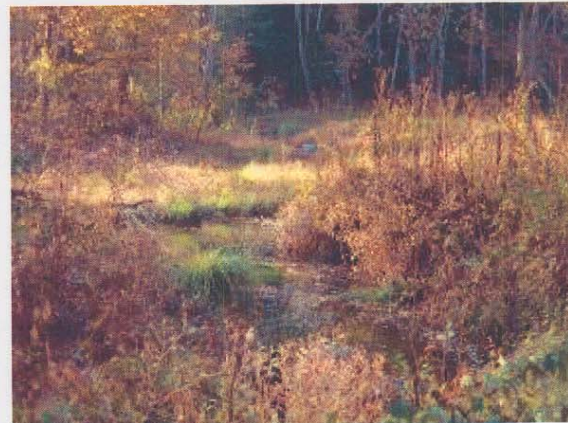
Photo Station #4. Looking downstream from as-built Station ~44+00. Oxbow wetland in foreground.

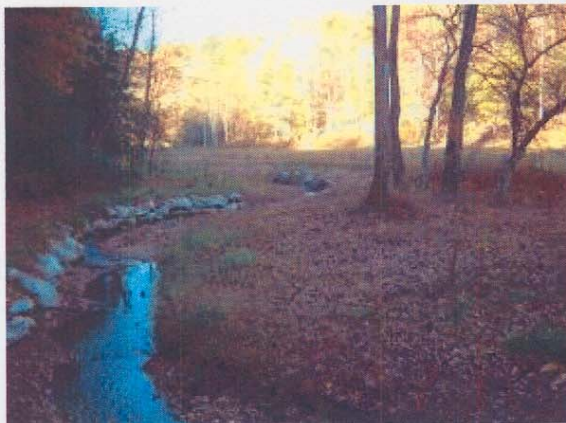
Photo Station #5. Looking downstream at channel plug protection from as-built Station ~41+25.

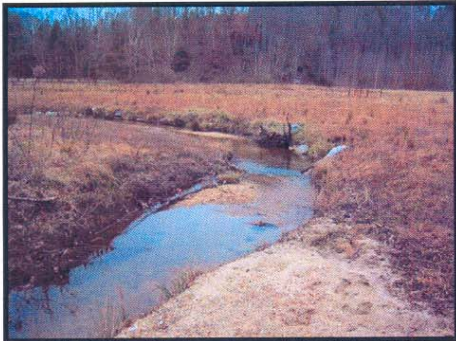
STA 41+50 Looking Downstream @Lateral Channel Bar

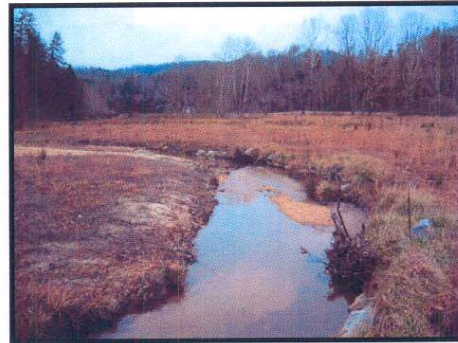
STA 42+10 Looking Downstream @Root Wad Scour

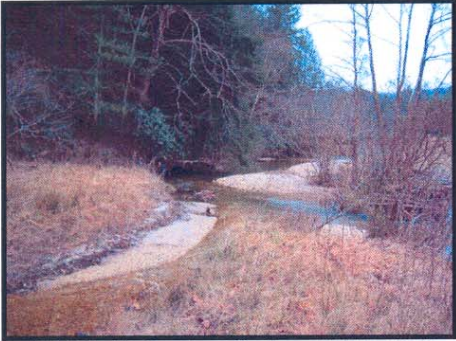
STA 50+60 Looking Downstream @ Confluence with Mulberry Creek
