# Brown Creek Tributaries Restoration Project Final Year 1 Monitoring Report

DMS Project ID No. 95351, DEQ Contract No. 004641

Project Info:           Monitoring Year: 1 of 7  
                              Year of Data Collection: 2015 (vegetation) and 2016 (survey)  
                              Year of Completed Construction: 2015  
                              Submission Date: January 2017

Report Prepared and Submitted by Michael Baker Engineering, Inc.

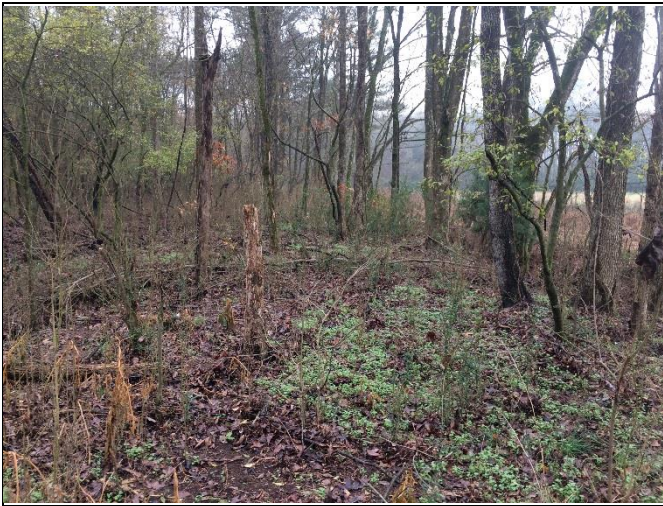
9) Reach HC-R3 – VPA: Invasive species resprouts (Chinese privet), Station 14+00
