Brown Creek Tributaries Restoration Project Final Year 2 Monitoring Report

DMS Project ID No. 95351, DEQ Contract No. 004641

Monitoring Year: 2 of 7
Year of Data Collection: 2016
Year of Completed Construction: 2015
Submission Date: January 2017

Report Prepared and Submitted by Michael Baker Engineering, Inc.

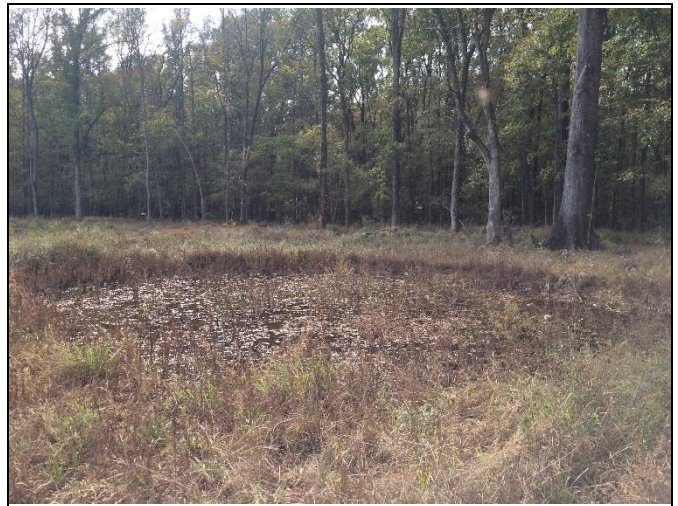
HC Reach 1, vernal pool at Station 26+25

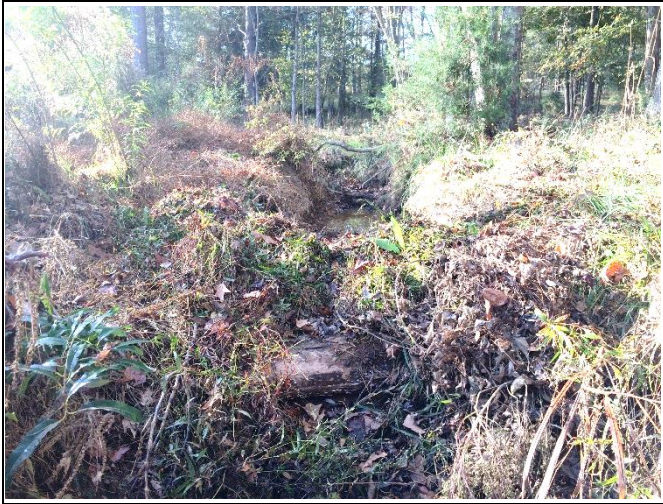
Reach UT4-R4ab – View upstream, Station 11+50
